Pre-Purchase Report of Marine Survey

1981 40' Ocean Alexander Ocean 40

Cpt. Mark Van der Vliet

Date Of Survey: November 19, 2025

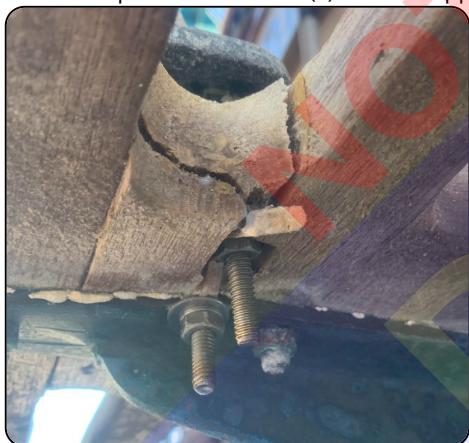
**Finding C-2**

A minor crack in the teak at the starboard dinghy mounting hardware fasteners was sighted.

No action is required at time of survey. Monitor often and repair, as necessary.

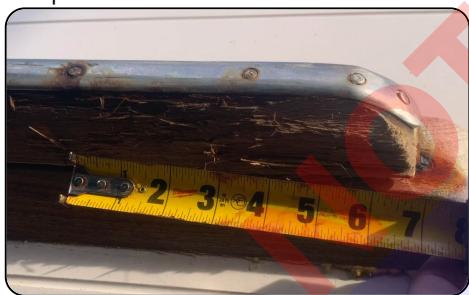
**Finding C-3**

Approximately 7" of the starboard forward rubrail base sighted with slight damage. No soft wood was observed, and no hull damaged was sighted.

No action is recommended at time of survey. Monitor often, and address as necessary.

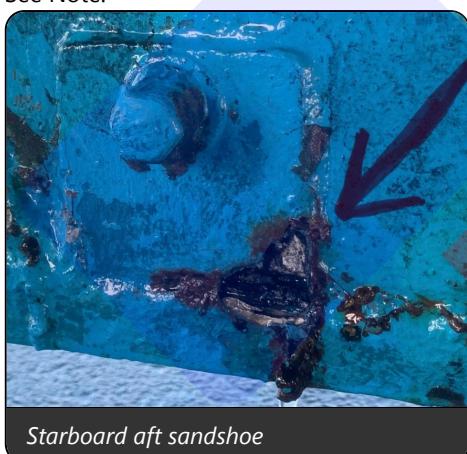
Starboard aft sandshoe

Finding B-1

The sandshoe/skeg aft starboard keel tab was slightly damaged.

No action is required at time of survey. Recommend at next haul-out for bottom painting, remove paint to bare metal, weld a small cover plate or replace tab.

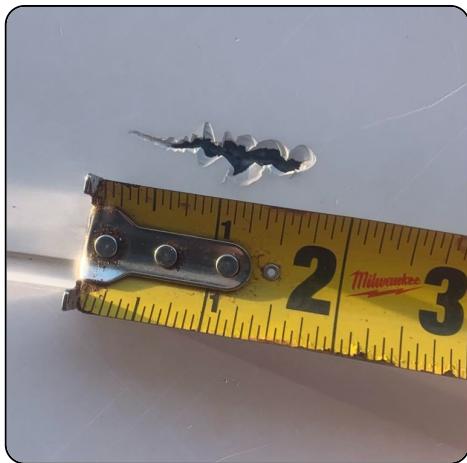
**Finding C-7**

An approximately 1/4" diameter and a 1.5" long gelcoat chip were sighted just below the port forward rubrail and port bow above the waterline.

Prepare the surface and repair the gelcoat to prevent laminate water intrusion, as necessary.

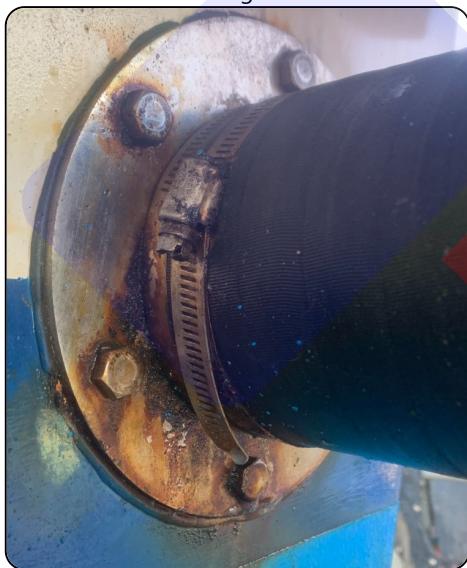
Finding C-8

Minor corrosion was sighted at base of exhaust through-hull plate.

Clean corrosion from plate, polish, and monitor frequently.

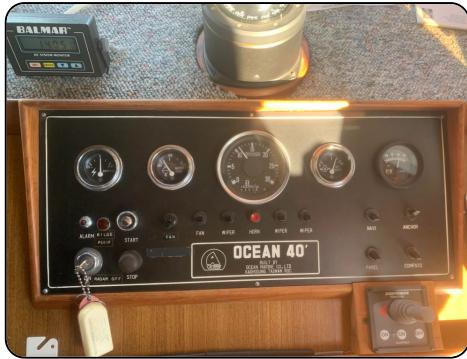
**Finding B-2**

Reportedly, the Volts gauge at the lower helm does not function properly.

Investigate further/trace, and service, repair or replace as necessary.

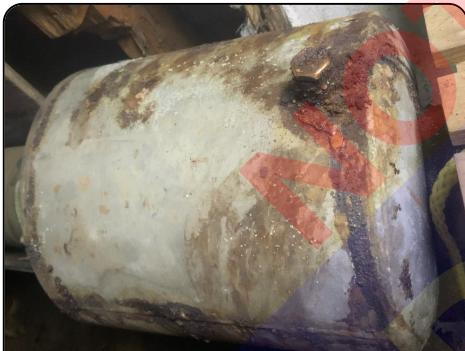
Exhaust muffler in lazarette

Finding C-9

Minor corrosion was sighted at the exhaust muffler in the lazarette.

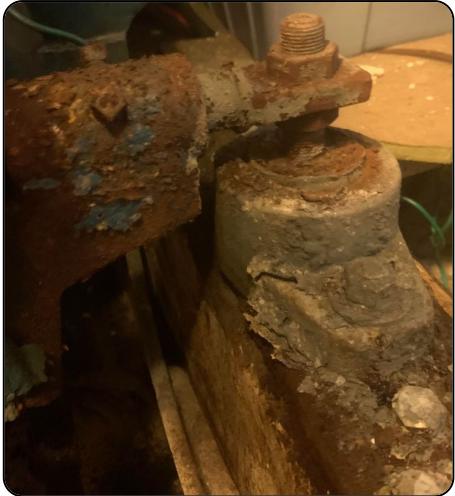
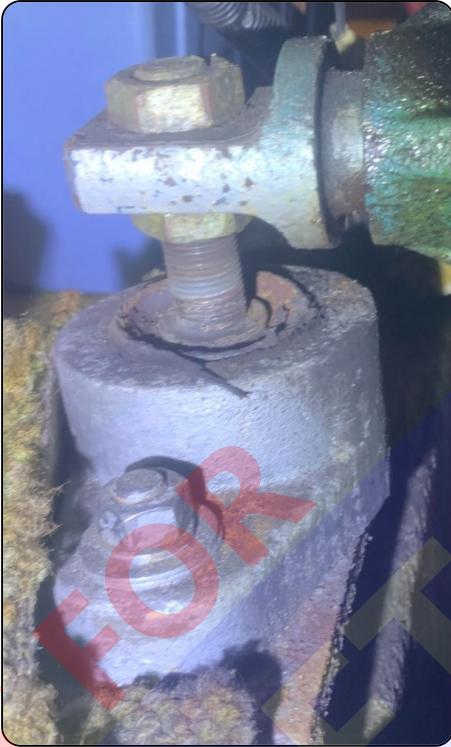
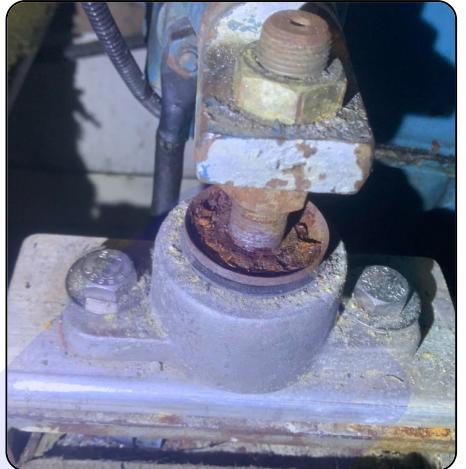
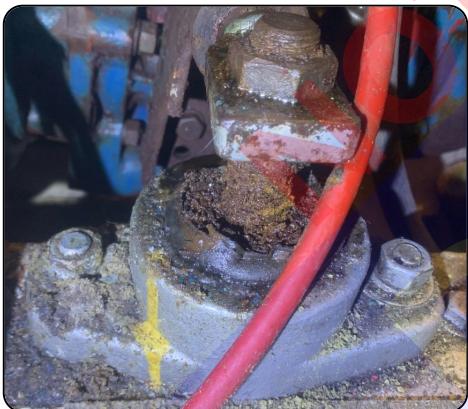
**Finding B-3**

Two (2) engine motor mounts were sighted with slight corrosion. See Engine Survey.

Recommend cleaning corrosion to investigate further and address as necessary.

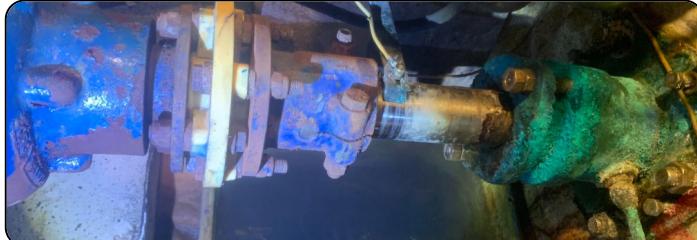
Finding B-4

The propeller shaft's packing glands leaked slightly excessive raw water while underway.

Also recommend emptying the sump below the packing gland and cleaning the shaft through-hull fitting plate to inspect further. Consider installing an automatic sump pump in the shaft packing gland sump.

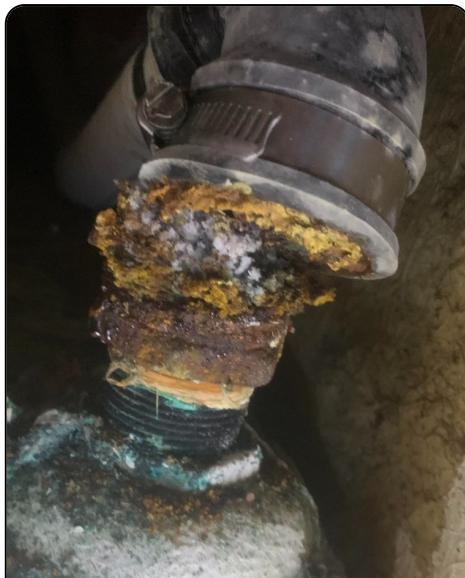
Forward tank connection

Finding B-10
