Pre-Purchase Report of Marine Survey

2023 34' Ranger Tugs R-31 S

Cpt. Mark Van der Vliet

Date Of Survey: August 21, 2025

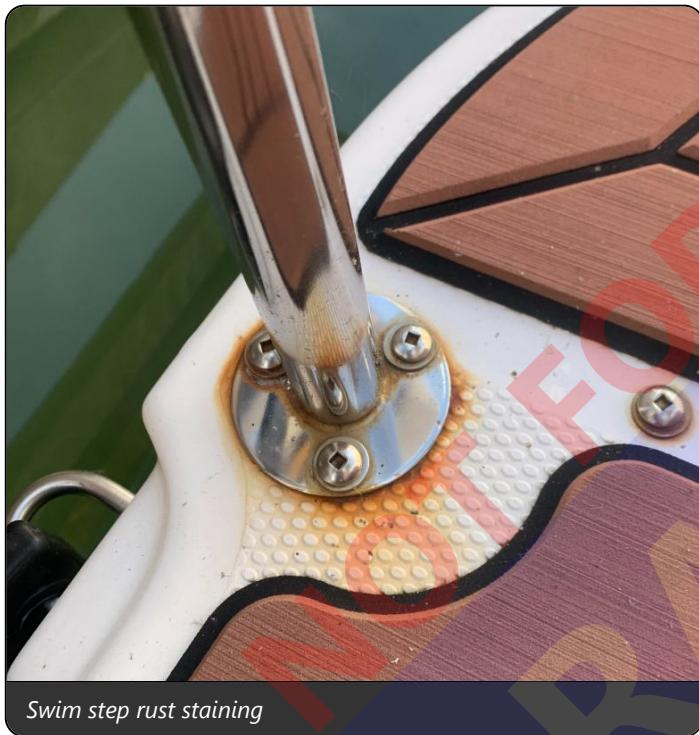
**Finding C-1**

Several of the swim steps stanchions had rust staining around their bases.

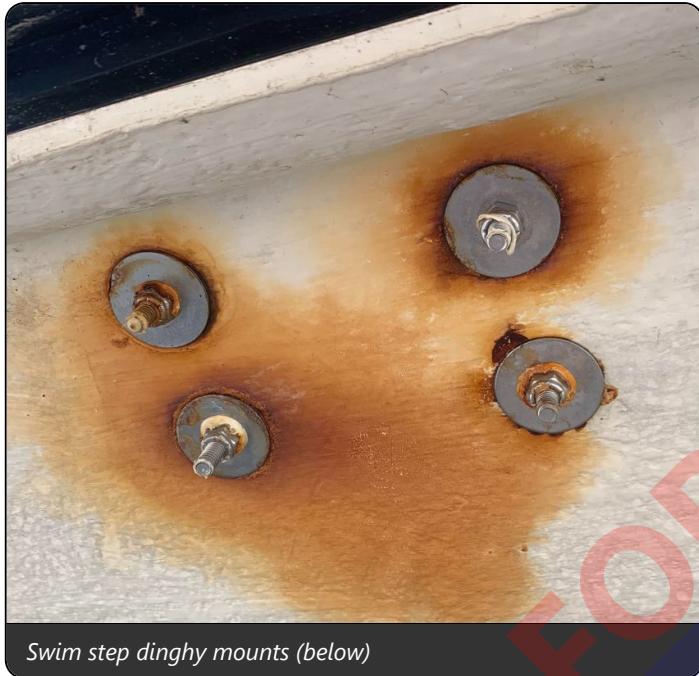
Swim step dinghy mounts (below)

Minor rust staining was observed around the port swim step dinghy mounting hardware washers.

Finding B-2

At next haul-out, recommend remove dinghy mounting hardware, investigating further, and coating all surfaces with anti-corrosion application.

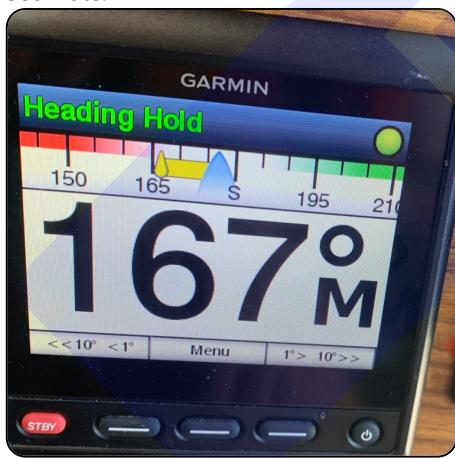
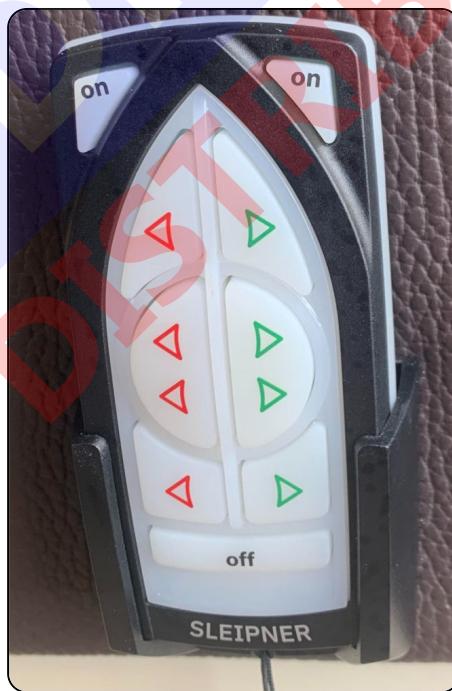
Finding A-1

The shadow drive appeared to malfunction during the trial run, causing a momentary steering failure that did not allow the helm to be turned over to port.

Investigate further/trace, and service, repair or replace and test/prove, as necessary.
