Pre-Purchase Report of Marine Survey

1947 40' Chris Craft Constellation

Cpt. Mark Van der Vliet

Date Of Survey: December 11, 2025

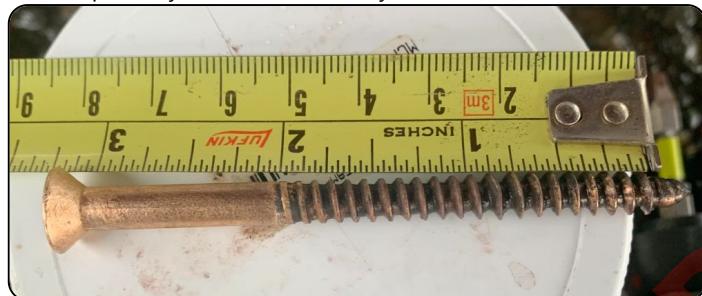
A randomized set of fasteners were removed for inspection from the hull bottom in areas determined to be most susceptible to failure such as below the engines, chines, and garboard plank. The removed fasteners were clean and dry, with sharp/defined threads, and free of corrosion at the time of survey.

Note: reportedly, the hull underbody was refastened in 2013.

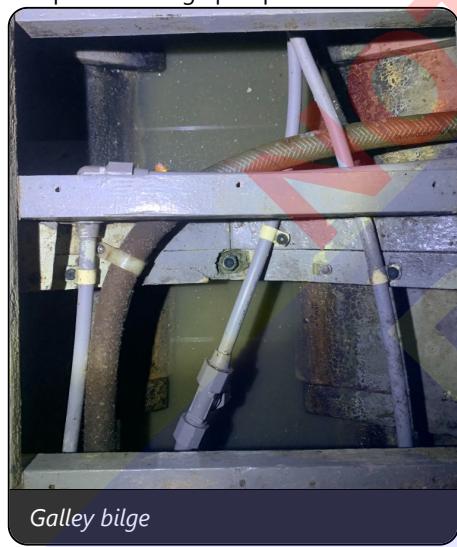
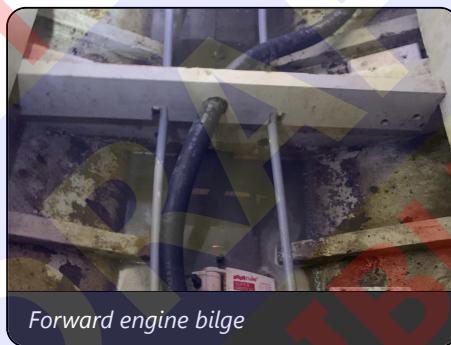
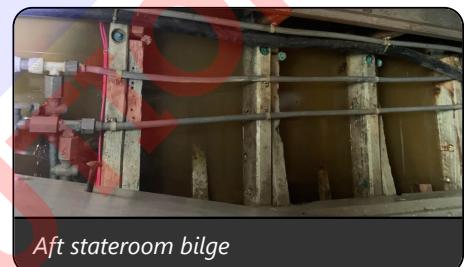
Minor water accumulation was observed in the bilges after the trial run. Recommend drying the bilges and monitoring.

Note: The water accumulated in the aft stateroom bilge appeared to be below the limber hole, inhibiting drainage to the engine compartment bilge pump.

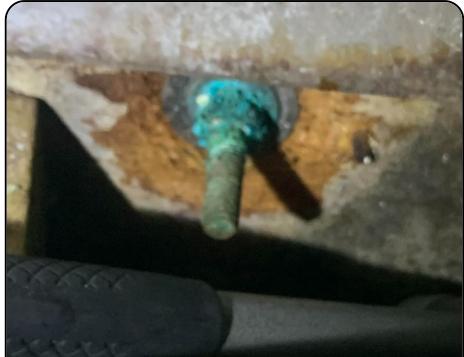
Minor soft wood was sighted at centerline transom swim support fastener (inside lazarette) and starboard aft corner batten (lazarette).

Transom swim support fastener in lazarette

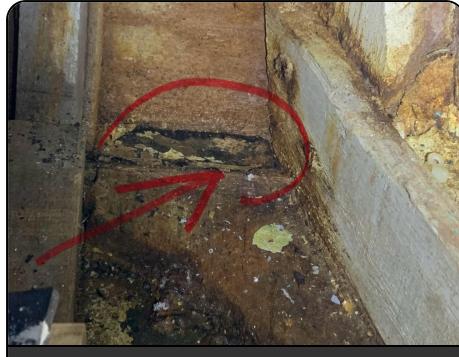
starboard aft corner batten

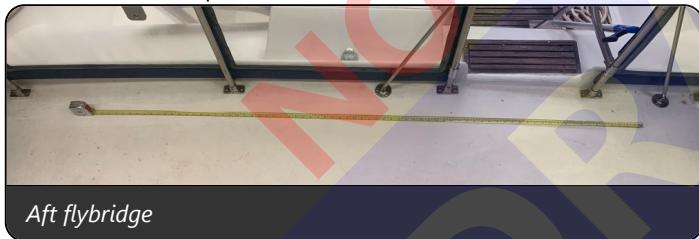
Aft flybridge

Finding B-1

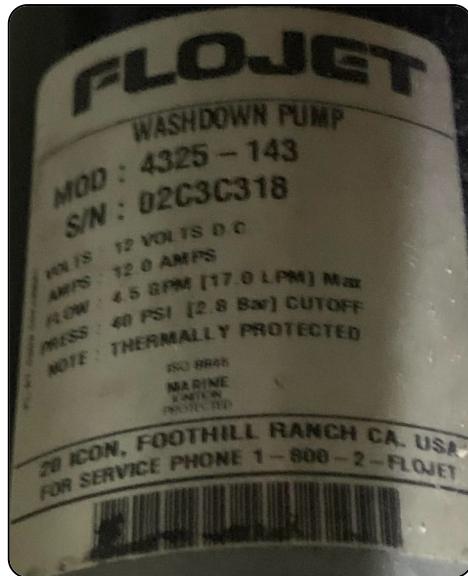
**Finding B-2**

The raw water washdown pump did not power up when tested.

Investigate the raw water washdown pump to determine the cause of the failure and repair or replace, as necessary.

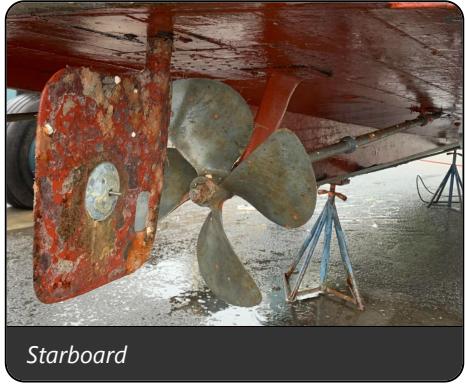
Starboard

Dual 4-bladed bronze propellers. No visual indication of alloy breakdown, cavitation erosion, dents, or damage were sighted on the propeller blades and roots. There was no excessive play between the propeller hubs.

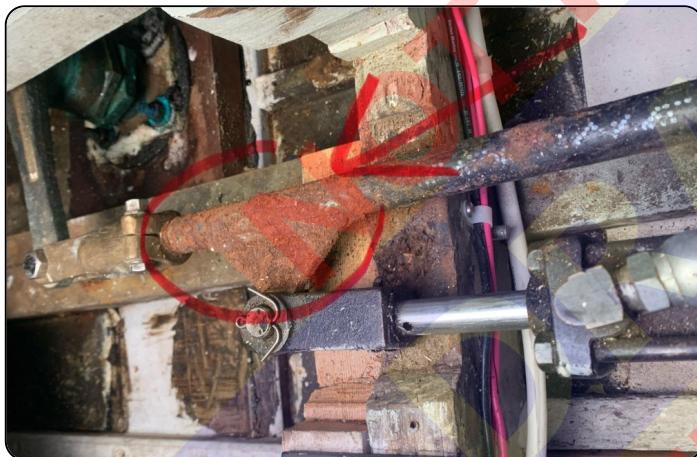
**Finding B-3**

Corrosion was sighted on the starboard rudder arm assembly.

Clean corrosion, inspect further, treat with corrosion inhibitor, replace if necessary.

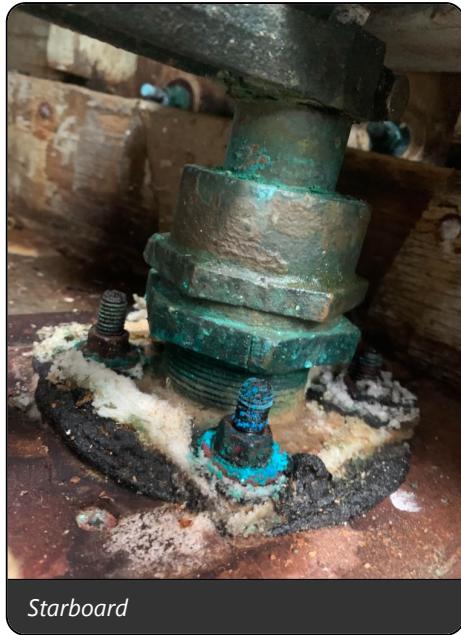
Starboard

NOTE: some green corrosion was observed around the starboard packing gland.

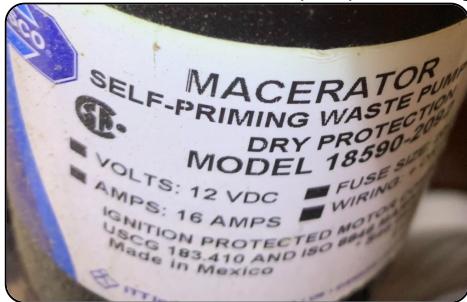
**Finding B-4**

The bronze blackwater discharge valve appeared recently new, but was not able to be operated by hand.
