2002 42' Valiant V42CE

Pre-Purchase Report of Marine Survey

Date Of Survey: October 7, 2025

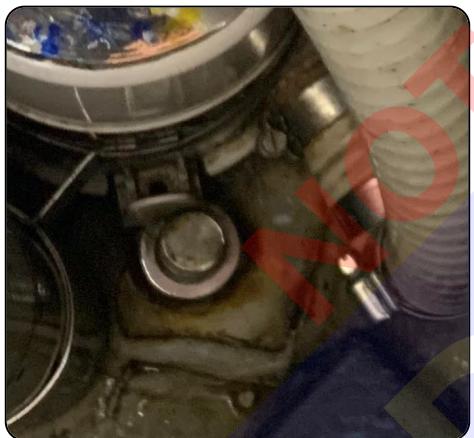
Minor galvanic corrosion on backing plate from a SS washer- removed at survey.

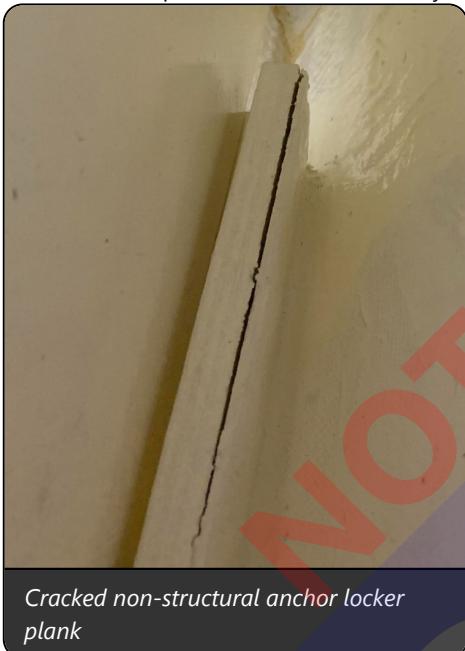
The painted/epoxied chain separator plank at the stem in the anchor locker (non-structural) was sighted to be split/cracked.

No action is required at the time of survey. Monitor and address, as necessary.

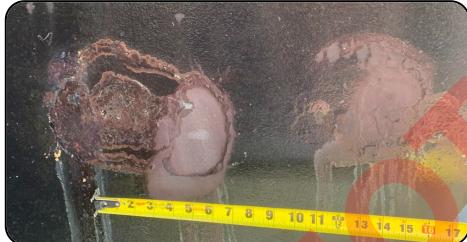
**Finding B-2**

Large paint blisters were sighted on the port aft keel and small paint blisters were sighted on the keel.

At next haul out, recommend prepare and repaint bottom paint.

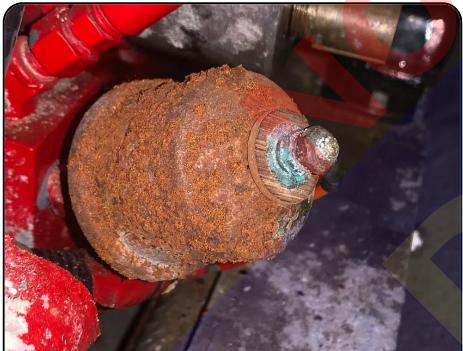
Oil pressure sender

The oil pressure sender was corroded and the heat exchanger caps were sighted with salt residue and minor corrosion.

Replace the oil pressure sender unit, clean the salt and corrosion from the heat exchanger caps to investigate further. Replace cap gaskets, if necessary, and replace zincs regularly.

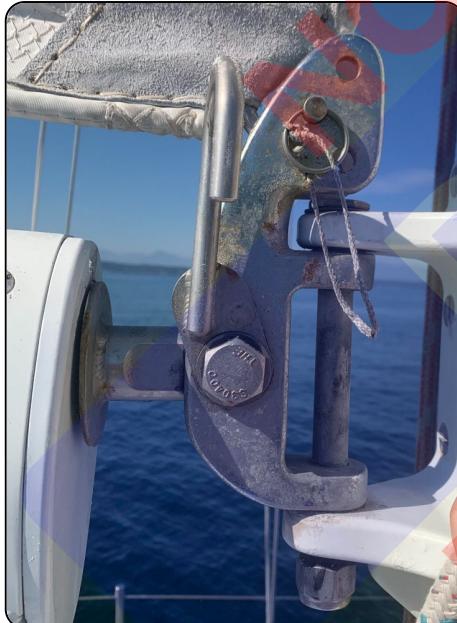
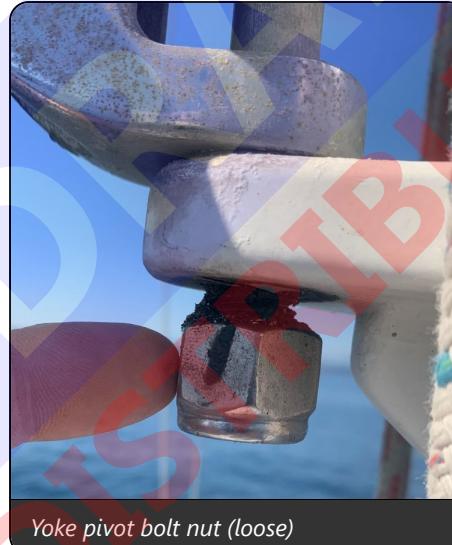
Yoke pivot bolt nut (loose)

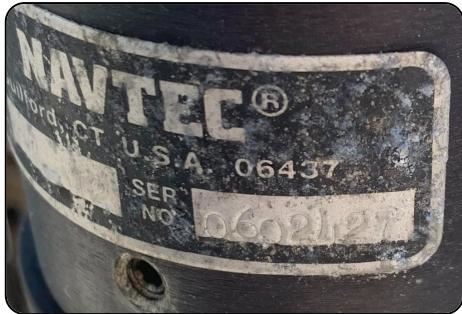
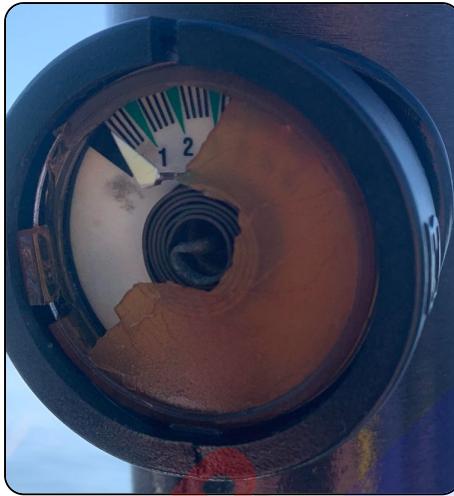
**Finding B-5**

The hydraulic backstay gauge window was broken, and minor hydraulic fluid was observed at the top of the strut.

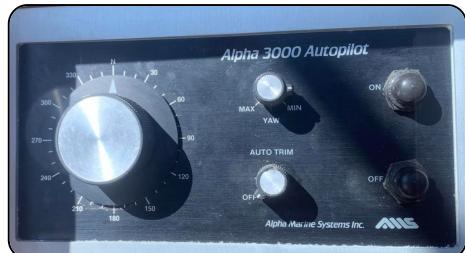
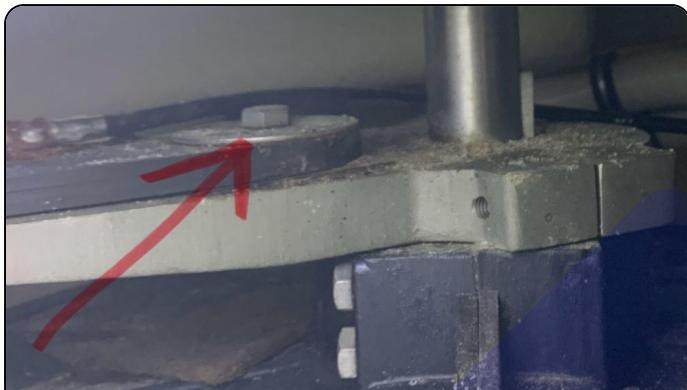
Alpha 3000 Autopilot. The autopilot actuator powered up but the arm was not secured to the rudder post. A nut was missing from the retaining bolt.

Autopilot actuator arm bolt with missing nut.
