# Pre-Purchase Report of Marine Survey

**2018 43' Catalina 425**

**Date Of Survey:** July 9, 2025

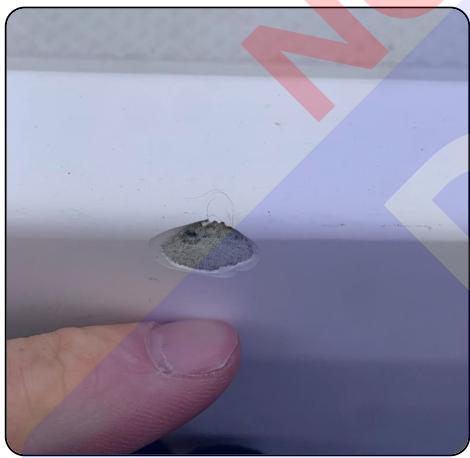
#### Finding B-1

A 1/4" diameter gelcoat chip was sighted on the port side midships molded toe-rail.

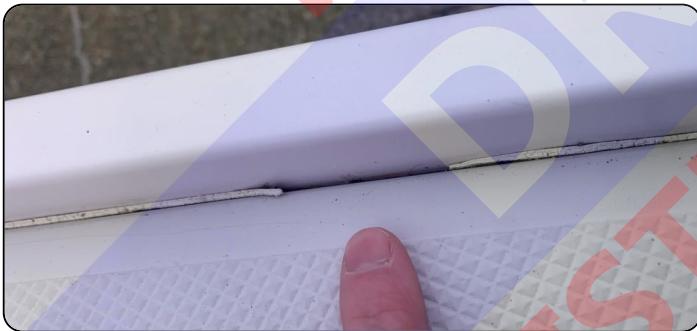
**Finding B-2**

No significant weathering was observed on the vessel's exterior caulking sealants (minor general weathering observed between the deck and molded FRP toe-rail).

Minor general weathering observed on the sealant between the deck and molded FRP toe-rail.

No action recommended at this time but eventually will need to reef out and renew the caulking sealant, as necessary.

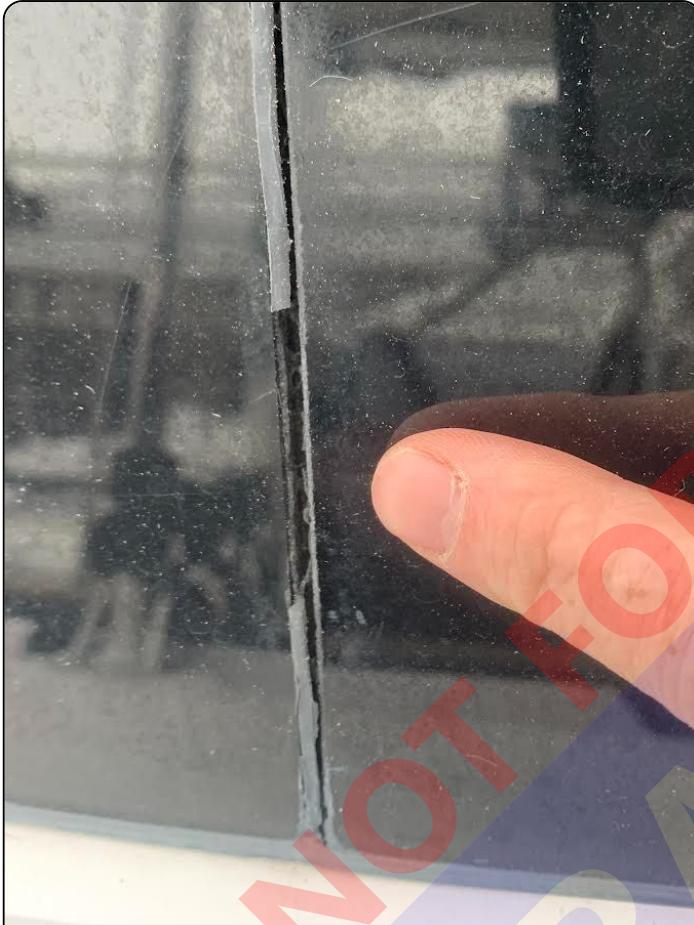
**Finding B-3**

Weathered exterior stripping between trunk cabin port windows

Replace the weather stripping, as necessary.

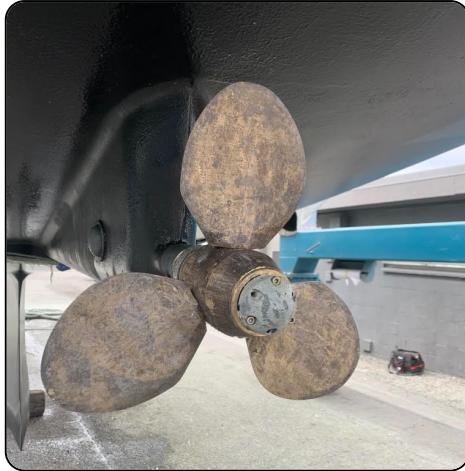
Three bladed bronze Max propeller. The propeller blades were visually inspected with no exceptions.

No cavitation erosion, dents, or damage were sighted on the propeller blades and roots. There was no excessive play between the propeller hub and shaft.

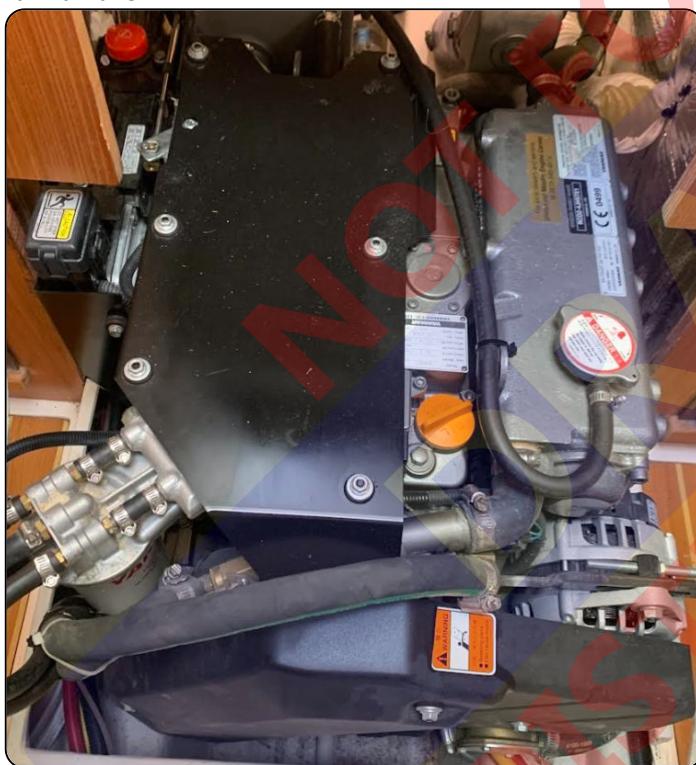
Yanmar 4JH57
