2006 42' Beneteau Oceanis 423 2C

Pre-Purchase Report of Marine Survey

Date Of Survey: September 8, 2025

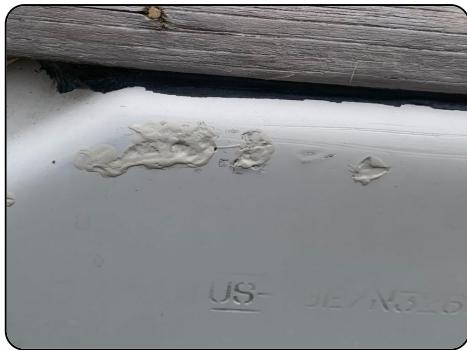
Minor surface blemish/repair sighted at the starboard quarter between the HIN and teak toe-rail.

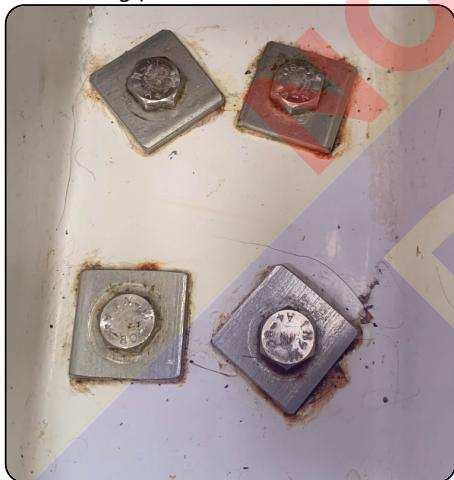
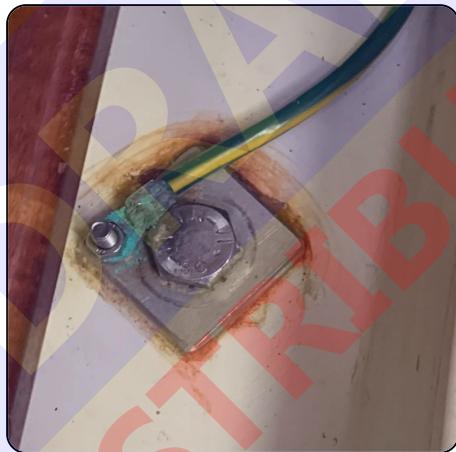
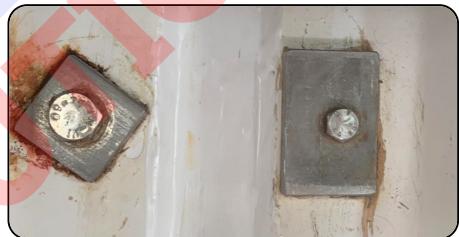
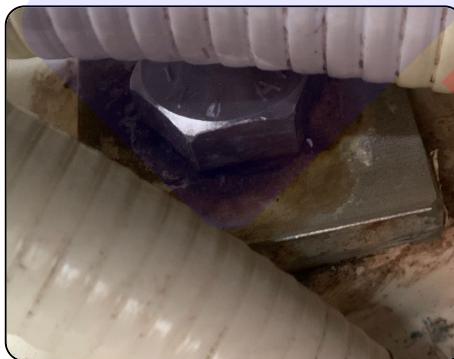
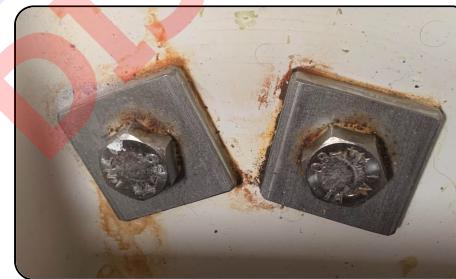
Stainless steel keel bolts cast into the lead ballast. No cracking, thread separation, lifting, or staining was observed on the keel bolts and backing plates.

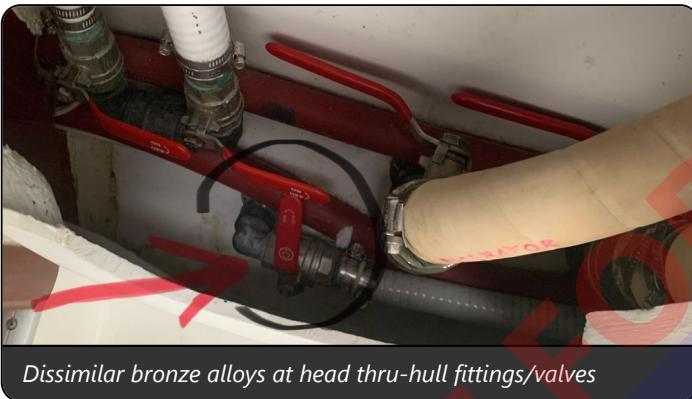
Finding B-1

The intake/discharge valves appeared to be different specific bronze alloys than the thru-hull fittings (see photo).

It is possible that the head ball valves are Euro-style, and do not meet ABYC H-27 recommendations. The inside thread of the ball valves may be tapered NPT onto straight thru-hull threads (ABYC H-27.6.2). Furthermore, if the ball valves are Euro-style, they conform to the EU's Recreational Craft Directive per ISO 9093-1, which only requires a five-year lifespan and therefore the components may be brass that is subject to dezincification.

Place emergency bungs near all ball valves, ensure nothing is stowed near the valves, and at next haul-out, replace all dissimilar alloy ball valves and ensure sea-cocks are flanged bronze (or Marelon). Inspect thru-hull fitting threads and replace, if necessary.

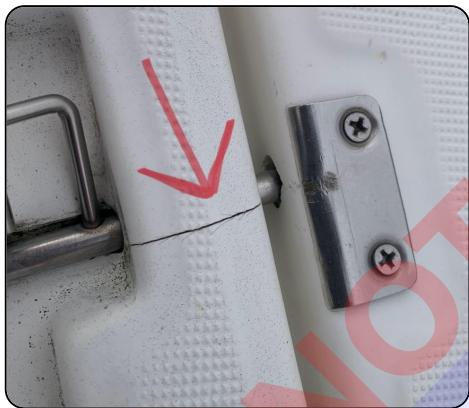
Finding C-2

A minor crack was sighted above the latch on the anchor locker FRP.

Repair/refinish in accordance with good marine practice, as necessary.

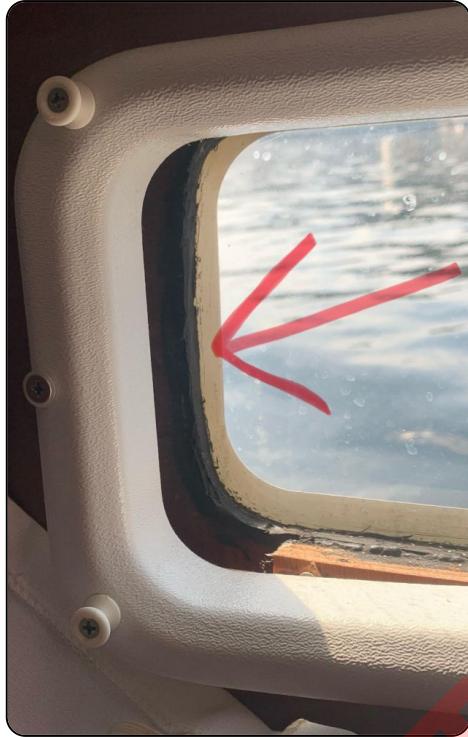
**Finding C-4**

The plastic frame fasteners on the aft cabin fixed portlight's aft 1/2 have pulled out of the liner.

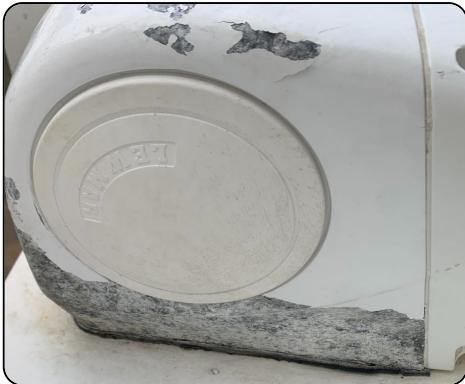
**Finding C-5**

The windlass housing was observed with missing paint and surface corrosion.

Refinish the windlass motor housing to prevent excessive corrosion, as necessary.

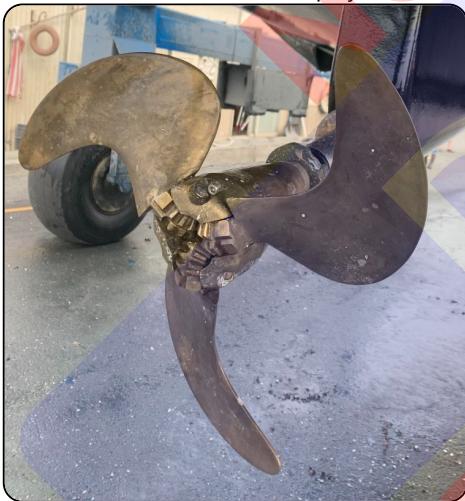
Bronze 3-bladed folding Volvo Penta propeller. No cavitation erosion, dents, or damage were sighted on the propeller blades and roots. There was no excessive play between the propeller hub and shaft.

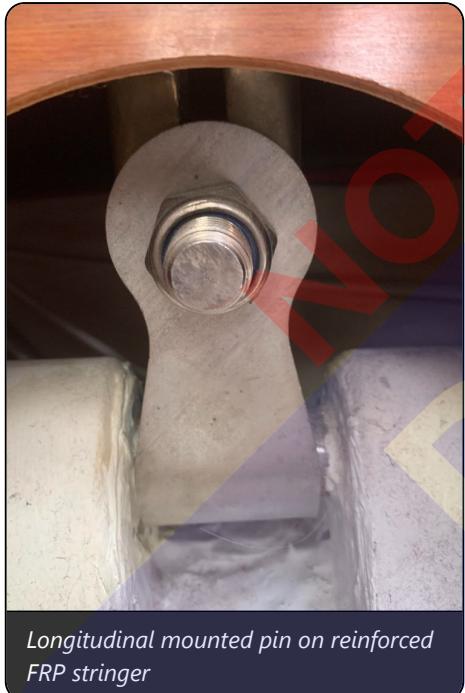
Longitudinal mounted pin on reinforced FRP stringer

Internal chain plates bolted to ball-joint rods on longitudinal-mounted pins, with external forestay & backstay chain plates. The chain plates were visually inspected where accessible only, and no exceptions were observed. Observed with 40x Loupe LED magnifying glass.

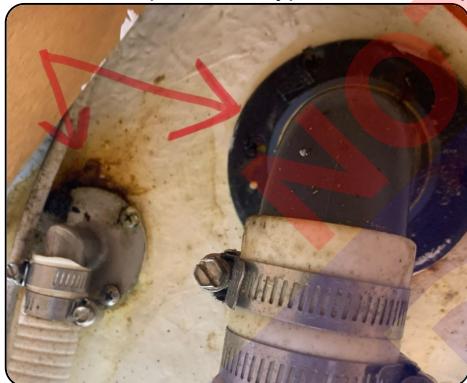
Finding C-6

Minor corrosion was sighted on the forward stateroom water tank fill pipe flange and under the vent flange.

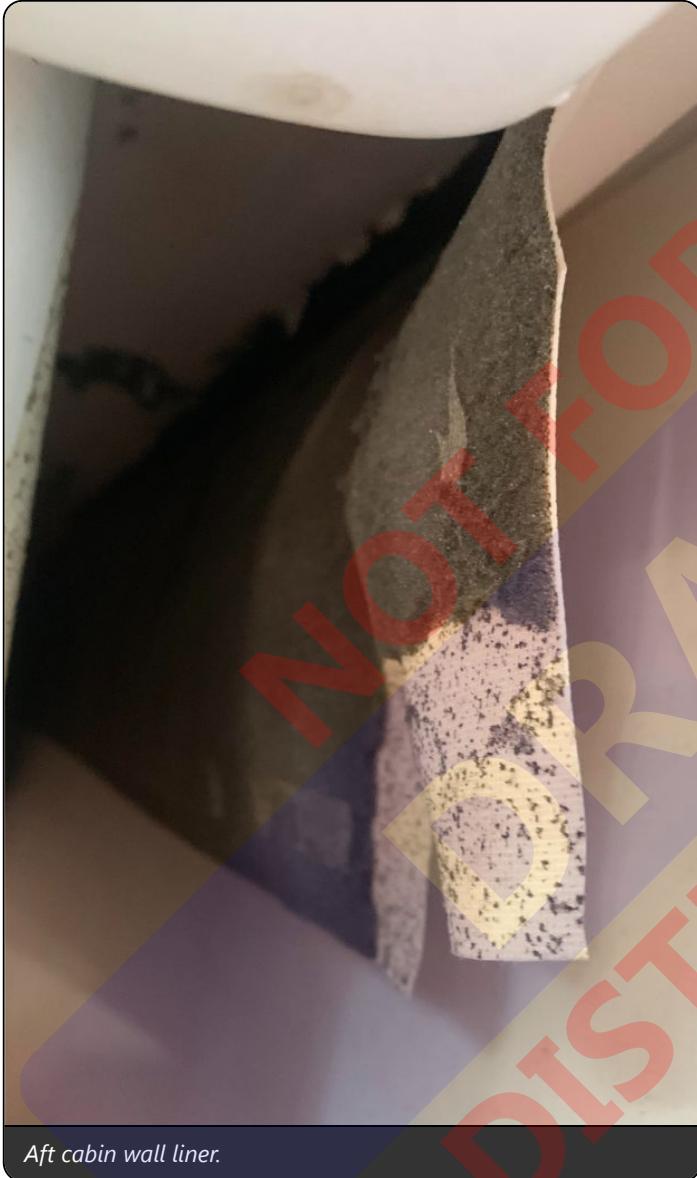
**Finding C-7**

The aft port stateroom wall liner was peeled away from the molded FRP headliner.
