## 1993 36' Solaris Sunrise Catamaran

# Pre-Purchase Report of Marine Survey

1993 36' Solaris **Sunrise** Catamaran

**Date Of Survey:** October 8, 2025

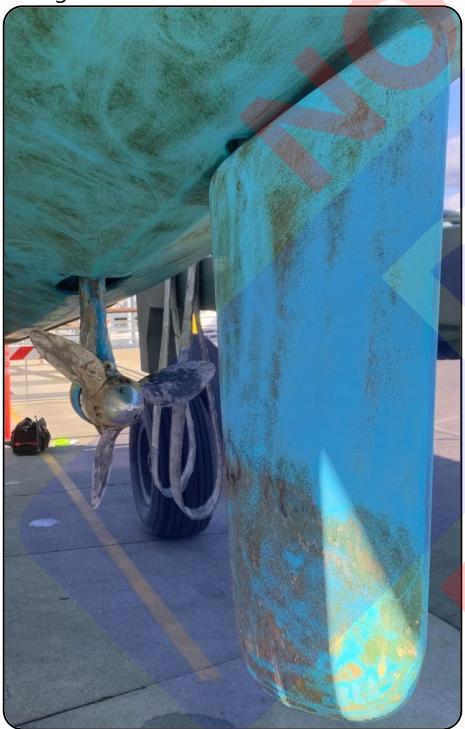
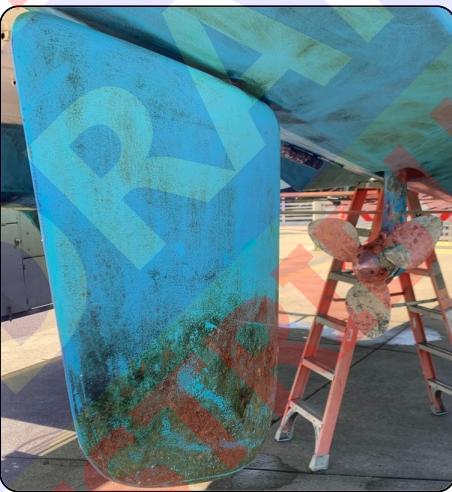
#### RUDDER MOUNTING

Appeared to well secured. Approximately 1/2" of horizontal and fore/aft movement was observed on the starboard rudder and approximately 1/4" of horizontal and fore/aft movement was observed on the port rudder.

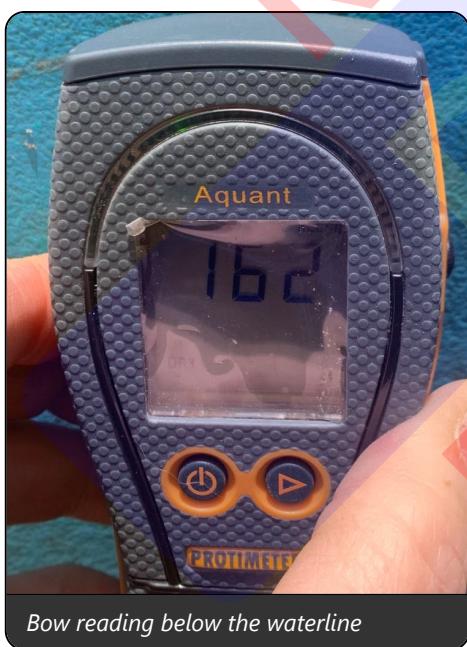
Note: both forward hulls below the waterline were percussion sounded with abnormal (dense) soundings. Moisture meter observations were normal (below 230/999) and no delamination was visible.

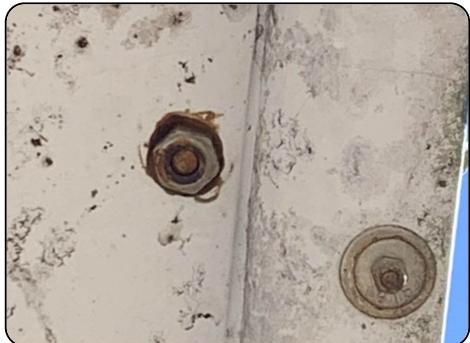
### Finding B-2

An anchor windlass backing plate bolts' nut was missing a washer.

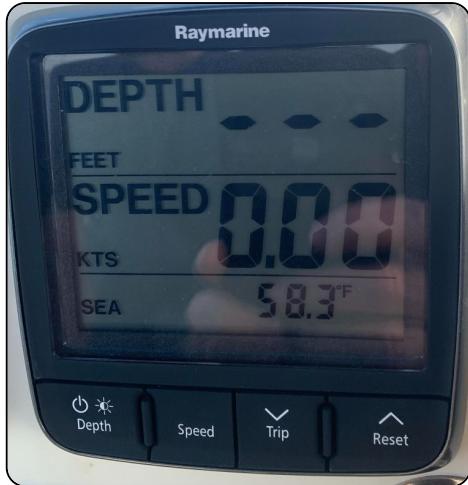
## SPEED DISPLAY

The Raymarine integrated speed display did not produce an accurate reading (0.00).

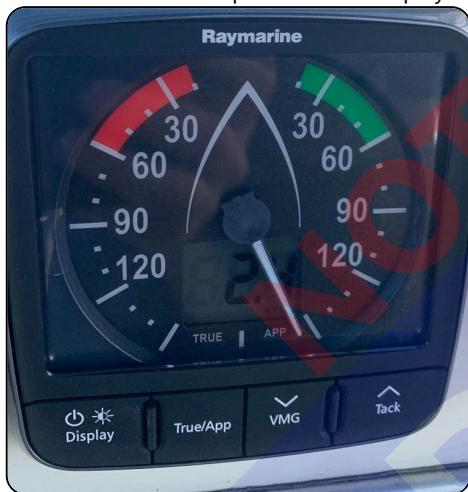
#### WIND INSTRUMENT

Note: The True wind speed did not display a reading. It may be integral to the Raymarine speed display.

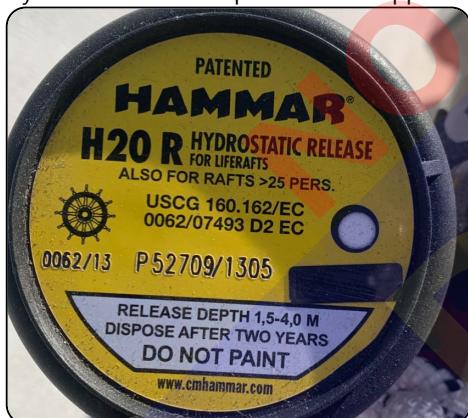
#### LIFE RAFTS

Viking RescYou 4 UKSL with Hammar hydrostatic release.  
Hydrostatic release expiration date: appeared to be 2013.

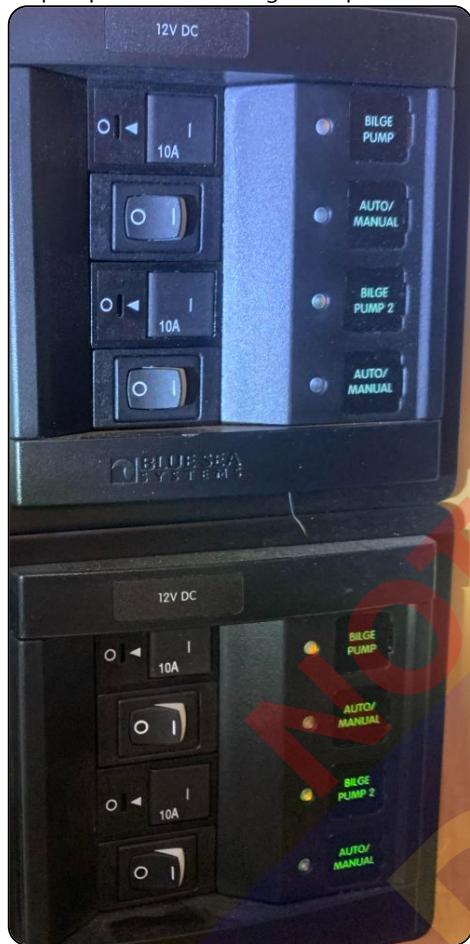
Two (2) 12VDC automatic Rule 2000 gph in mid-bilges.

All pumps had ULTRA bilge Pump-Switches and powered up manually from their remote switches.

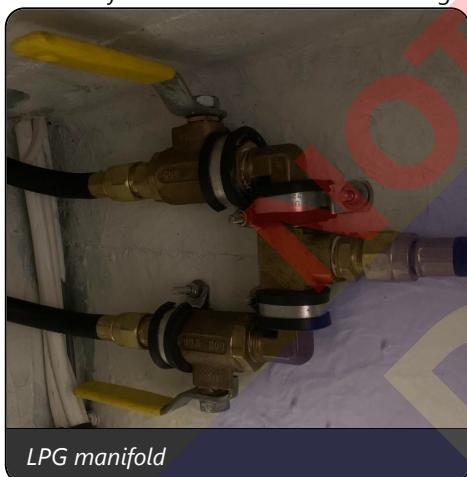
*LPG manifold*

The LPG system has a dedicated line to a gas line dual manifold to the stove and to the oven.
