Pre-Purchase Report of Marine Survey

2021 35' Sea Ray 350 SLX

Date Of Survey: October 14, 2025

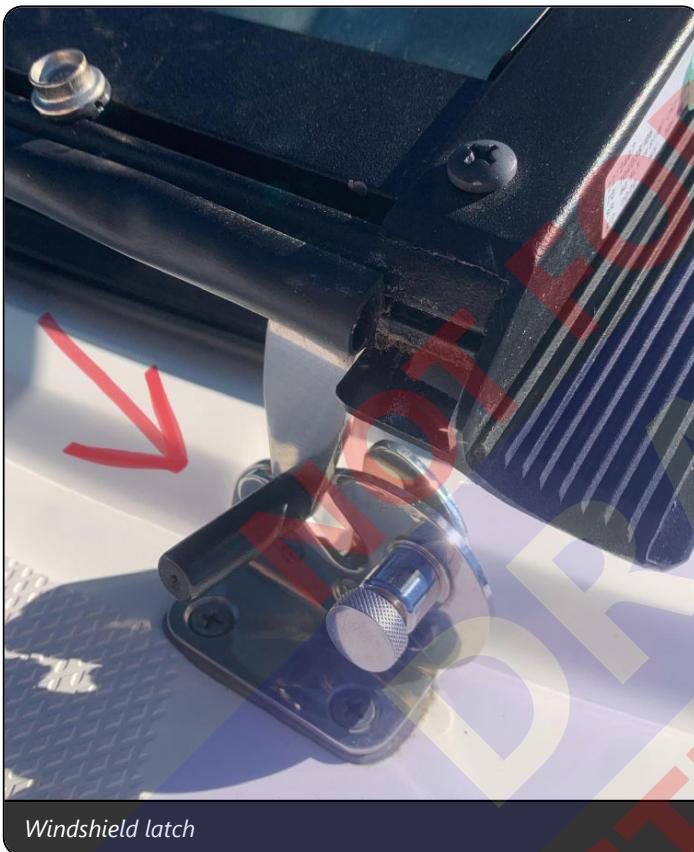
Finding B-2

The centerline walk-through windshield's open-position securing fastener appeared bent and could not be secured in the latch.

Repair or replace, as necessary.

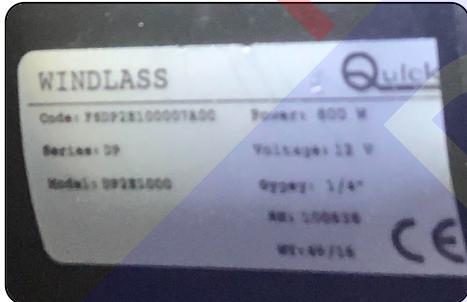
Finding A-1

The windlass down controls did not power up when tested from the helm or bow switches.

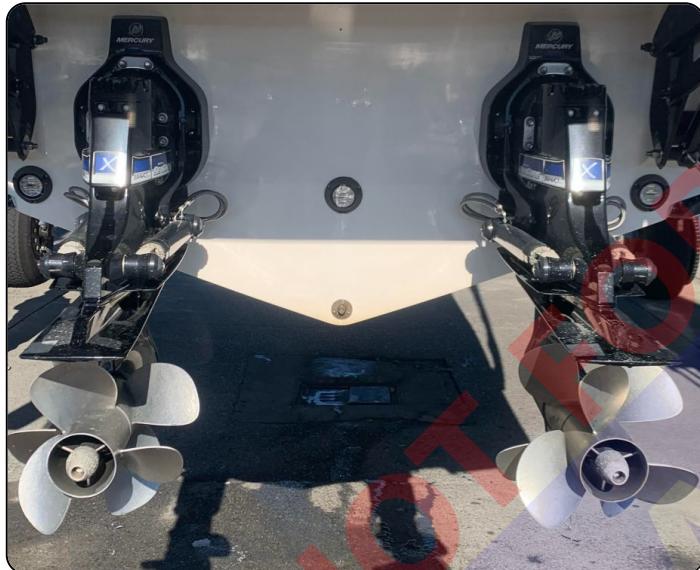
No cavitation erosion, dents, or damage were sighted on the propeller blades and roots. There was no excessive play between the propeller hubs.

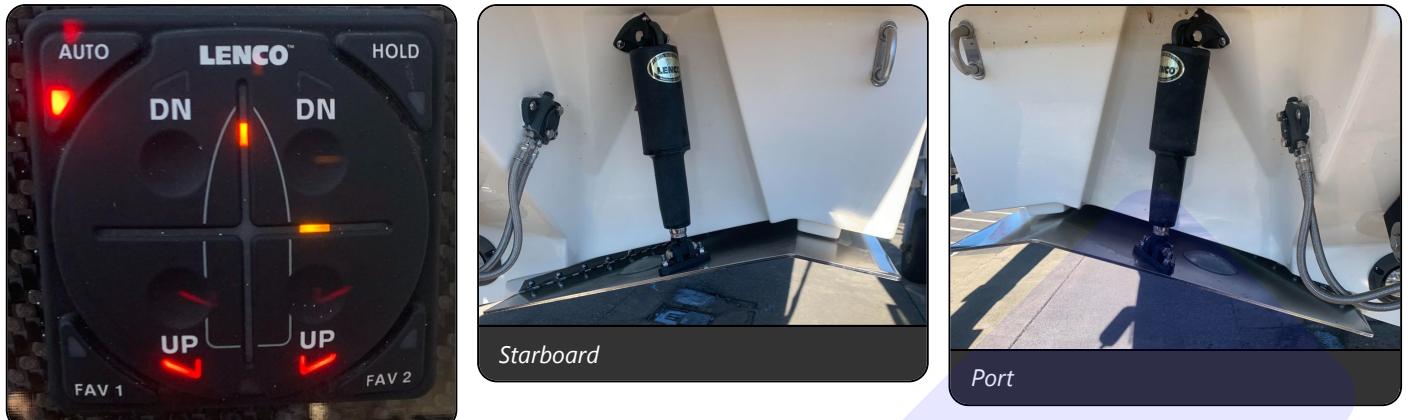
Lenco Marine 12 volt electric trim tabs with level indicator gauges. No damage, pitting, or corrosion was observed on the trim tabs. Demonstrated.

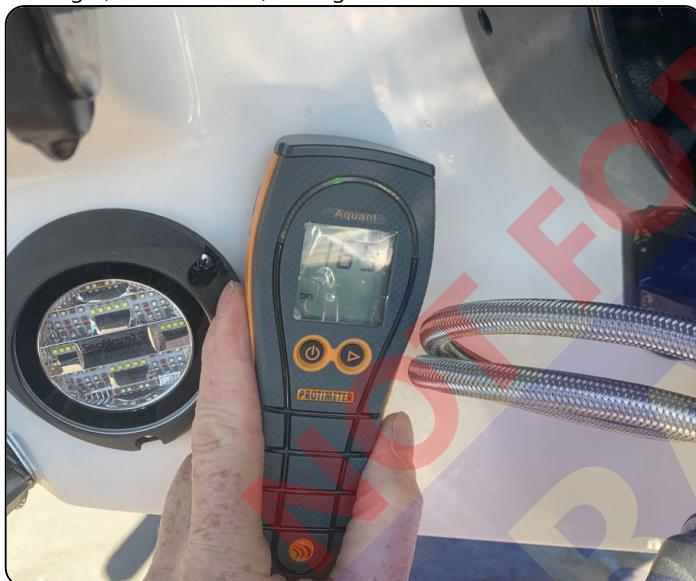
A phenolic hammer percussion sounding was performed on the accessible areas of the hull bottom and hull sides with no abnormalities noted.

A Protimeter FM wave moisture meter was used at various places around the below-waterline and outdrive areas with no elevated readings (under 170/999) average observed.

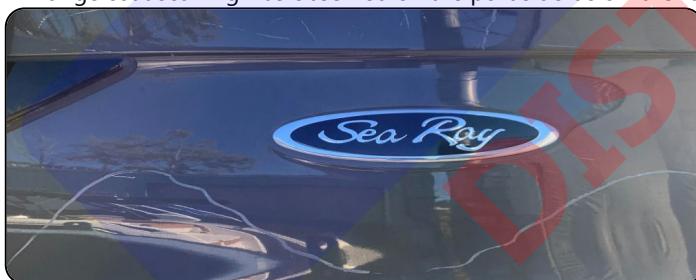
Finding C-2

Minor gelcoat scuffing was observed on the port side below the rub-rail.

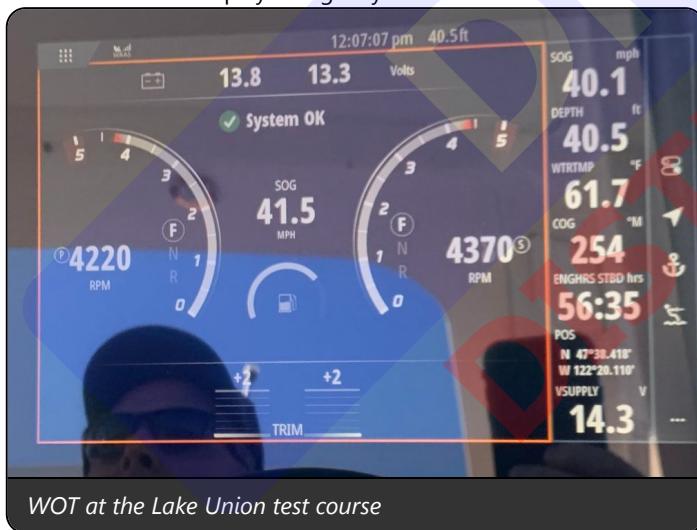
41.5 MPH @ wide open throttle (port: 4220 RPM, starboard: 4370 RPM).

Note: the manufacturer engine maximum revolutions per minute WOT (wide open throttle) RPM on a Mercruiser 8.2L MAG 380hp is 4400-4800. The surveyor requested a trial run on Lake Union at the test course. The short course appeared to not be long enough to get the engines up to manufacturers suggested WOT specification (180+ RPM port, 30+ RPM starboard). The surveyor was taking consecutive photographs rapidly as the throttle was opened and closed, and the photographs may not have captured the full WOT RPM's reached as displayed digitally at the moment the throttle was reduced.

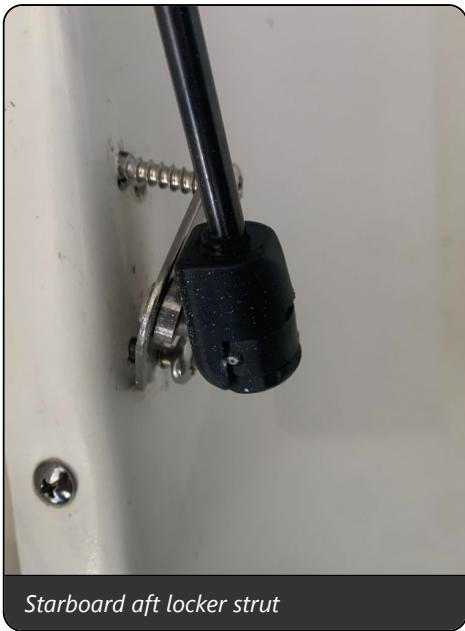
**Finding C-3**

The starboard aft locker strut fasteners were loose.

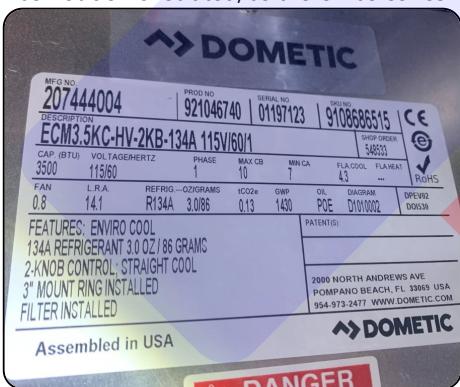
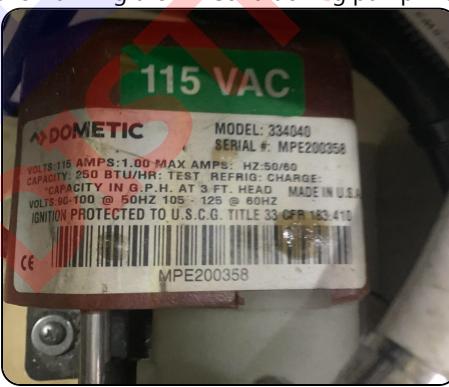
**Finding B-3**

The Dometic air conditioner compressor raw water pump was not observed discharging water overboard. The air conditioning system was not demonstrated, as there was concern over running the Air Conditioning pump without proper water flow.

The Dometic air conditioner compressor raw water pump was not observed discharging water overboard.

Investigate further/trace, and service, or repair as necessary.
