1999 57' Bayliner 5788

Condition & Value Report of Marine Survey

Date Of Survey: October 16, 2025

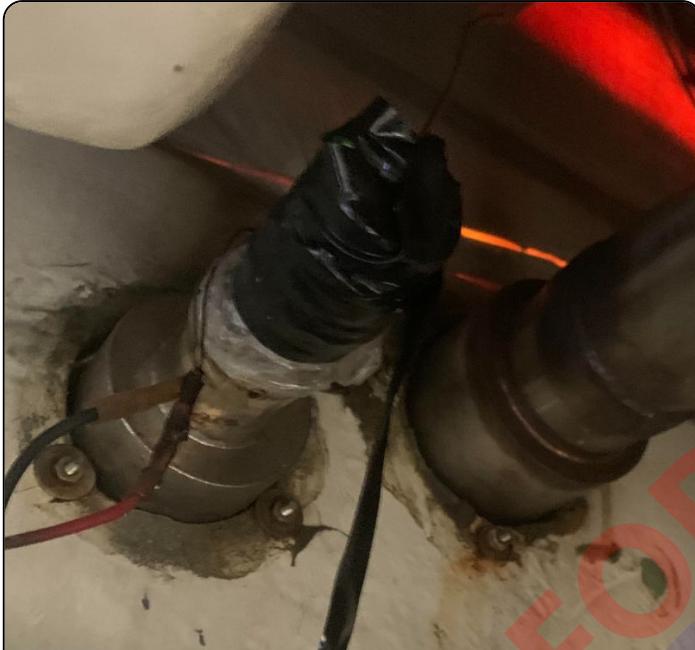
Finding B-1

Amended: A discontinued-use exhaust port just aft of the diesel heater exhaust port on the port aft hull **approximately 4' above the waterline** was not capped properly.

Discontinued-use exhaust port.

Recommendation

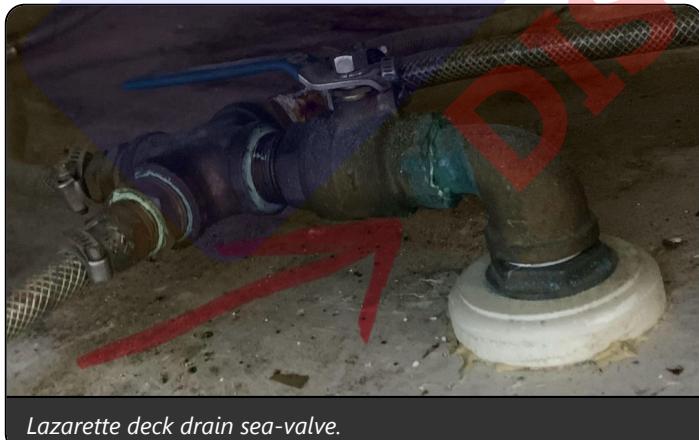
Finding B-3

The lazarette centerline deck drain sea-valve was sighted with minor corrosion on the valve-to-elbow connection.

Recommend cleaning the connection, investigating further, and monitoring. Replace the fitting and/or valve, if necessary.

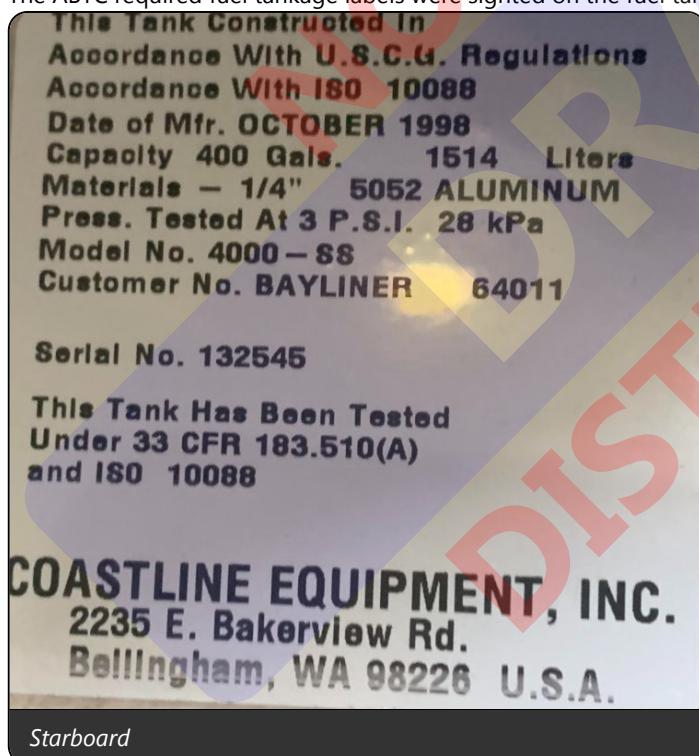
The ABYC required fuel tankage labels were sighted on the fuel tanks. The port tank label was partially obscured.

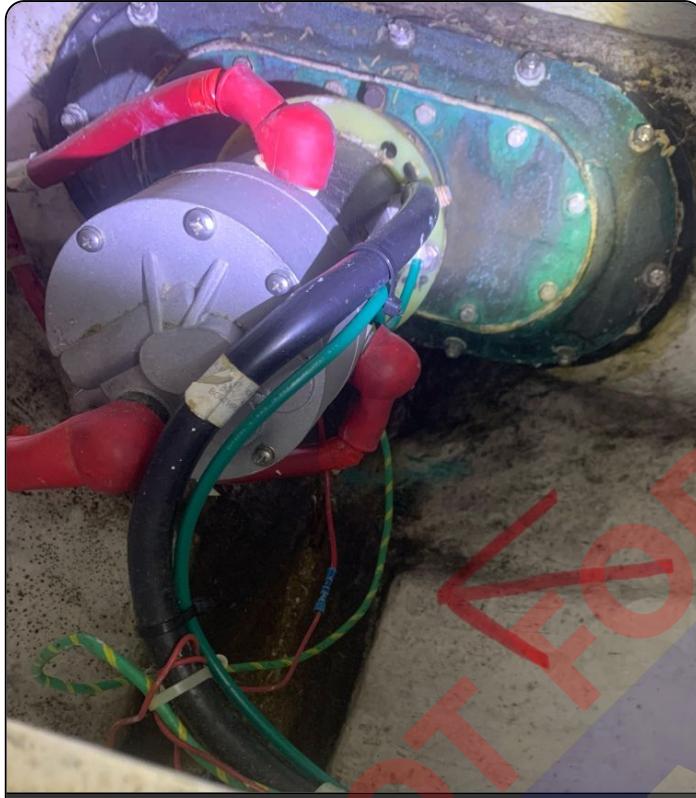
Finding B-4

Bow thruster staining below through-hull penetration

Staining was sighted below the bow thruster through-hull fitting.

Recommend cleaning staining from bilge, inspecting further, and if necessary, address at next haul-out.
