Pre-Purchase Report of Marine Survey

2021 35' Aspen C-108

Conducted By
Cpt. Mark Van der Vliet

Date Of Survey: February 4, 2026
Report Submitted On: February 5, 2026

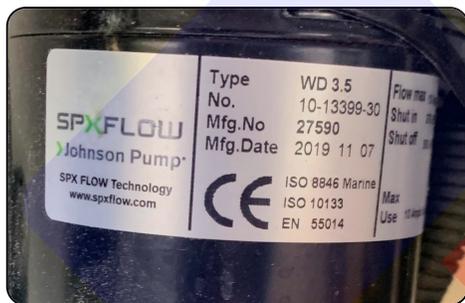
Port cockpit washdown with SPXFlow 12VDC 3.5 washdown pump. Powered up.

Note: the washdown hose did not have a matching receptacle fitting (required test/prove).

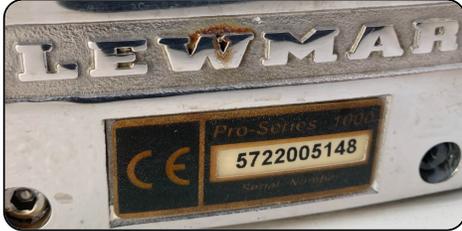
Lewmar Pro Series 1000 windlass. Powered up from the helm and bow switches.

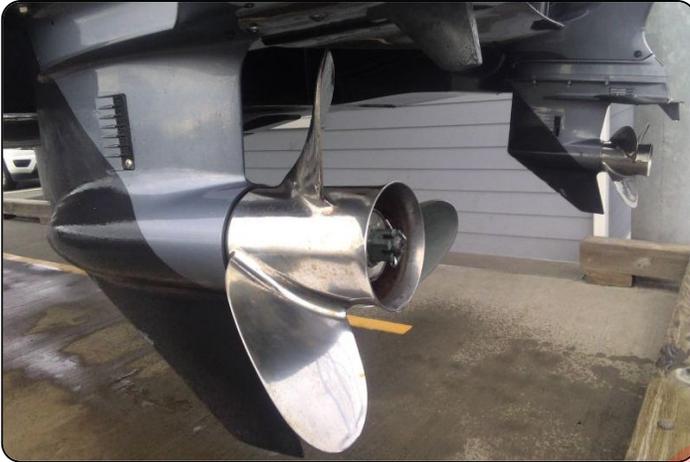
Port: Stainless steel 13.125" x 16"P Yamaha Reliance Series.

Starboard: Stainless steel 14.5" x 13"P Yamaha Reliance Series.

No visual indication of alloy breakdown, cavitation erosion, dents, or damage were sighted on the propeller blades and roots. There was no excessive play between the propeller hubs.

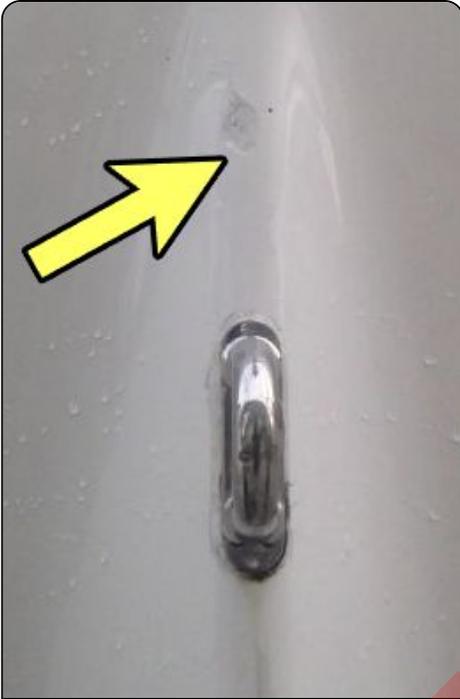
Finding C-2

Small gelcoat scrape above bow tow-eye

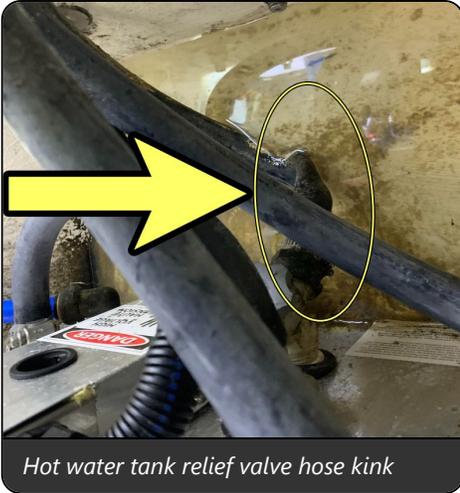
Finding C-3

Hot water tank relief valve hose kink

Recommend reducing kink. Plumb overboard, if necessary.

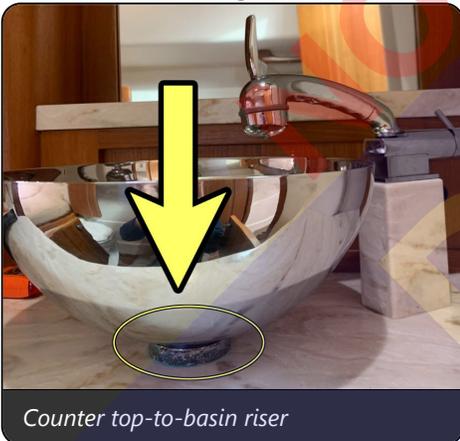
Finding C-4

Minor corrosion was sighted on the riser fitting between the counter and the sink basin.

No action is required at time of survey. Clean corrosion and apply corrosion inhibitor, as necessary. Monitor.
