1995 48' Oyster 485 Deck Saloon

Pre-Purchase Report of Marine Survey

Date Of Survey: October 23, 2025

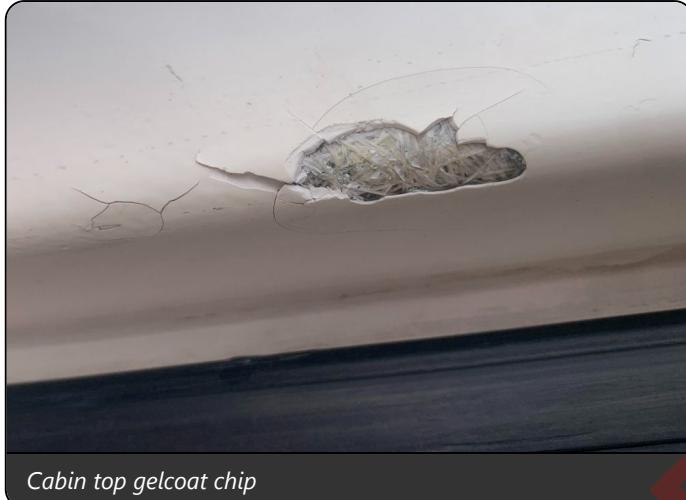
Cabin top gelcoat chip

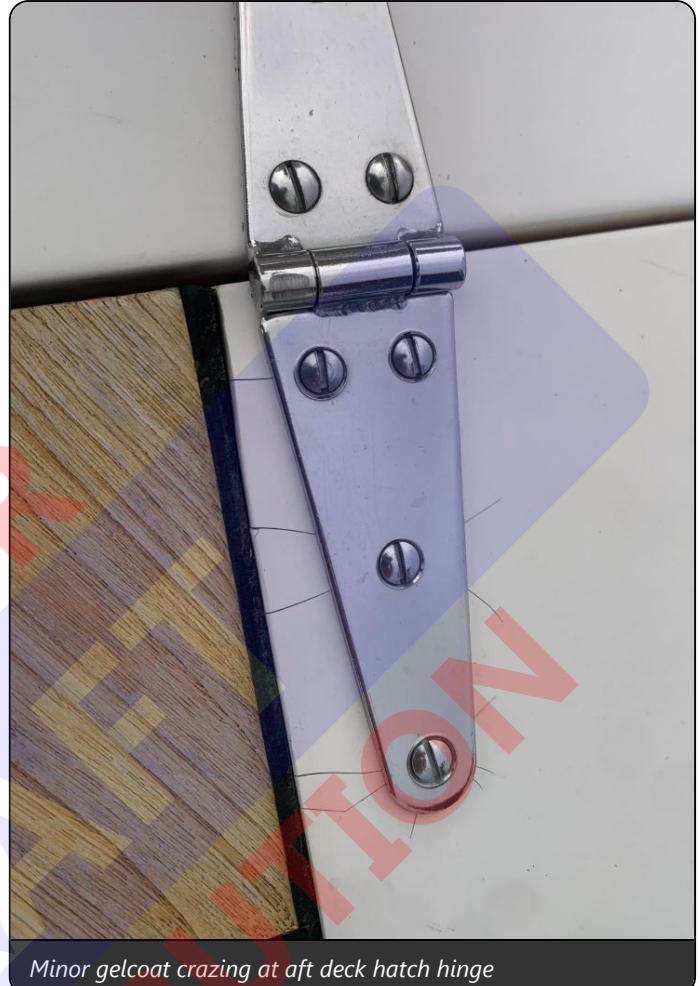
Minor gelcoat crazing at aft deck hatch hinge

Finding B-1

Recommendation

No action is recommended at time of survey. Consider refinishing the gelcoat, as necessary.

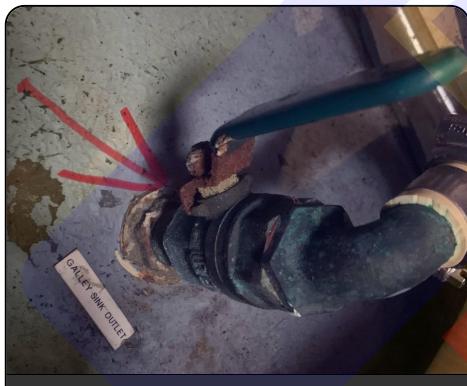
Galley sink discharge fitting handle

Finding C-2

The galley sink outlet discharge fitting handle was sighted with corrosion.

Replace galley sink discharge fitting handle.

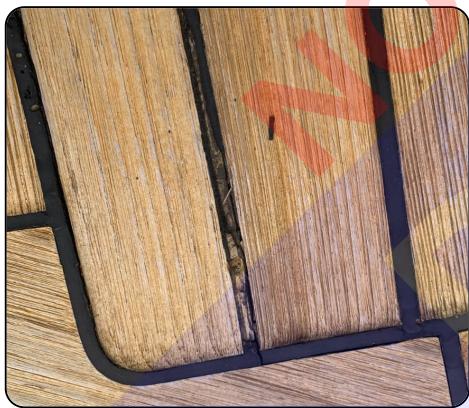
**Finding B-2**

Minor deck teak caulking and teak surface anomalies were observed.

Repair, refinish, as necessary.

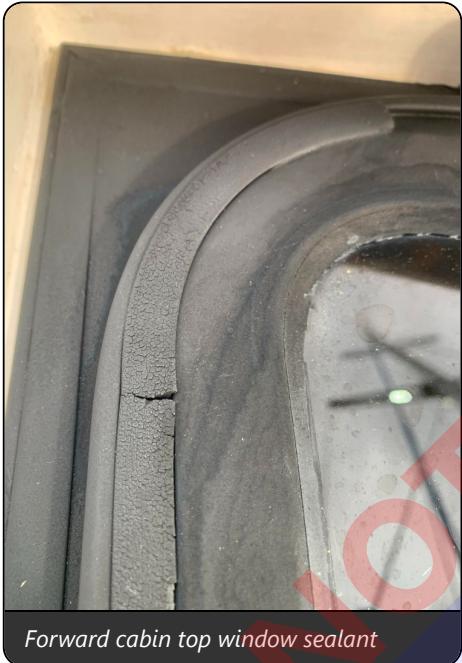
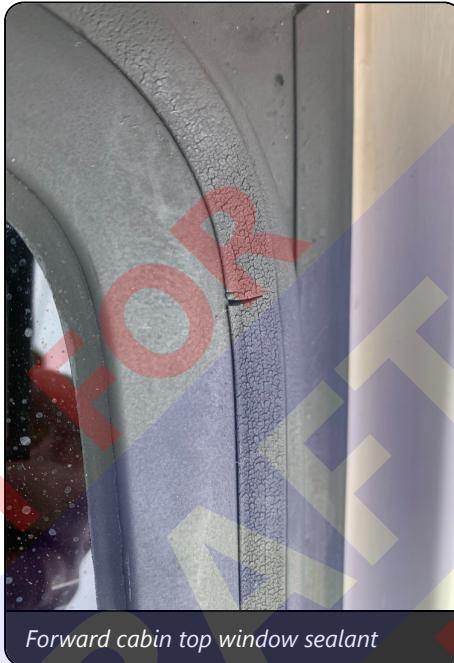
Forward cabin top window sealant

Finding C-3

The cabin top window sealant appeared weathered/cracking.

No action is recommended at the time of survey. Monitor frequently and consider reefing out sealant and renewing.

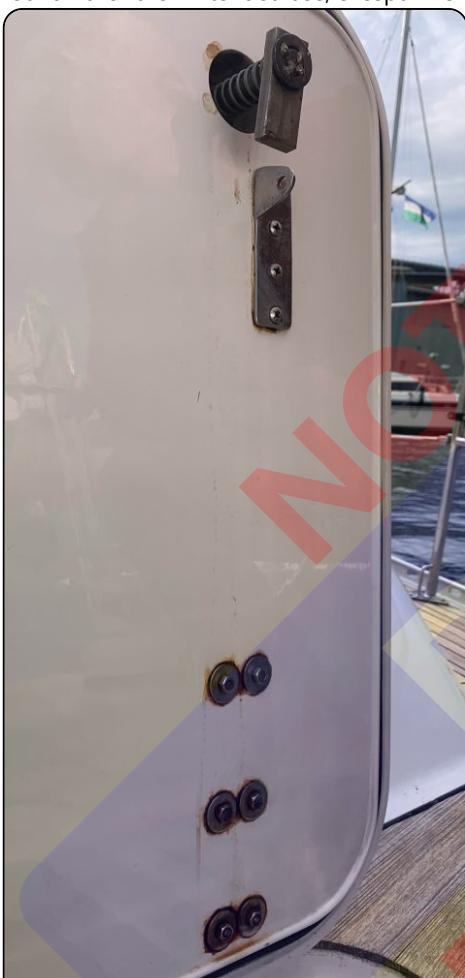
Centerline aft deck locker, missing hatch starboard strut.

Finding B-3

The centerline aft deck locker was missing the starboard strut.

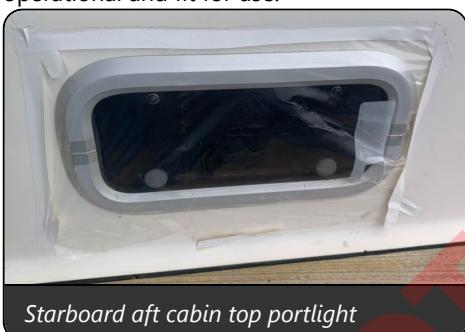
Starboard aft cabin top portlight

Finding B-4

The starboard aft cabin top portlight gasket was missing.

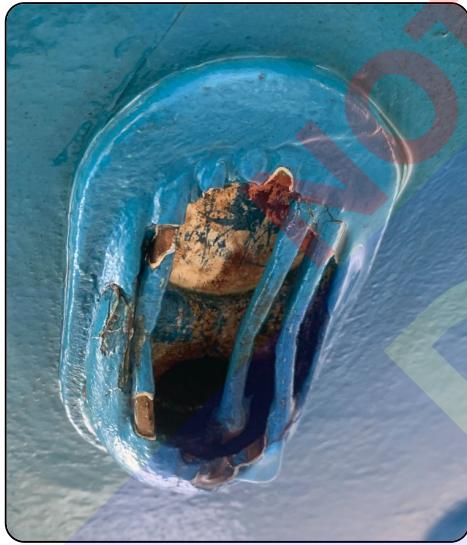
The hull sea strainer for the discontinued water maker was damaged.

Finding C-5

No action is recommended at time of survey. Recommend removing sea strainer and properly sealing all discontinued below waterline intake/discharge fittings.

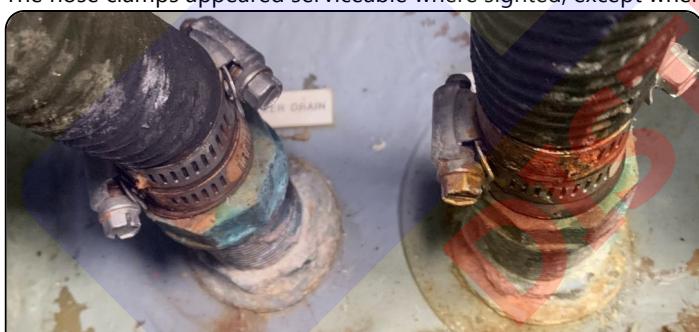
Lazarette hose clamps

Finding B-5

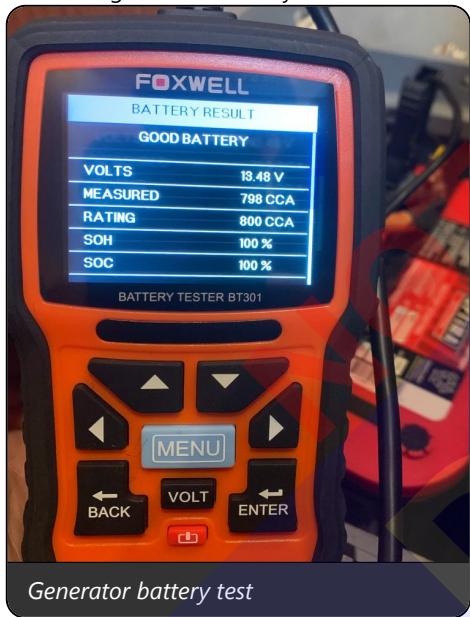
**Finding B-6**

Wing nuts were utilized to connect the generator battery's cable conductors to their terminals (not recommended for cables over 6 AWG or 13.3 mm diameter).

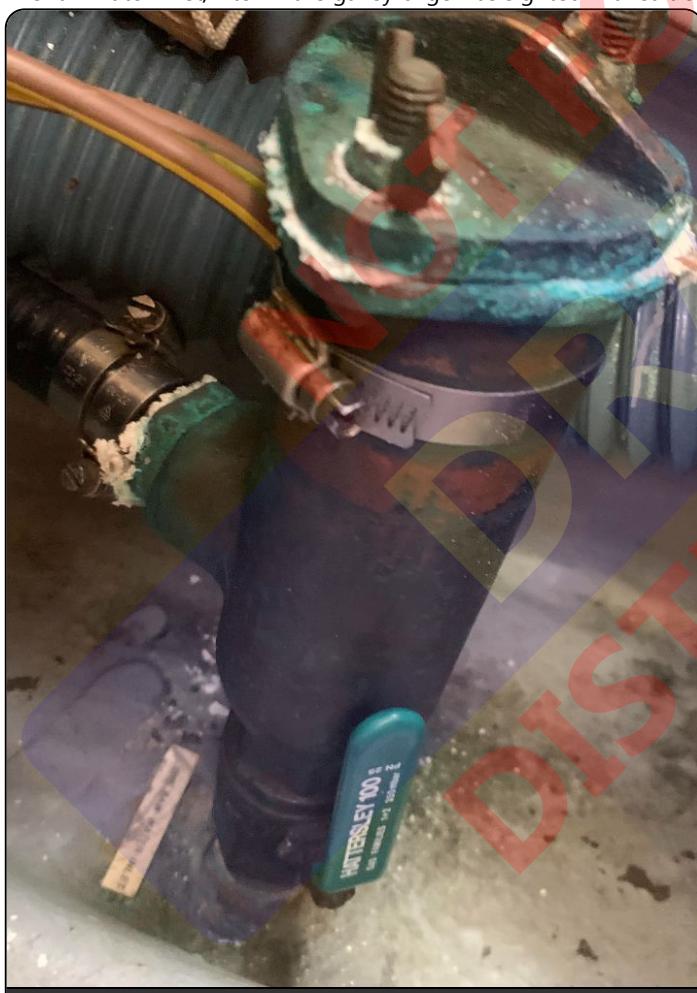
Galley bilge raw water inlet

The raw water inlet/filter in the galley bilge was sighted with salt crystal build-up at its' connections/gaskets.

Finding C-6

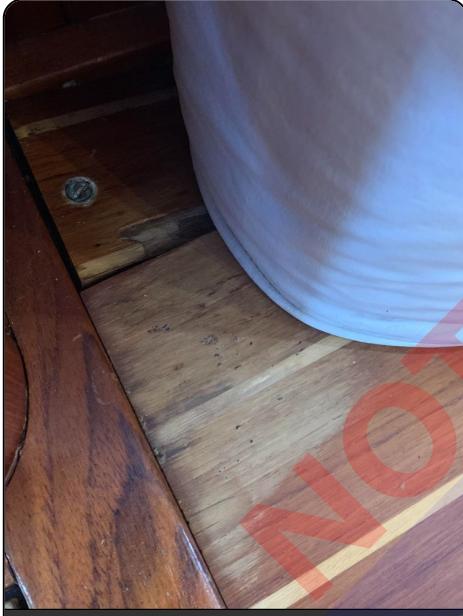
Note: The teak and holly sole board to port of the mast keel step was sighted with water damage. Condensation on the mast was sighted and may be the cause.

Mast at deck penetration/water staining

Finding C-7

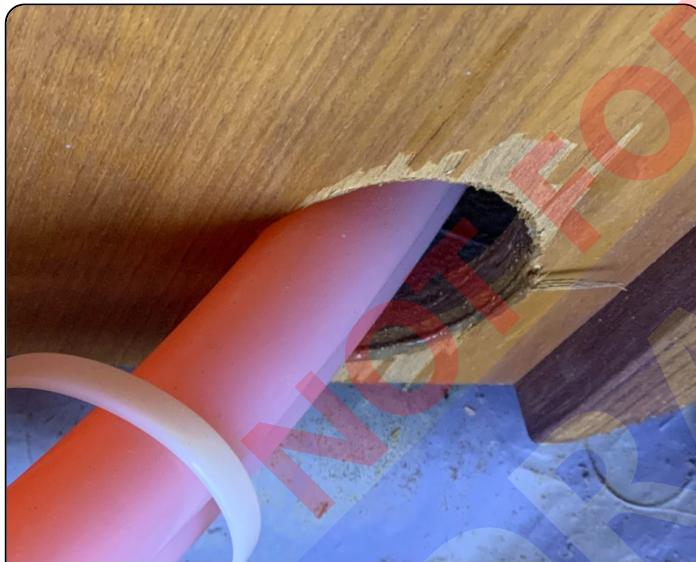
Heating hose at port guest cabin aft bulkhead transit.

Finding B-7
