Pre-Purchase Report of Marine Survey

2023 34' Ranger Tugs R-31 S

Cpt. Mark Van der Vliet

Date Of Survey: August 21, 2025

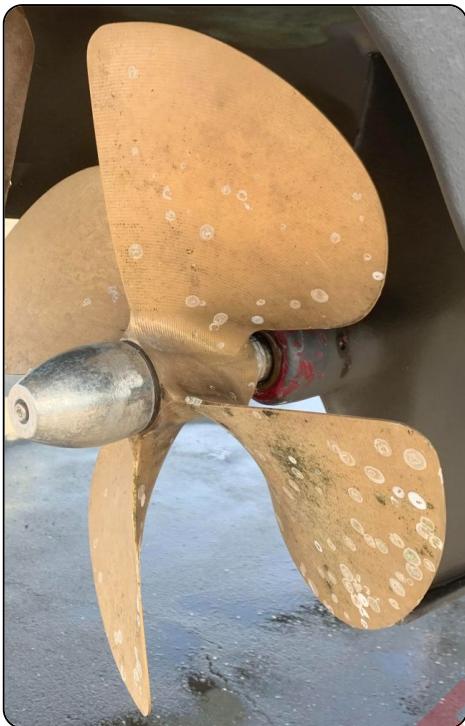
PROPELLER SHAFTS

1 1/2" inch diameter stainless steel. The shaft tracked straight through the shaft log transit and no pitting or corrosion was sighted on the shaft.

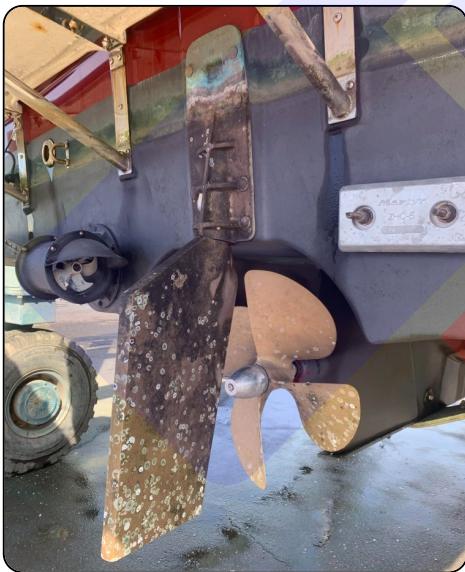
RUDDER MOUNTING

Bronze exterior rudder assemblies mounted to transom. Found secure.

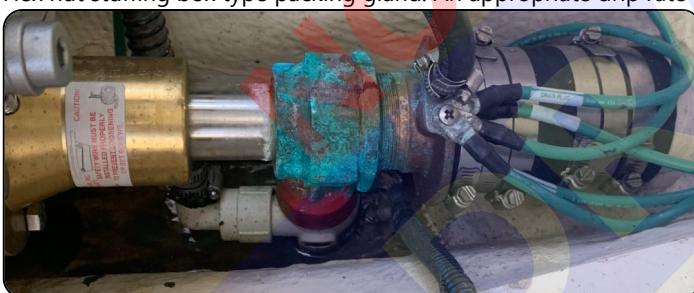
***Machinery & Bilge Space Equipment*****HOSES**

Reinforced rubber hose double clamped and well routed and supported where sighted. The hoses appeared serviceable where sighted.

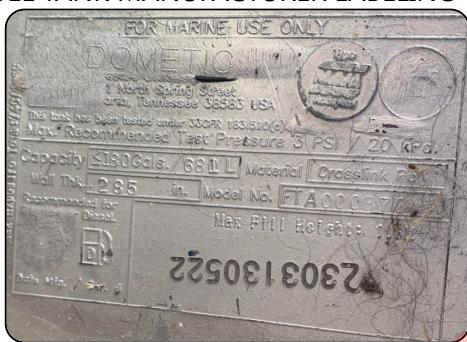
**FUEL TANKAGE SECURING**

The fuel tankage appeared to be adequately secured where sighted.
