# Pre-Purchase Report of Marine Survey

**2018 43' Catalina 425**

**Date Of Survey:** July 9, 2025

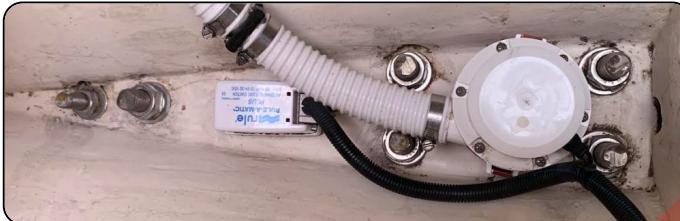
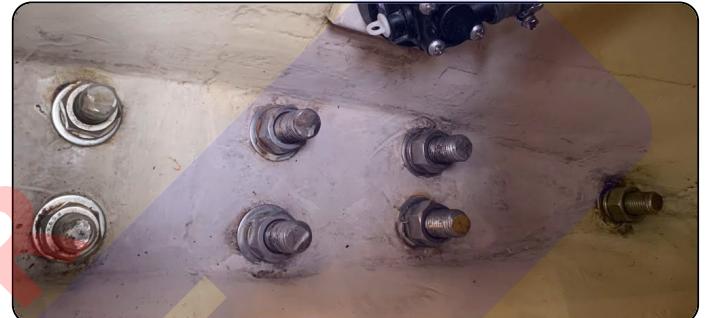
**KEEL BOLTS**

Stainless steel keel bolts. Inspected with no exceptions sighted.

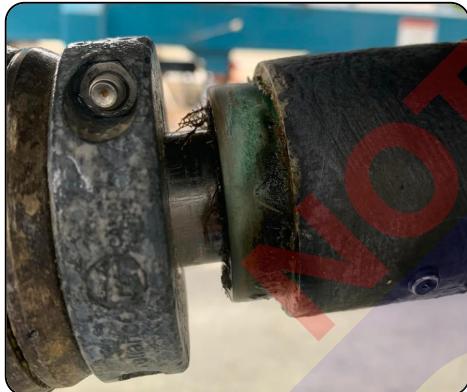
#### PROPELLER SHAFT LOGS

The shaft log was constructed of fiberglass composite.

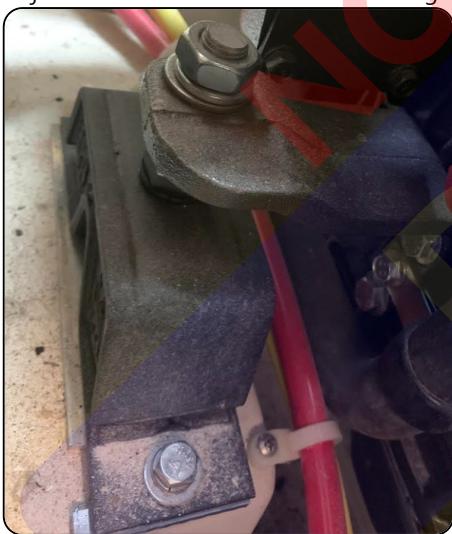
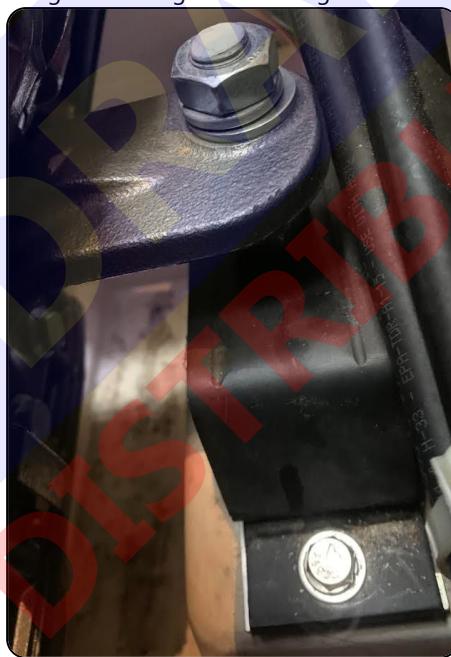
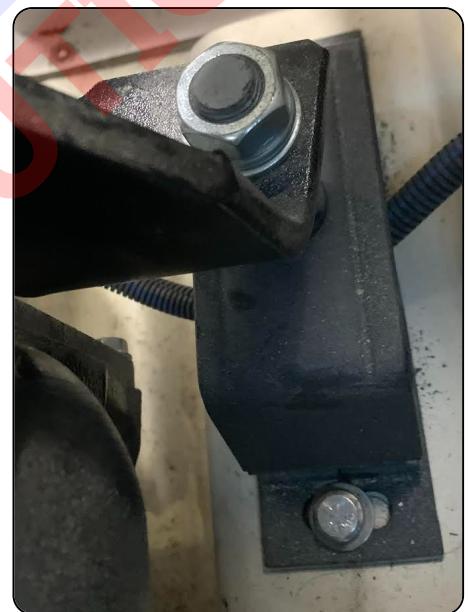
**ENGINE BED MOTOR MOUNTS**

Adjustable motor mounts on cored fiberglass longitudinal engine bed stringers.

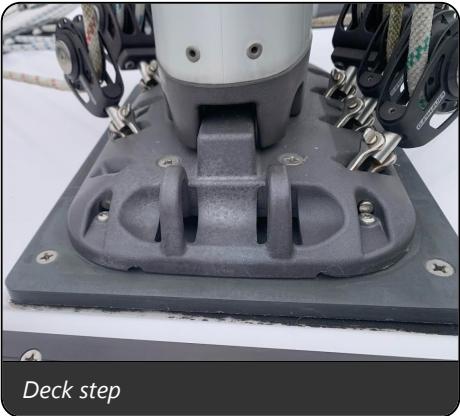
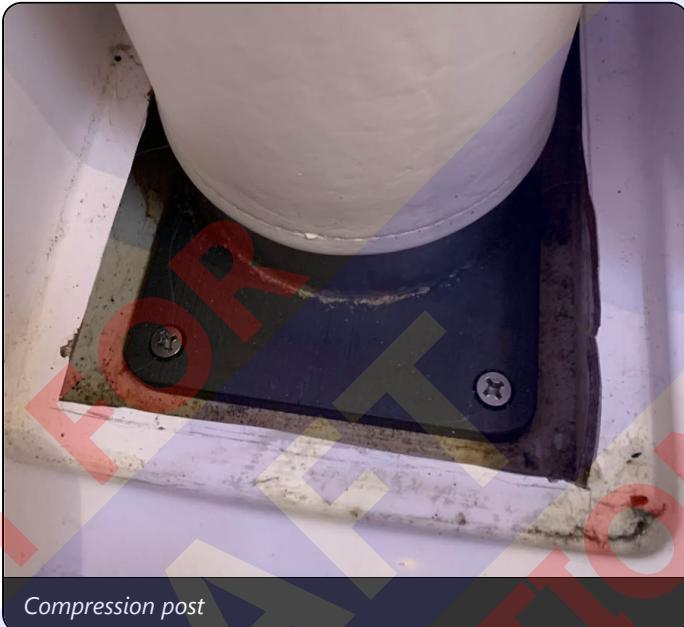
**MAST STEP**

T-Beam mast step. The mast was stepped to the deck with a compression post. Appeared secure and fit for intended use.

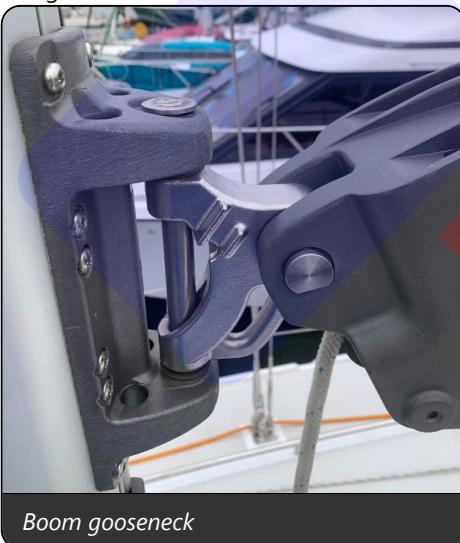
**GOOSENECK**

The gooseneck was found secure.

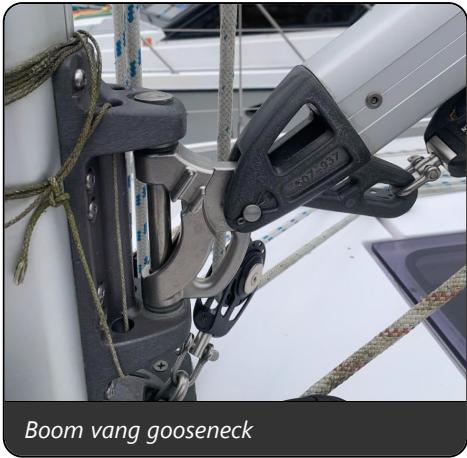
## BOOM VANG

Selden Rodkicker anodized aluminum boom vang. The boom vang gooseneck was inspected and found secure. The boom vang was briefly demonstrated and found in working order.

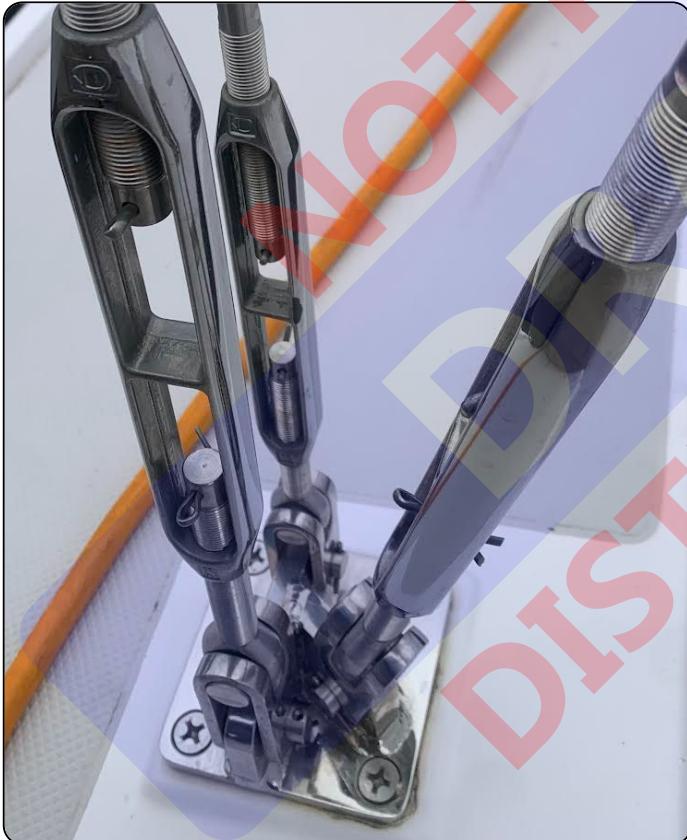
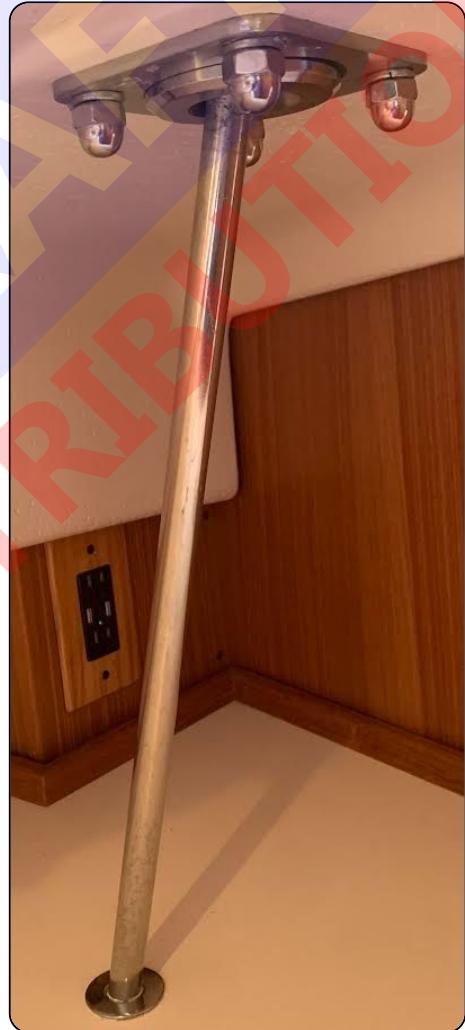
## RIGGING CHAIN PLATES

Internal chain plates bolted to rods and knees (SecureSocket) or deck backing plates with double nuts where sighted. Jib stay chain plate and backing plate (chain locker) were inspected with no exceptions.

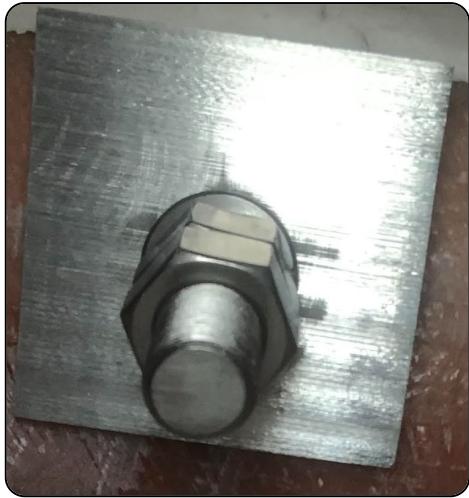
#### SHROUDS/STAYS/TERMINAL ENDS

10mm 1 X 19, 816 stainless steel cables. The condition of the shroud's and stay's and their terminal ends were visually inspected from deck level only, with no exceptions observed.

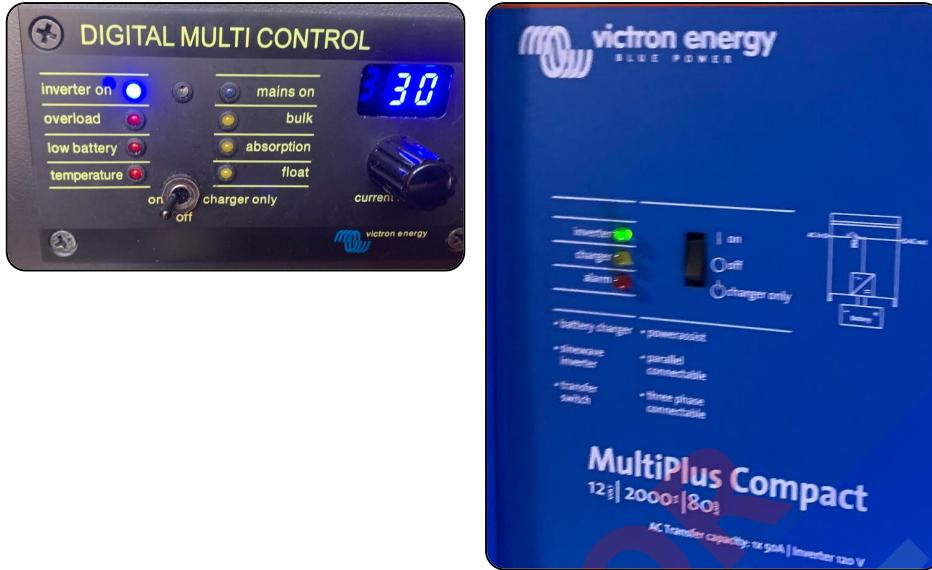
#### **INVERTER SYSTEMS (ABYC E-11, A-31)**

Victron Energy MultiPlus 12/2000/80 50A 120V inverter/charger with digital multi control panel. Powered up.

The inverter system was well secured and its ventilation appeared adequate (ABYC A-31.6.2.1).

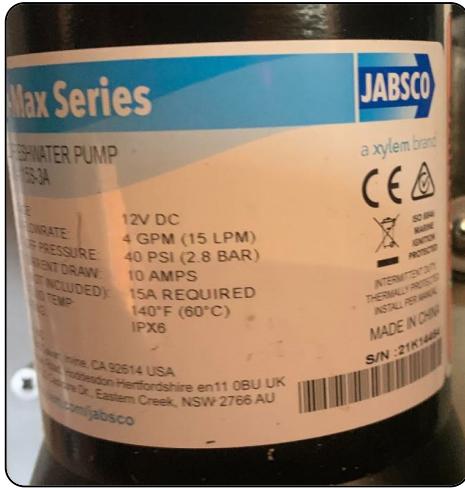
##### FRESHWATER PUMPS

Jabsco 12VDC Automatic water system pump.  
Series 42755

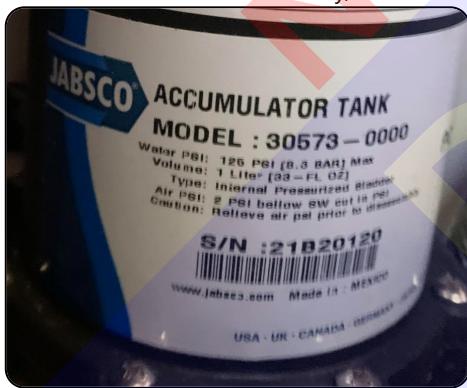
## FRESHWATER ACCUMULATOR TANK

Jabsco Model 30573-0000. No leaks were observed at the accumulator tank. While the internal pressure of the accumulator tank was not verified at the time of survey, no leaks were observed.

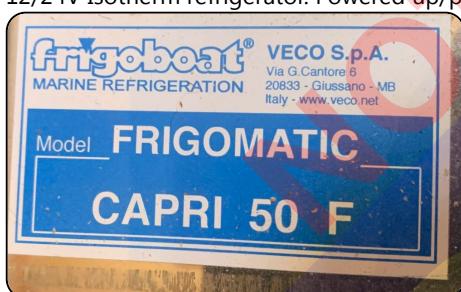
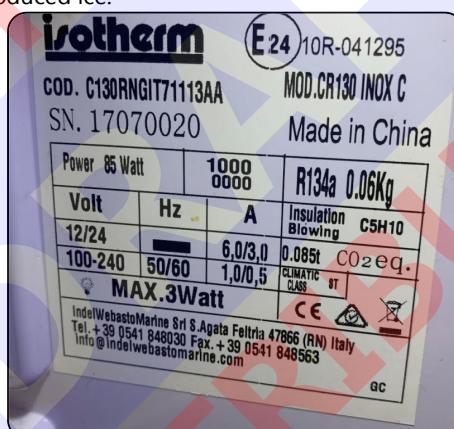
Frigoboard Frigomatic Capri 50 F. Powered up.

12/24V Isotherm refrigerator. Powered up/produced ice.
