Pre-Purchase Report of Marine Survey

2021 35' Sea Ray 350 SLX

Date Of Survey: October 14, 2025

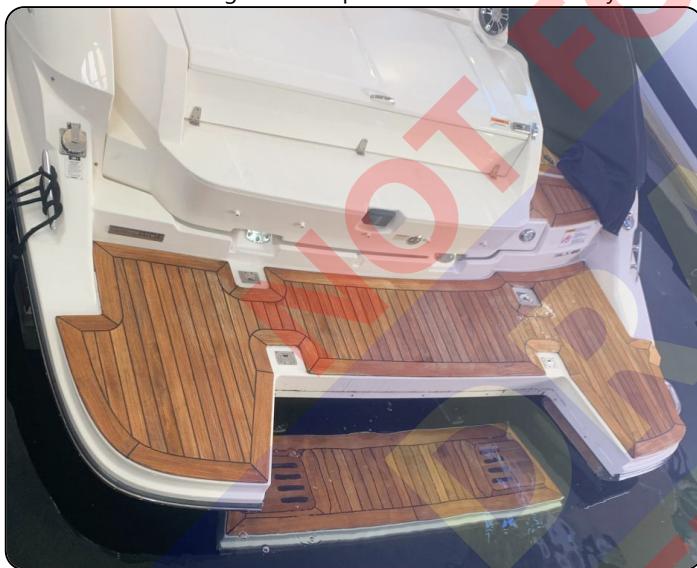
SWIM PLATFORM

Sandwich cored fiberglass swim platform with Teak overlay and electro-hydraulic swim step. Demonstrated.

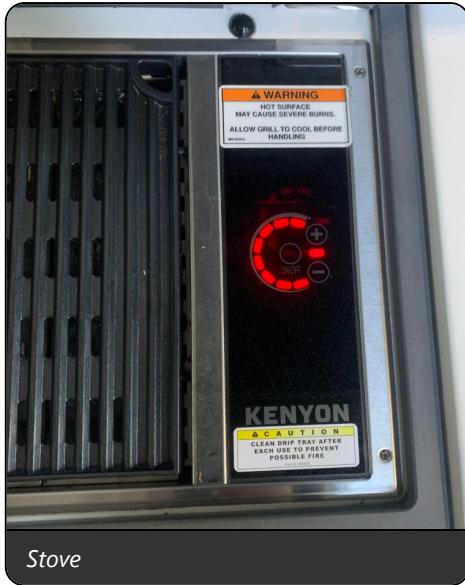
COCKPIT/AFT DECK EQUIPMENT

Kenyon 2-burner electric stove (with demonstrated safety cut-off switch), bar sink (demonstrated), and refrigerator/freezer. There are two (2) igloo coolers stowed in designated lockers.

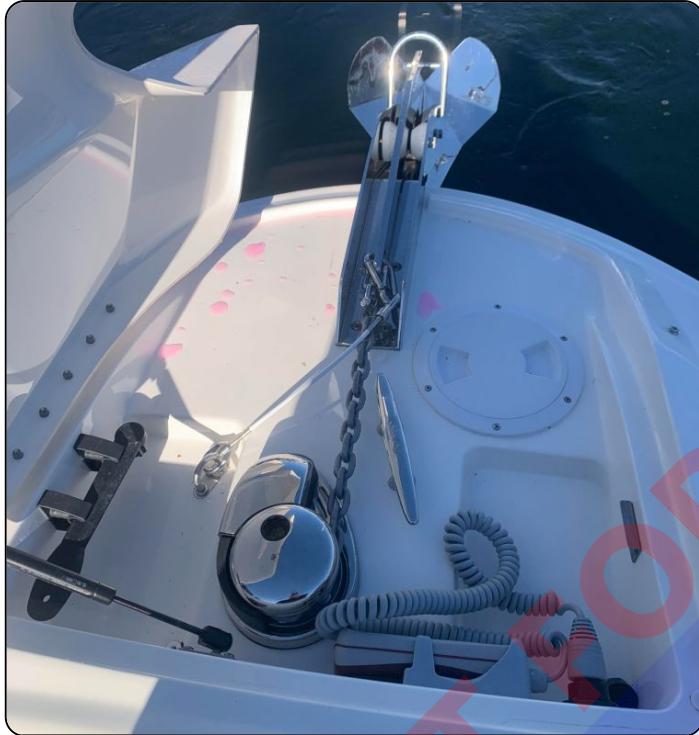
ANCHORS

Stainless steel ULTRA 22 lb. plow anchor. The anchor was ready to deploy and its swivel was properly secure.

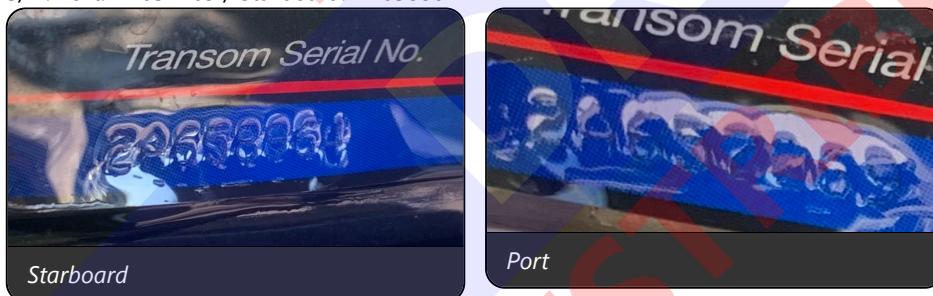
Twin, Mercruiser SeaCore Bravo Three outdrives.

S/N: Port: 2A657269 / Starboard: 2A658864

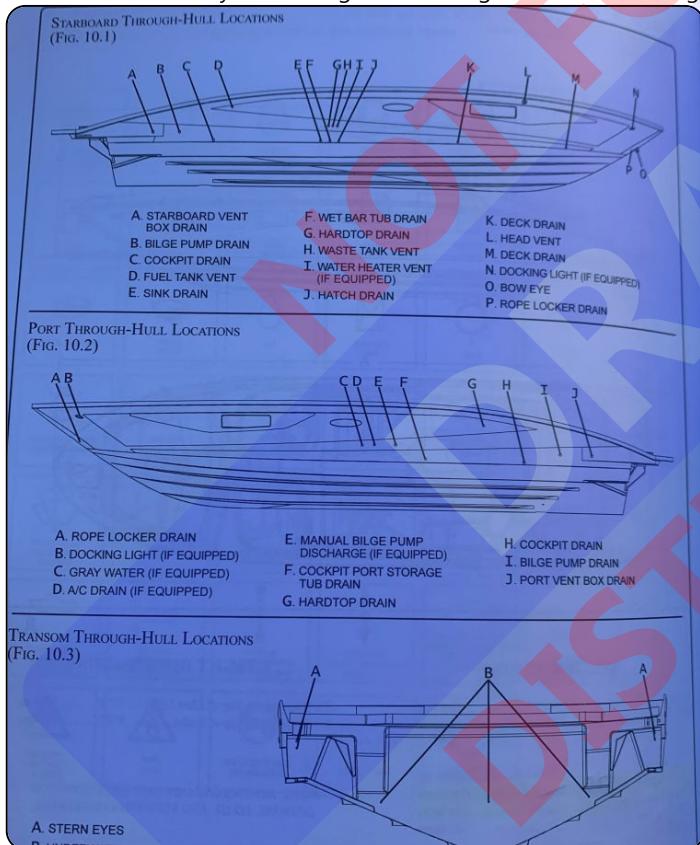
DRAINAGE THROUGH-HULLS

Marelon plastic composite hull side discharge through-hulls with stainless steel caps. No abnormal/soft percussion soundings, moisture conductivity, UV damage, or cracking around the drainage through-hull fittings was observed.

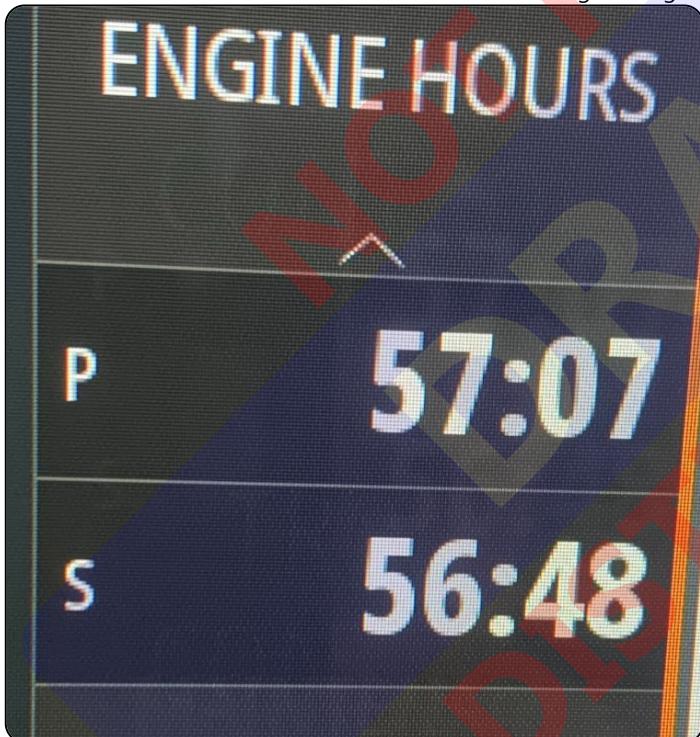
ENGINE HOURS

Port: 57 / starboard: 56 hours were observed on the engine's digital service hour meters.

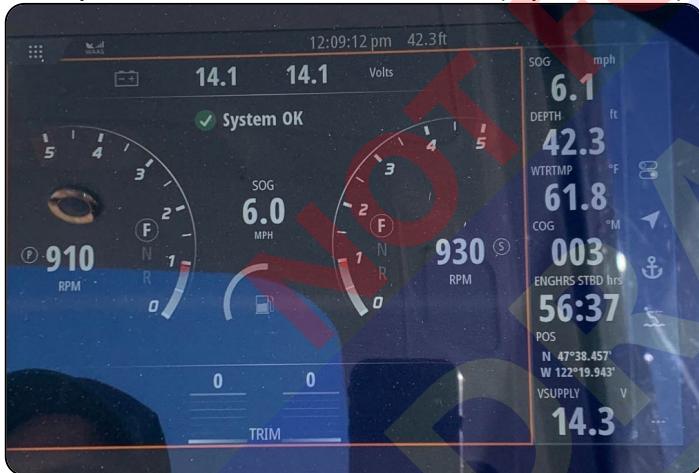
ENGINE DISPLAYS

Mercury Marine SmartCraft instrumentation displays. Powered up.

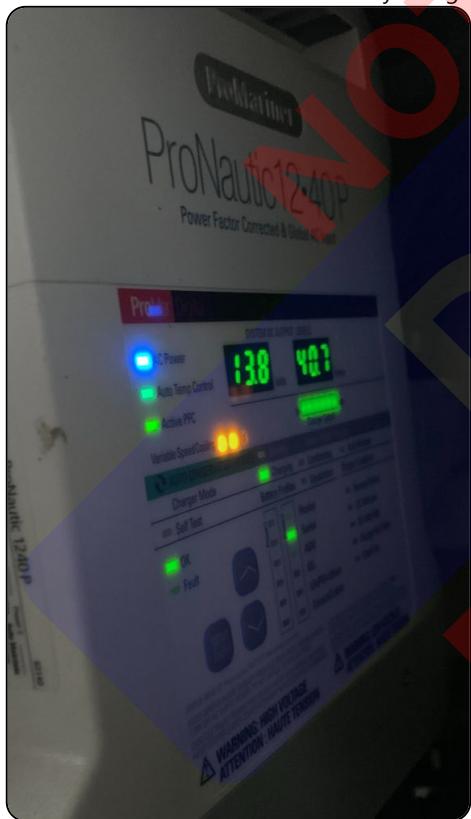
BATTERY CHARGERS

ProMariner ProNautic 12•40P battery charger with Blue Sea Systems ACR (Automatic Charging Relay).. Powered up.

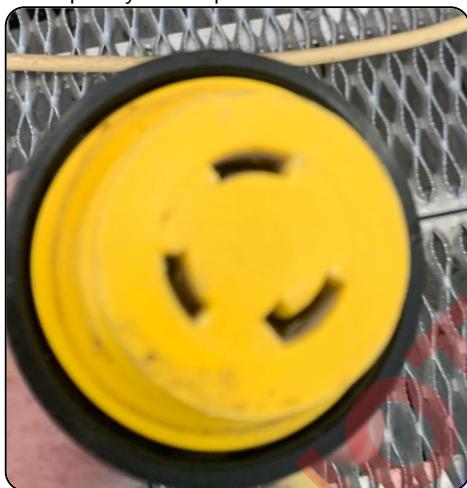
AC SHORE POWER CORDS

30 amp. vinyl shore power cord. No burn marks or corrosion sighted, and cord appeared serviceable.

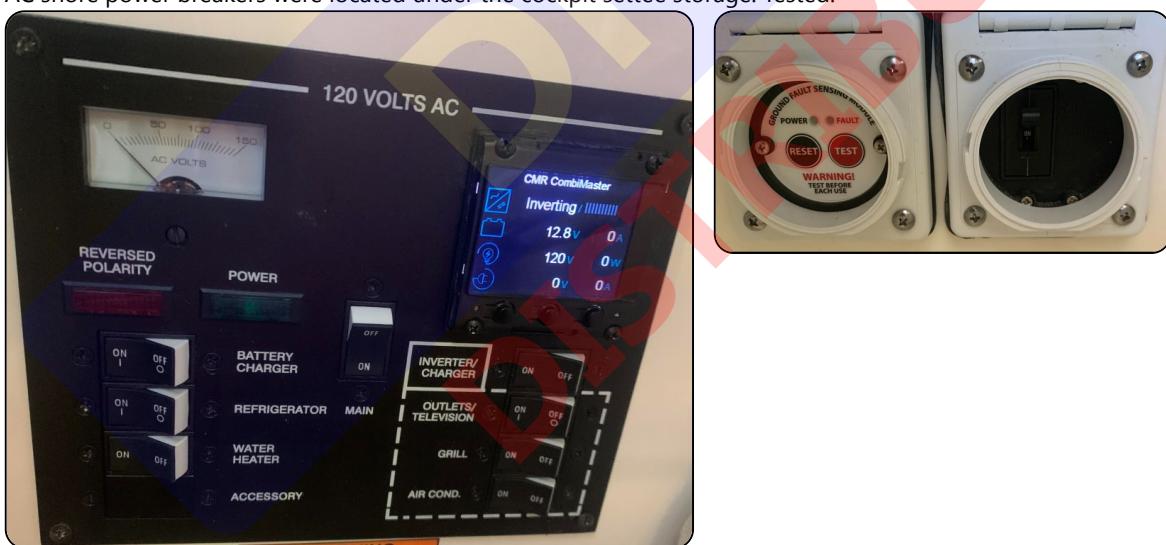
The main AC breaker was located in the main electrical panel.

AC shore power breakers were located under the cockpit settee storage. Tested.

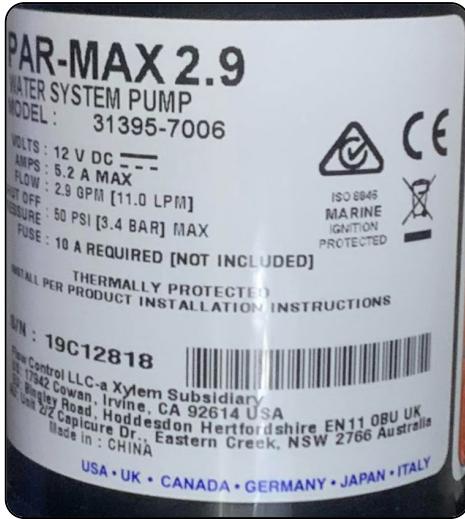
FRESHWATER PUMPS

Jabsco Par-Max 12 volt freshwater pump. Demonstrated. The freshwater system held pressure throughout the survey with no abnormal cycling or water leaks observed.

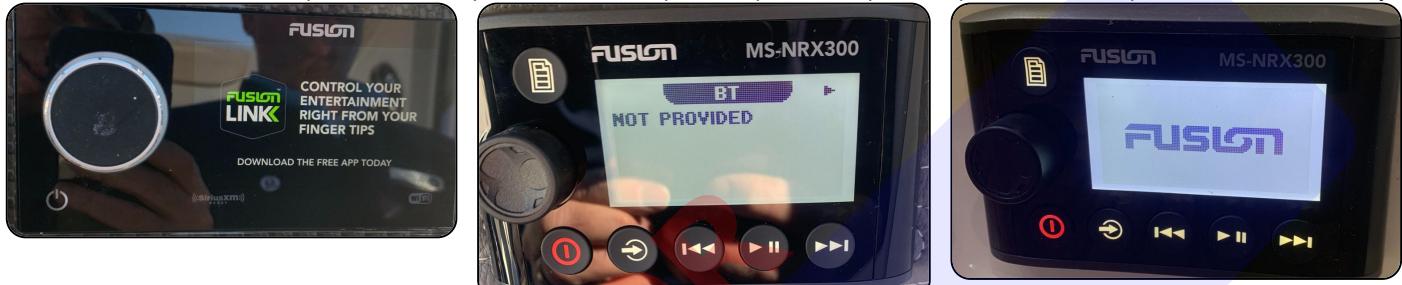
Fusion Apollo RA770 receiver at the helm with two (2) Fusion remote display controls; (one (1) MS-NRX300 at the transom and one (1) at the bow), with Fusion speakers and amps. The audio components powered up but required a full test/prove for all functionality.
