Pre-Purchase Report of Marine Survey

1981 40' Ocean Alexander Ocean 40

Cpt. Mark Van der Vliet

Date Of Survey: November 19, 2025

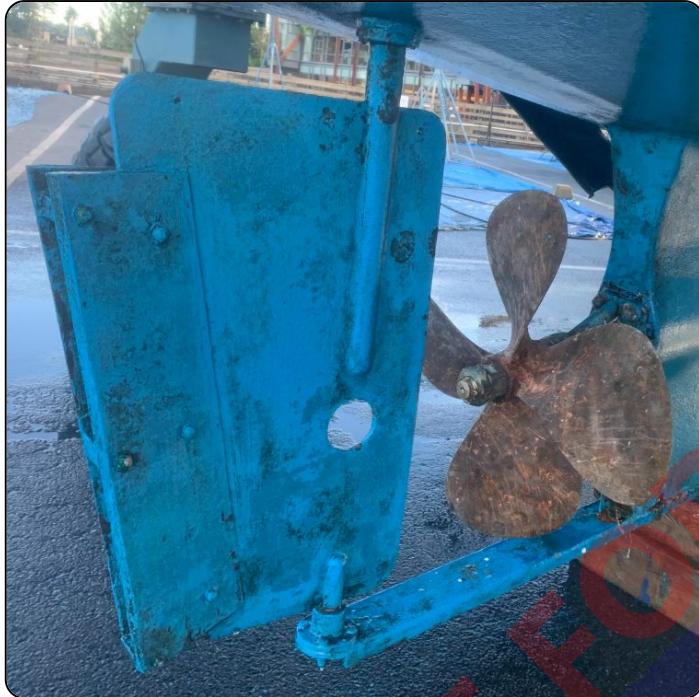
PROPELLERS

4-bladed bronze 26RH20. No cavitation erosion, dents, or damage were sighted on the propeller blades and roots. There was no excessive play between the propeller hubs.

Spare: 4-bladed bronze 26LH24.

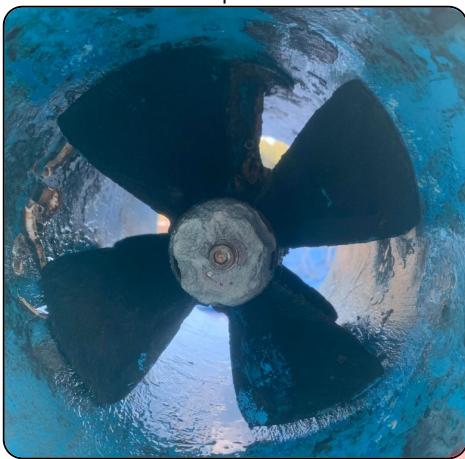
THRUSTERS

Four bladed bow thruster propellers either side. The bow thruster's external components and propeller blades were inspected without notable exception.

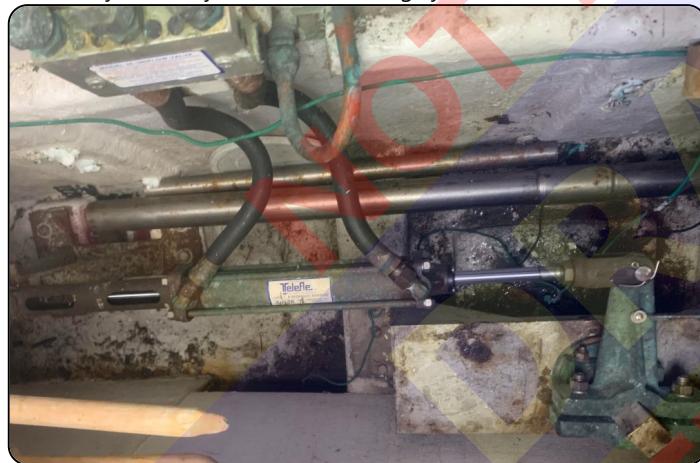
STEERING SYSTEM ACTUATORS

One (1) hydraulic cylinder. The steering system's actuator was observed to operate smoothly. No hydraulic fluid leaks were observed.

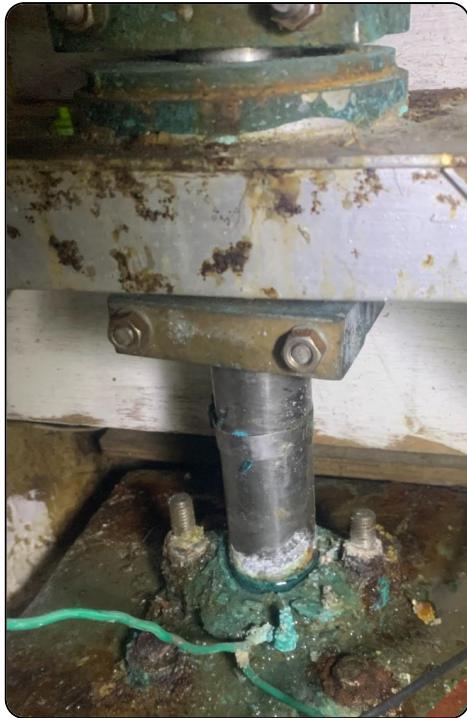
RUDDER LOG PACKING GLANDS

Flange & bolt type packing gland. No leaks were observed.

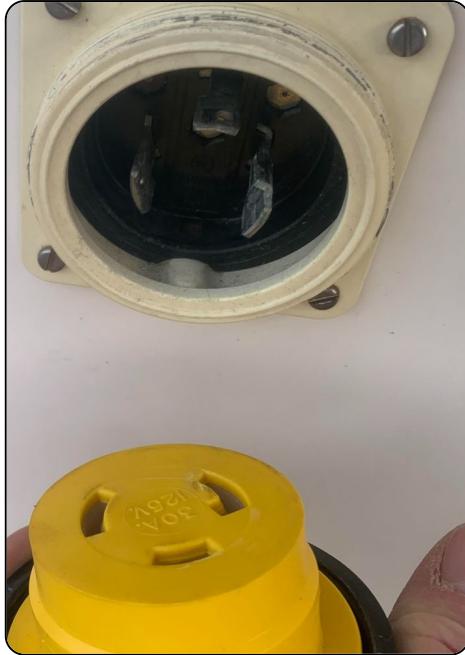
AC SHORE POWER INLETS

One (1) Hubbell 30A 125V inlet. No burn marks or corrosion sighted. Appeared serviceable.

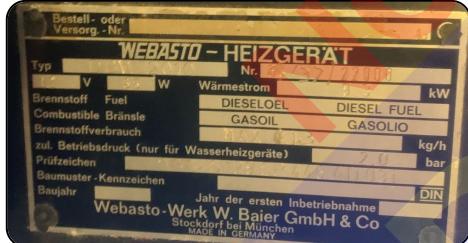
CABIN HEATING SYSTEM

Cabin heating was provided by engine heat exchanger and Webasto DBW 2010 diesel heater.

**Finding B-12**

The cabin heating system did not power up when tested.

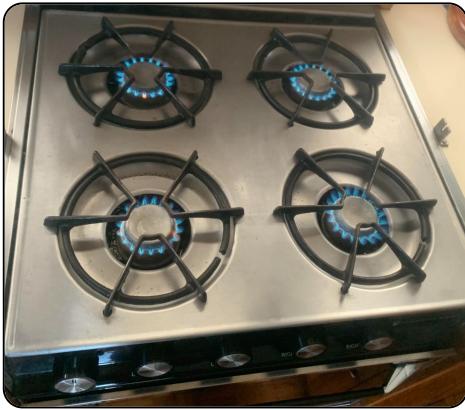
STOVE

Magic Chef LPG 4-burner stove/oven. Demonstrated.

Hinged burner cover with stainless steel heatshield.
