2002 42' Valiant V42CE

Pre-Purchase Report of Marine Survey

Date Of Survey: October 7, 2025

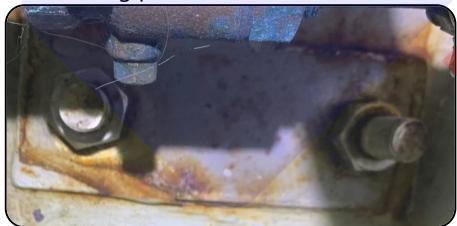
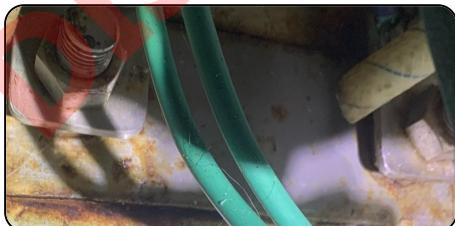
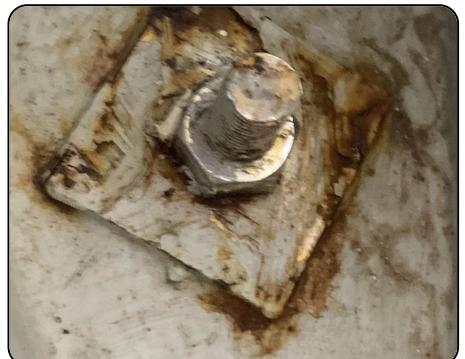
Stainless steel keel bolts cast into the lead ballast. No cracking, thread separation, lifting, or staining was observed on the keel bolts and backing plates.

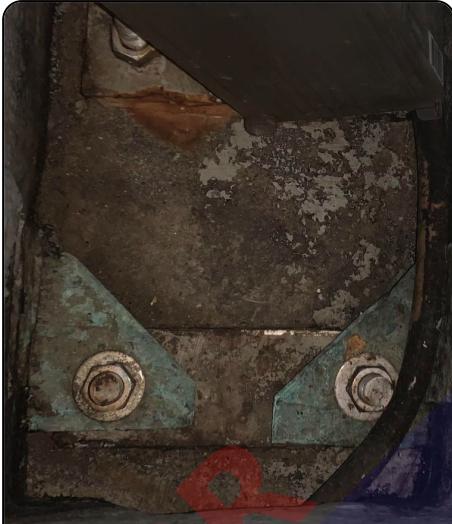
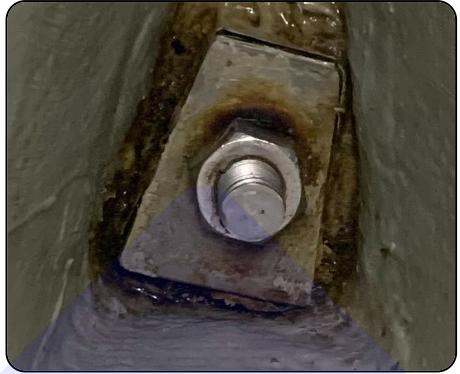
Minor galvanic corrosion on backing plate from a SS washer- removed at survey.

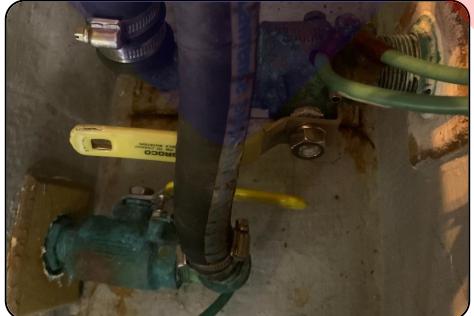
The bronze below waterline intake/discharge through-hulls were visually inspected, all appeared well fit with backing plates, double clamped and bonded, and all of the valves operated when tested.

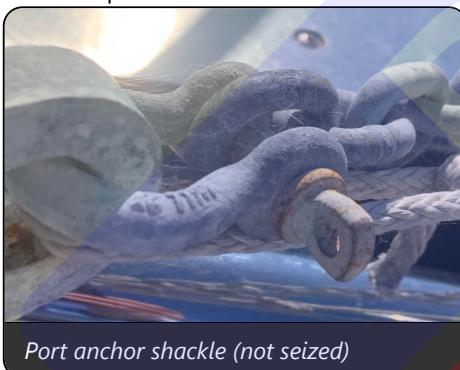
Note: the port anchor shackle bolt was not seized.

Port anchor shackle (not seized)

Finding B-1

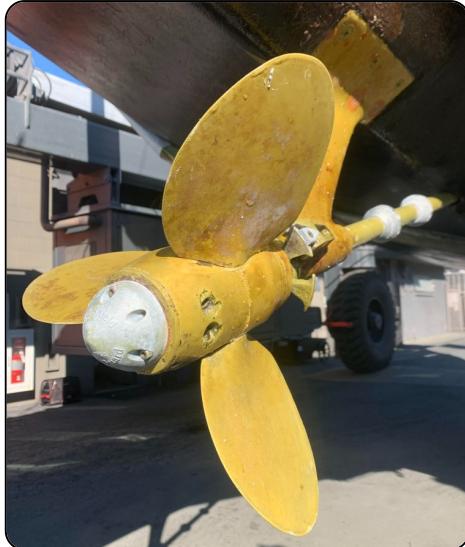
Bronze 3-bladed Max-Prop. No cavitation erosion, dents, or damage were sighted on the propeller blades and roots. There was no excessive play between the propeller hub and shaft.

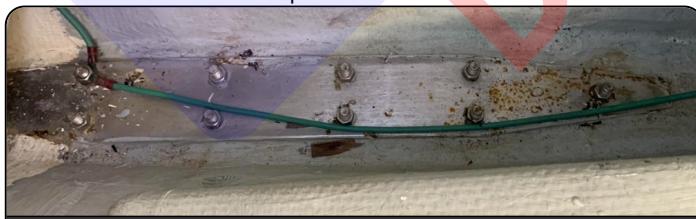
The skeg is mounted to the hull with through-bolts and a backing plate. The bolts and backing plate were visually inspected from inside the hull with no exceptions noted.

Skeg bolts and backing plate

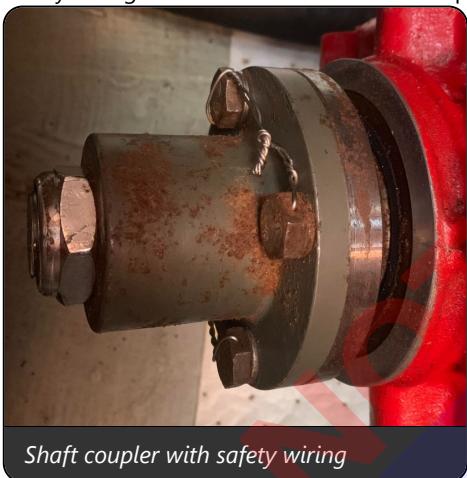
Safety wiring was installed on the shaft coupler.

Shaft coupler with safety wiring

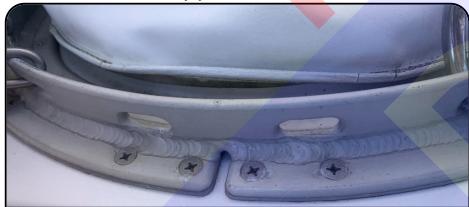
The mast was stepped to the deck on a cast aluminum pad with a compression post. Found secure.

Mast at Deck

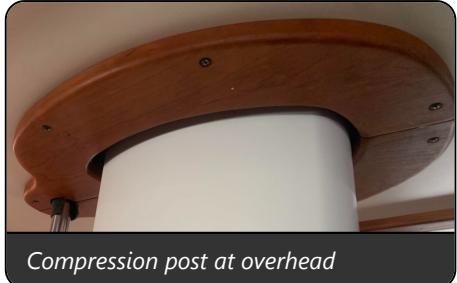
Aluminum compression post. No cracks or deformities sighted. Found securely fit to cabin top and fiberglass hull structure.

Compression post at overhead

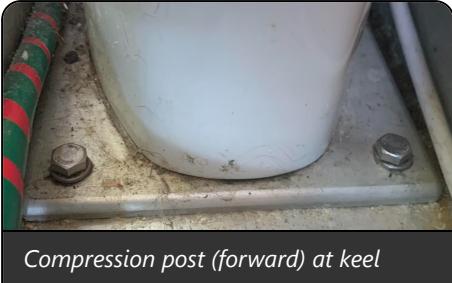
Compression post (forward) at keel table

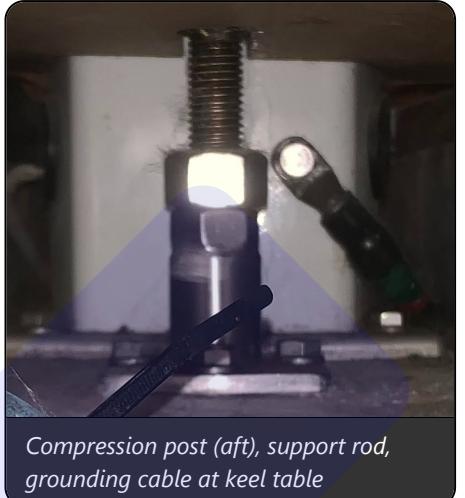
Compression post (aft), support rod, grounding cable at keel table

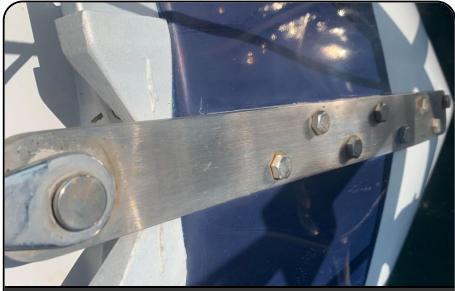
Internal stainless steel chain plates. No crevice corrosion, pitting, cracking, or deformations were observed.

Backstay chainplate

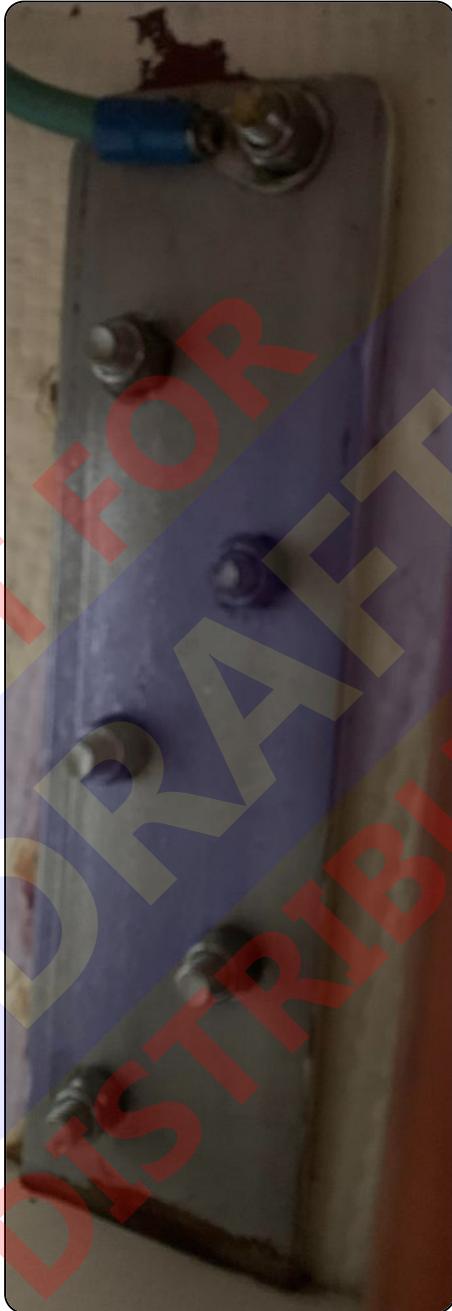
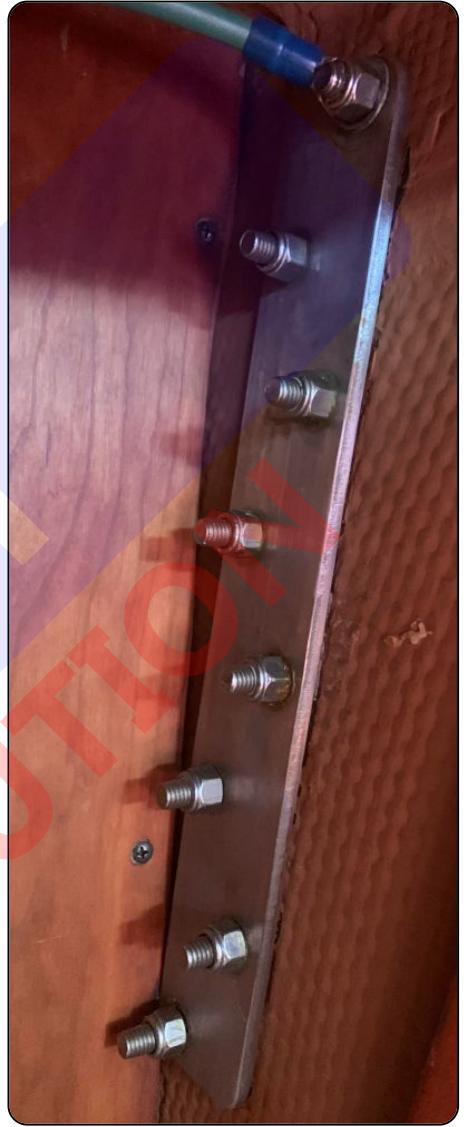
**SHROUDS/STAYS/TERMINAL ENDS**

The hydraulic backstay gauge window was broken, and minor hydraulic fluid was observed at the top of the strut.

Recommendation

Investigate possible hydraulic leak further, repair or replace pressure gauge.

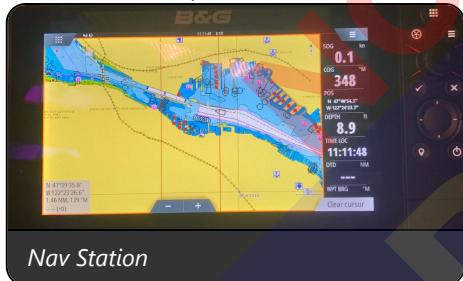
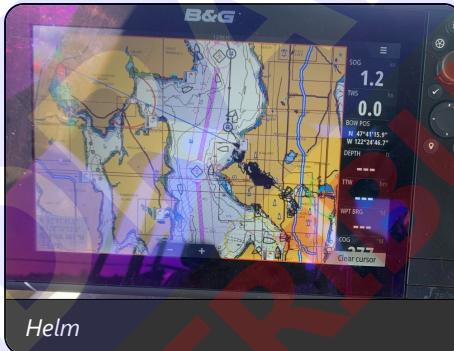
GPS CHARTPLOTTER

B&G Zeus3 chart plotters. Demonstrated.

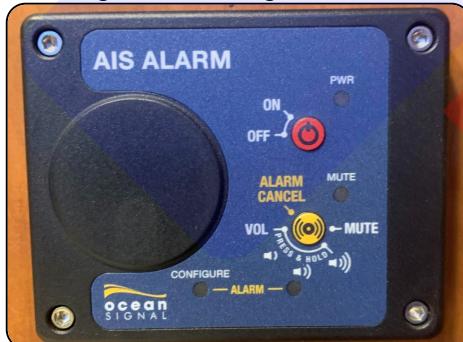
AIS (AUTO IDENTIFICATION SYSTEM)

Ocean Signal AIS. AIS target data was observed on the interfaced multi-function navigation units.

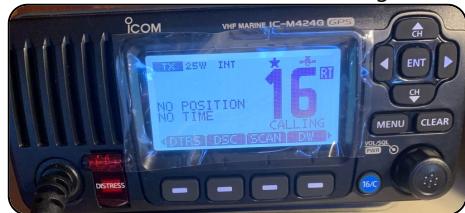
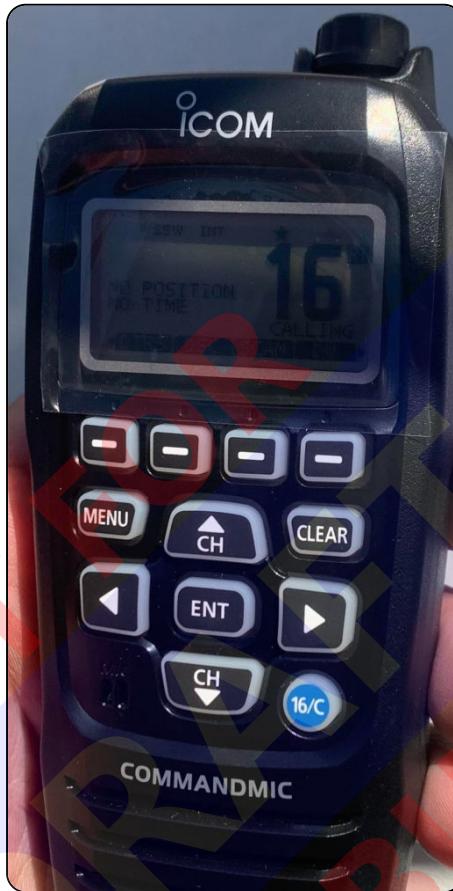
VHF RADIOS

iCOM M424G.

iCOM HM-195 CommandMic remote-control mic at helm.

Transmitted/received radio check signals.

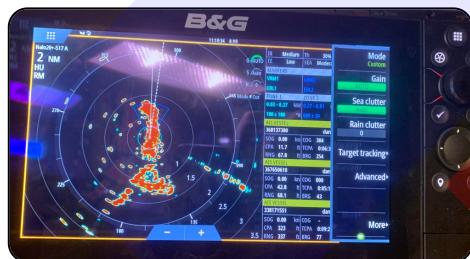
MARINE RADAR

Halo Dome radar interfaced with the B&G helm and navigation station monitors. Demonstrated.

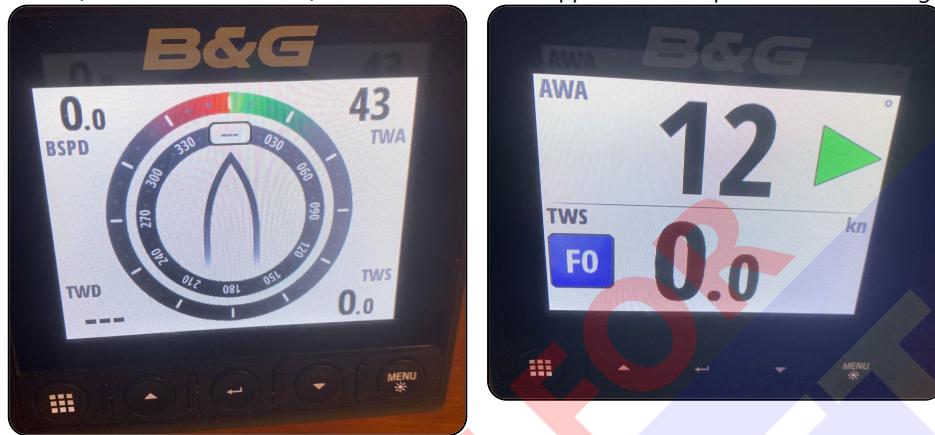
WIND INSTRUMENT

B & G (Brookes & Gatehouse) Triton2 network true/apparent wind speed and direction gauges. Demonstrated.

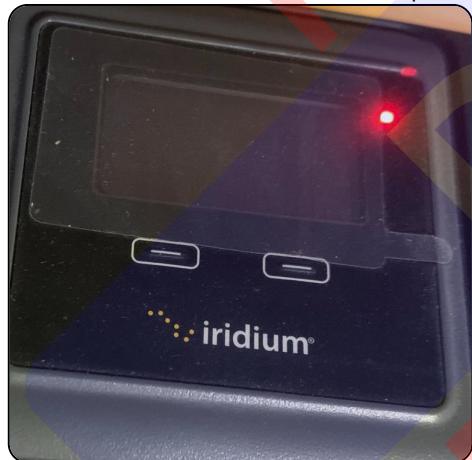
SATELLITE TELEPHONE

Iridium GO! satellite device. Powered up. Not demonstrated.

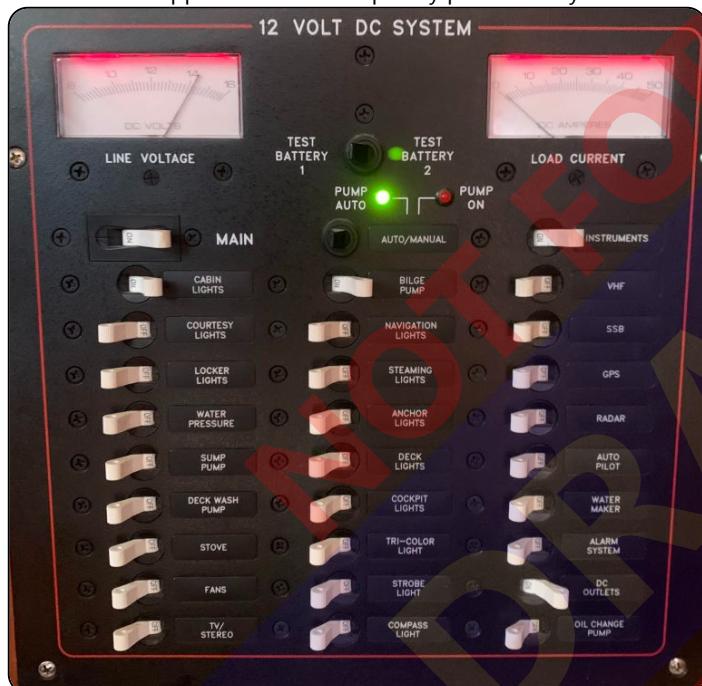
DC ELECTRICAL PANEL BREAKERS/FUSES

All DC circuits appeared to be adequately protected by branch or switched breakers.

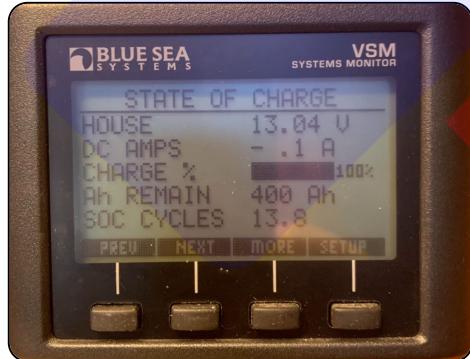
DC ELECTRICAL SYSTEM MONITORS

Analog DC voltage and amperage gauges were located in the main DC electrical panel. Powered up.

Blue Sea Systems VSM systems monitor digital display was located at the navigation station. Powered up.

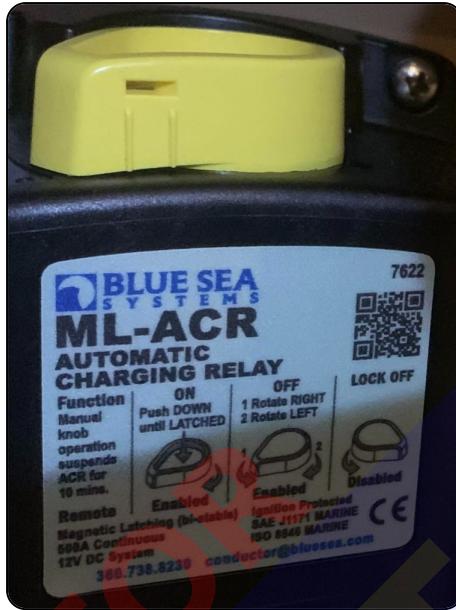
BATTERY CHARGERS

Xantrex True-Charge 40+ 12 volt / 40 amp. battery charger. Powered up.

Blue Sea Systms ML-ACR (Automatic Charging Relay).

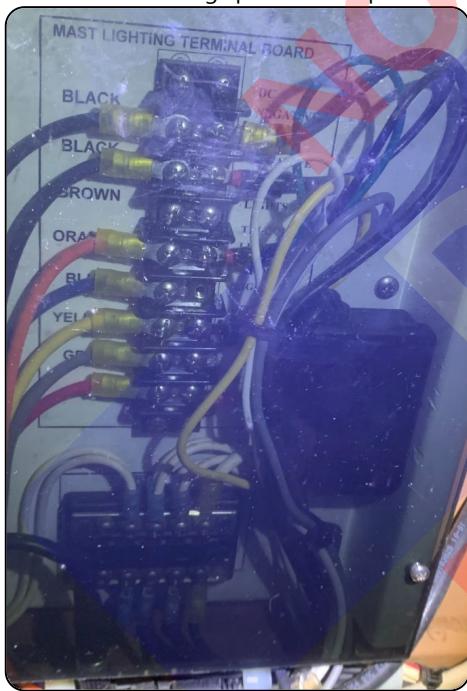
DC ELECTRICAL/WIRING COMMENTS (ABYC E-11)

The wiring appeared to be well supported and secured every 18" (ABYC E-11.15.4.1.9) where sighted, and conductor connections were made with ring spade or crimp-on connectors, where sighted.

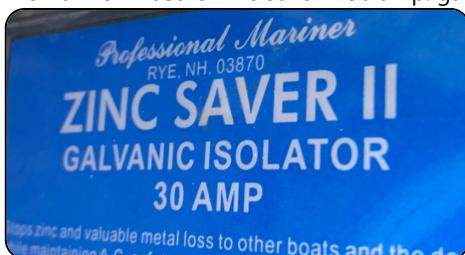
GALVANIC ISOLATION SYSTEM (ABYC A-28)

ProMariner ProSafe Zinc Saver II 30 amp. galvanic isolator.

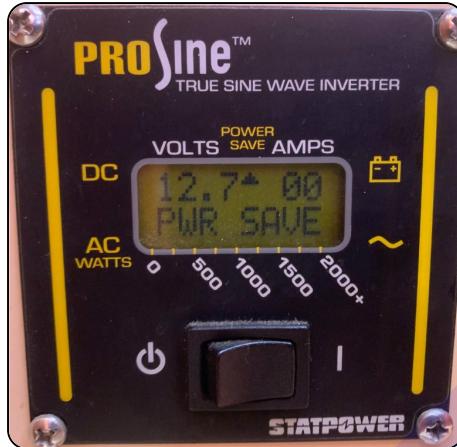
INVERTER SYSTEMS (ABYC E-11, A-31)

Xantrex ProSine 1800 True Sine Wave inverter with breaker and digital display. Powered up.

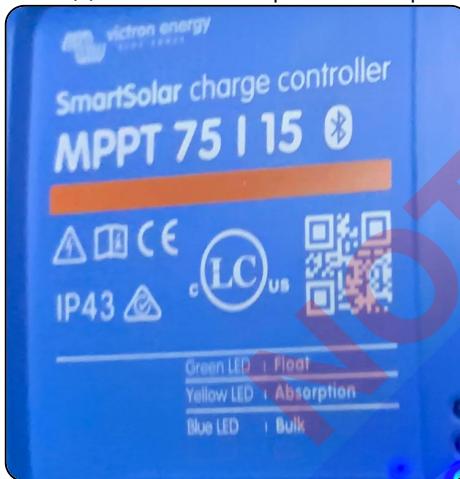
SOLAR POWER SYSTEM

Three (3) SunPower Solar photovoltaic panels with Victron Energy MPPT 75/15 Blue solar charger controller. Powered up.

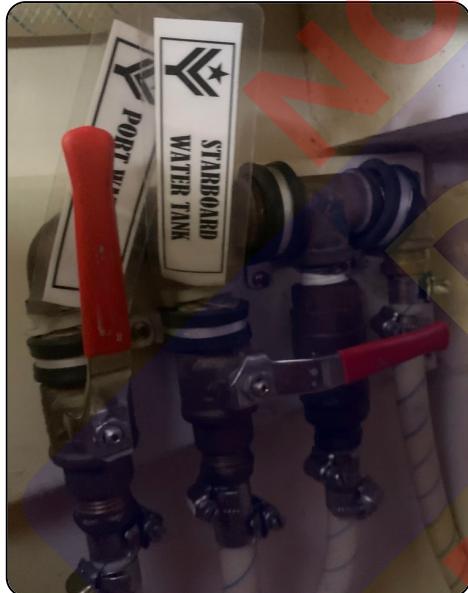
**MANIFOLD**

Two (2) bank water system manifold. The valves moved freely when tested.

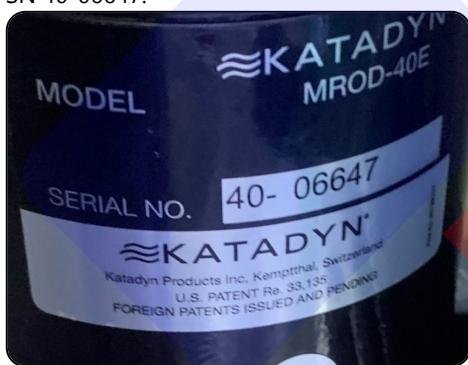
Model MROD-40E.

SN 40-06647.

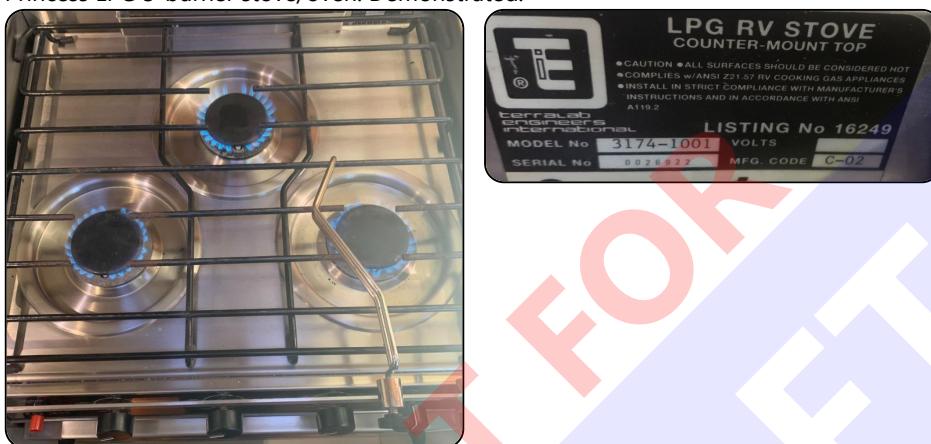
STOVE

Princess LPG 3-burner stove/oven. Demonstrated.

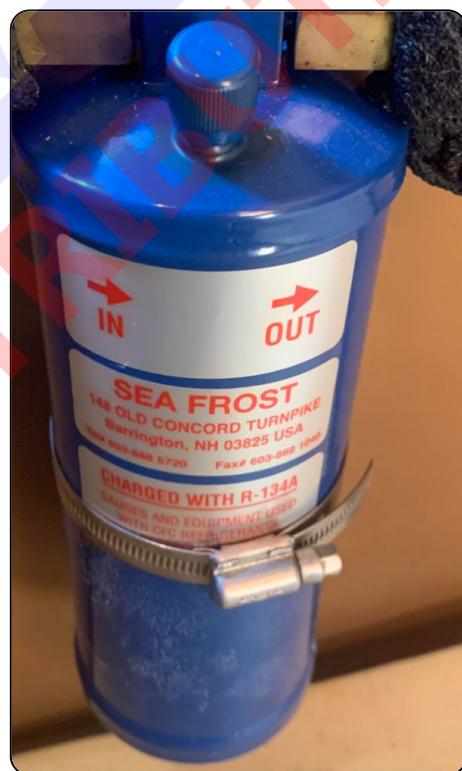
REFRIGERATION

Sea Frost dual counter drop-in refrigeration with analog temperature gauges, dedicated raw water intake and in-line filter, and Leeson 12VDC motor, and dedicated breaker. Powered up.
