2006 42' Beneteau Oceanis 423 2C

Pre-Purchase Report of Marine Survey

Date Of Survey: September 8, 2025

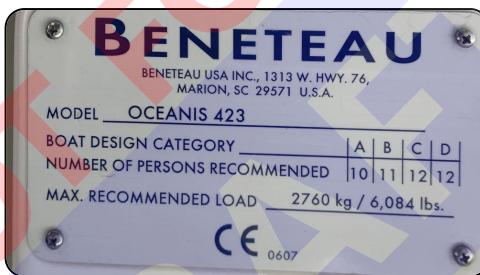
HIN (HULL IDENTIFICATION NUMBER) BEYNXXXXH506

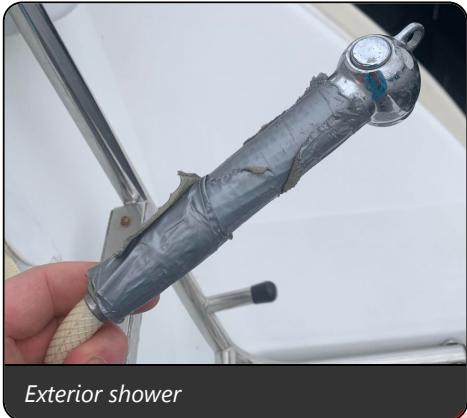
Exterior shower

Hot/cold shower in the starboard transom.

Finding B-4

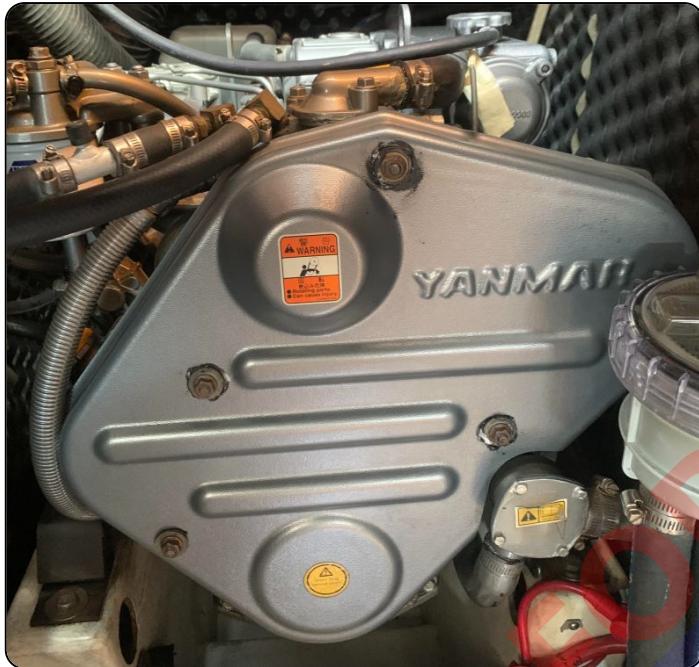
Yanmar 4JH4E

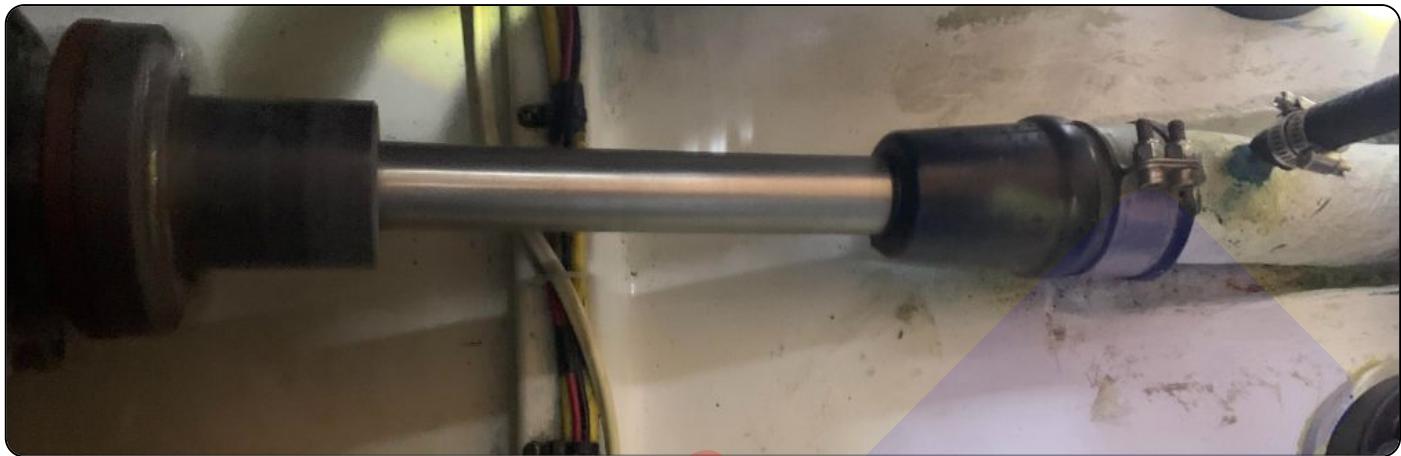
Size: 30mm. Material: stainless steel. No pitting or corrosion was observed on the shaft.

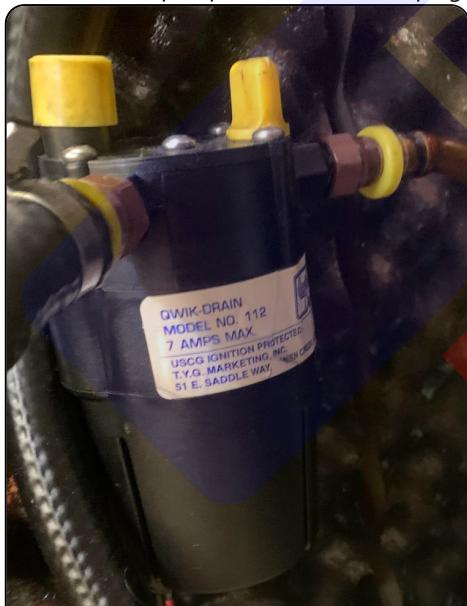
Lube transfer pump

12v electric oil pump attached to drain plug. Not demonstrated.

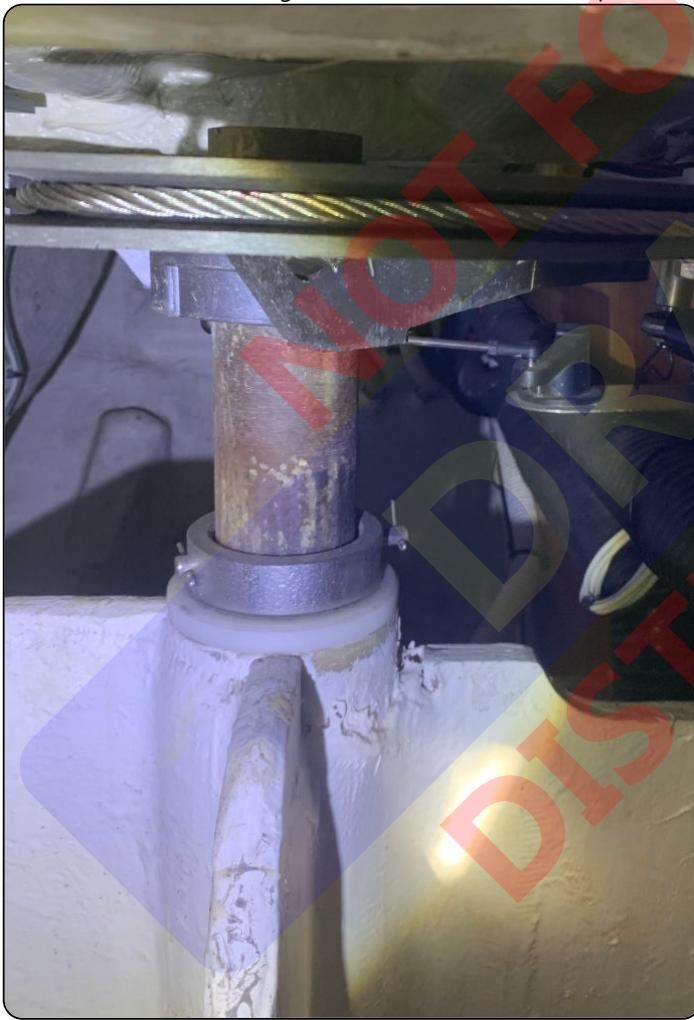
Bronze rudder stock. No significant corrosion had developed on the rudder stock.

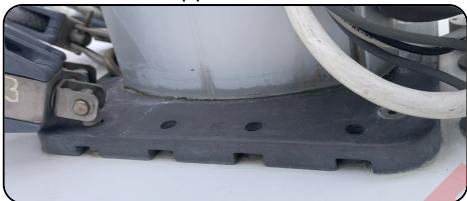
The mast was stepped to the deck on a cast aluminum pad. Appeared secure, no deck compression sighted.

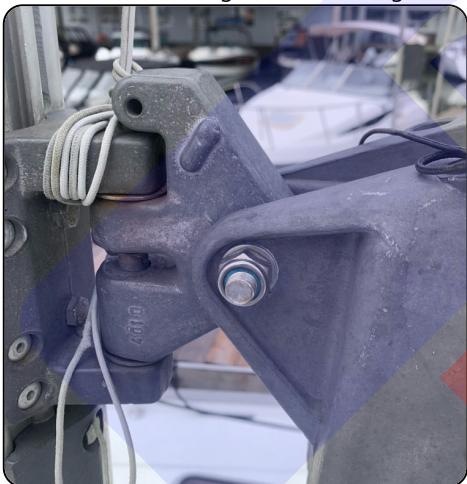
Anodized aluminum gooseneck. The gooseneck was found secure.

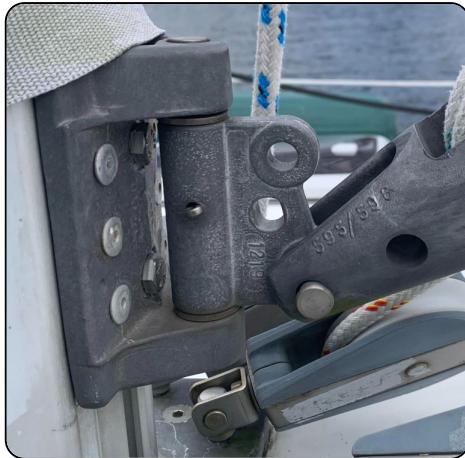
Spring loaded manual (line- controlled) boom vang. Found secure.

Found secure.

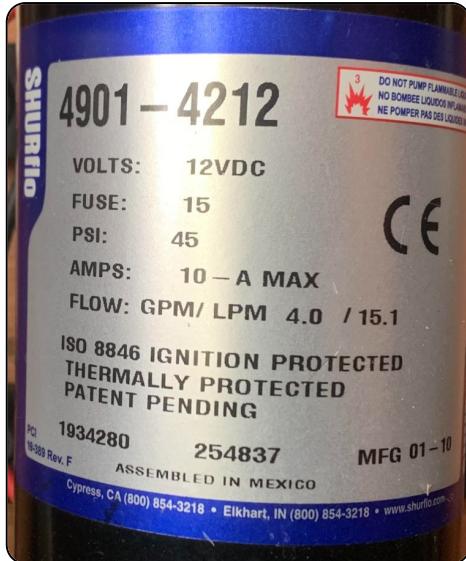
Shurflo 12VDC 4.0 gpm freshwater pump. Demonstrated. The freshwater system held pressure throughout the survey with no abnormal cycling or water leaks observed.

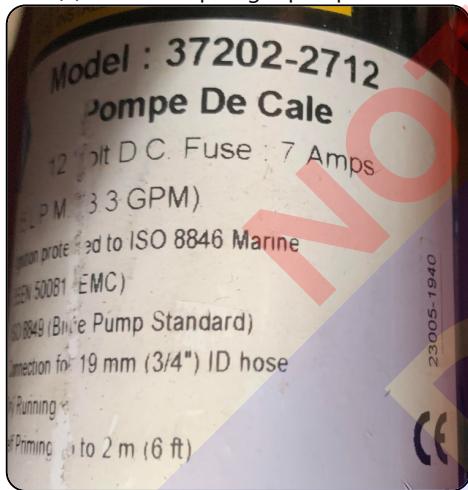
One (1) 12VDC diaphragm pump with float switch. Demonstrated from float switch and remote switch at electrical panel.
