1999 57' Bayliner 5788

Condition & Value Report of Marine Survey

Date Of Survey: October 16, 2025

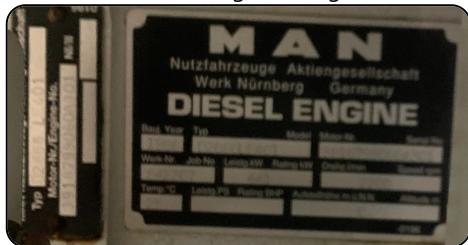
Unknown (the data tag was illegible).

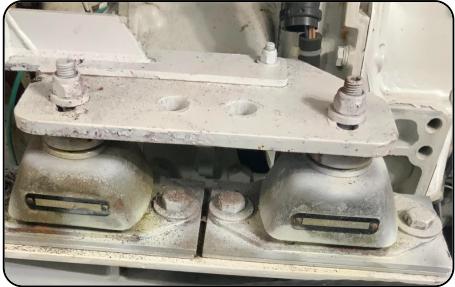
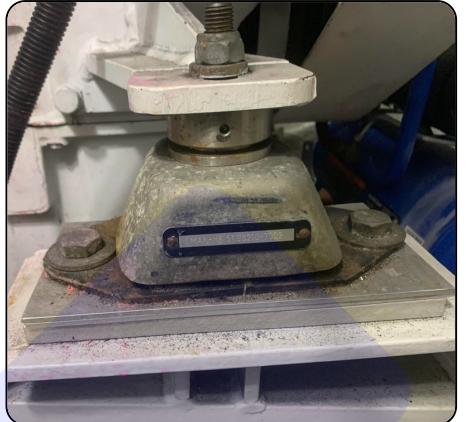
Adjustable captive rubber block type motor mounts on cored fiberglass longitudinal stringers with steel stringer caps. Appeared serviceable.

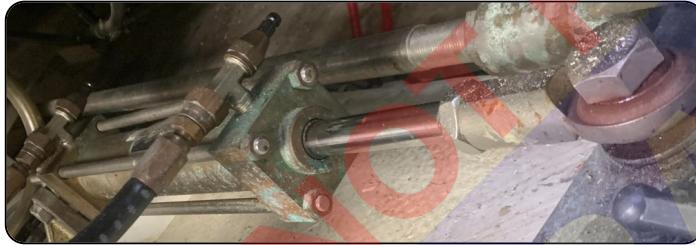
One (1) hydraulic cylinder. The steering system's actuator was observed to operate smoothly. No hydraulic fluid leaks were observed.

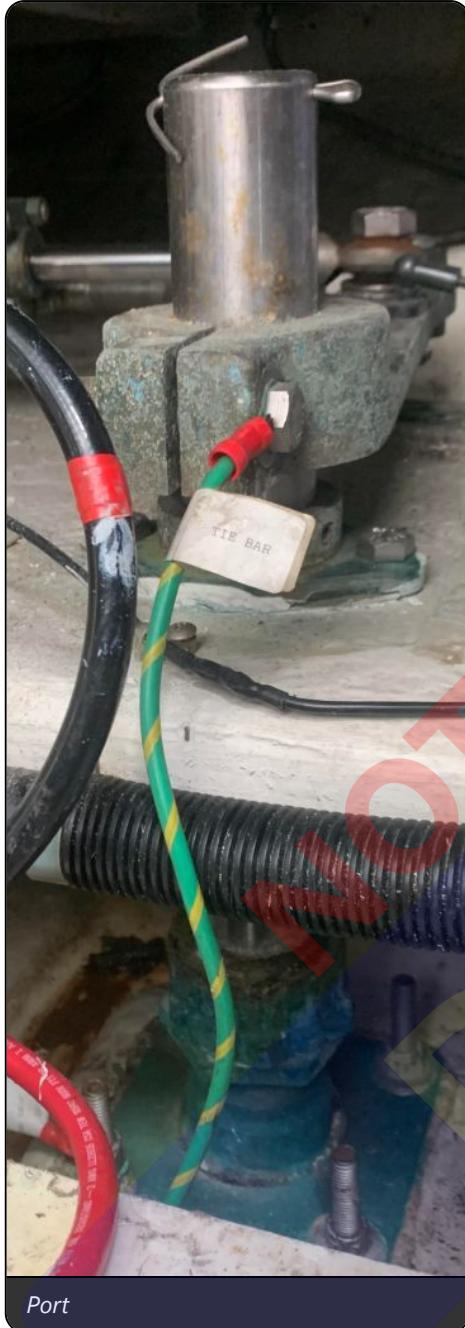
Bronze upper rudder bearings on cored fiberglass rudder tables. Found secure.

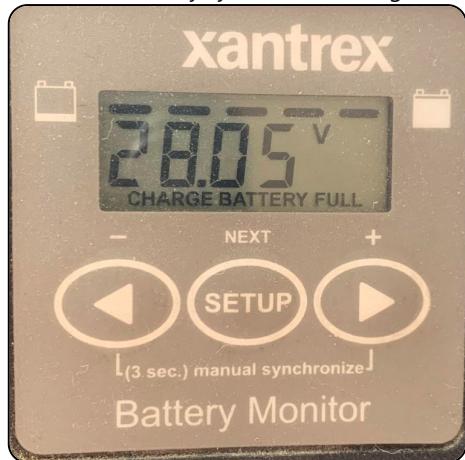
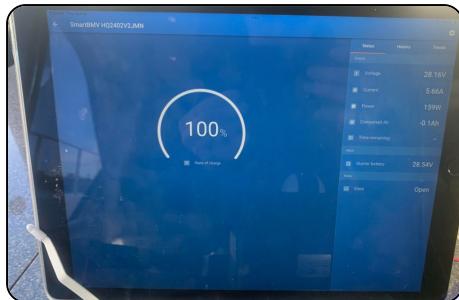
Xantrex battery monitor at pilothouse helm station. Powered up.

SmartBMV battery system monitoring. Demonstrated.

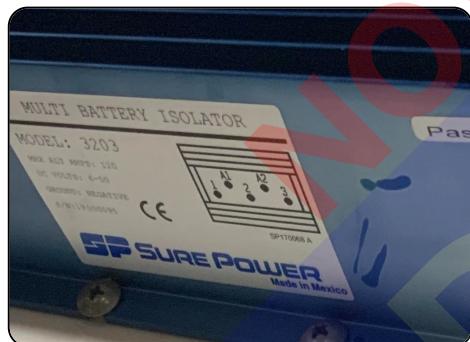
SurePower Multi Battery Isolator.

Model 3203.

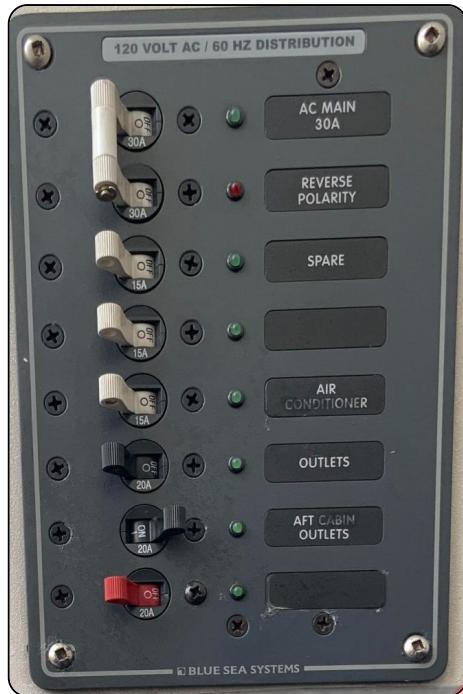
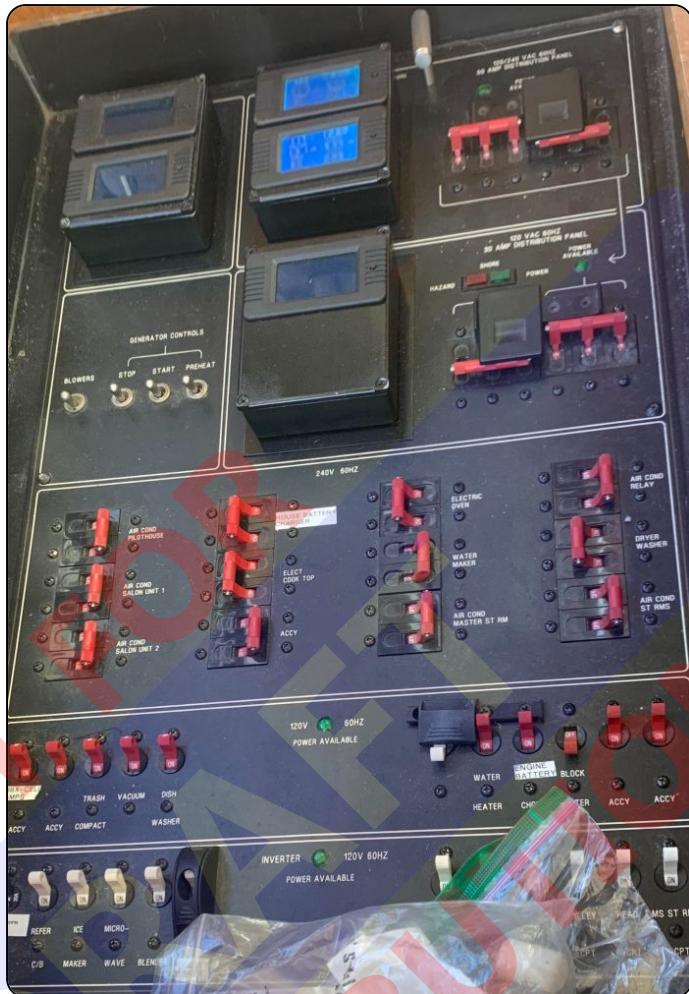
AC branch breakers were located in the AC electrical panel. AC circuits appeared adequately protected by branch breakers.

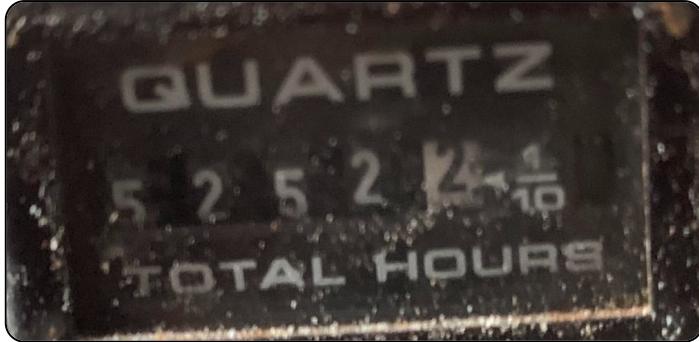
5252 hours were observed on the generator mounted hour meter.

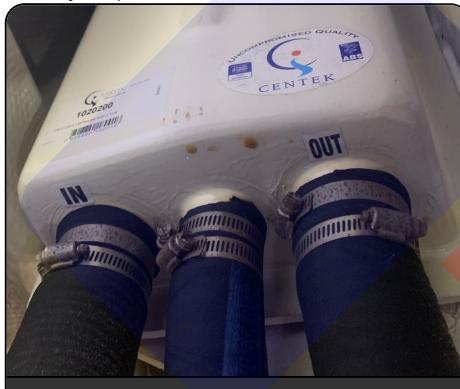
Raw water cooled with fiberglass water-lift type muffler and Centek Gen-Sep (demonstrated). The generator exhaust system was visually inspected with no deficiencies observed. No iron sulfide corrosion (rust) sighted.

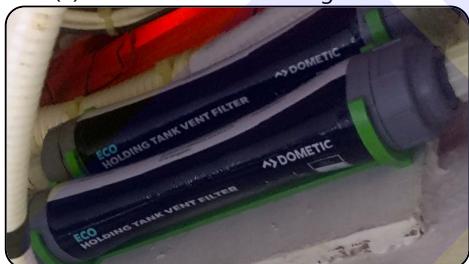
The blackwater tank's vent fittings were plumbed overboard at the starboard hull side.

Two (2) in-line Dometic holding tank filters.

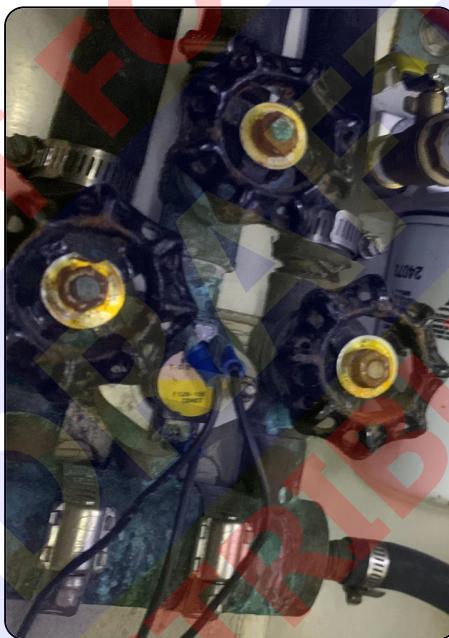
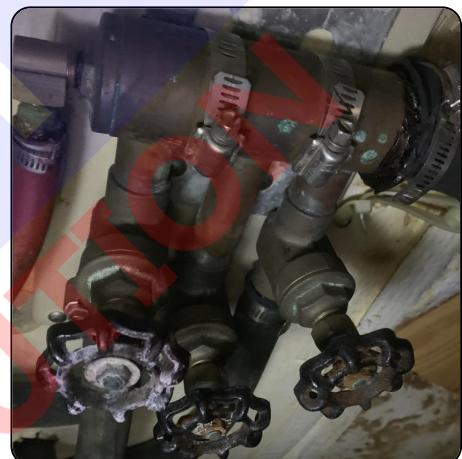
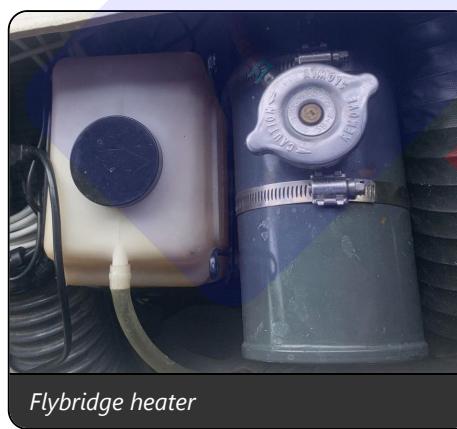
24V Webasto Diesel heater with circulation pump, two (2) hose manifolds, and circulation hoses to individually controlled cabin heating units. Demonstrated.

Flybridge heating unit.

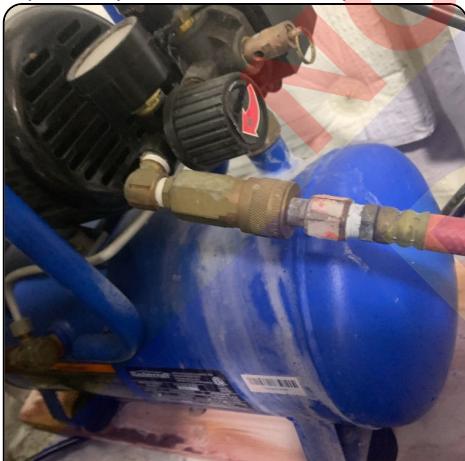
Compressor for air horn

Triple trumpet air horn with compressor and dual trumpet electric air horn. Powered up.
