1995 48' Oyster 485 Deck Saloon

Pre-Purchase Report of Marine Survey

Date Of Survey: October 23, 2025

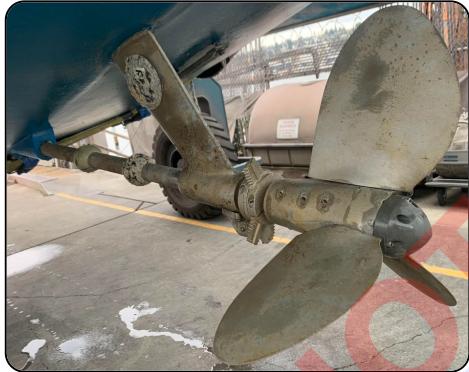
SHAFT STAVE BEARINGS (CUTLESS BEARINGS)

The cutless bearing showed no signs of significant wear.

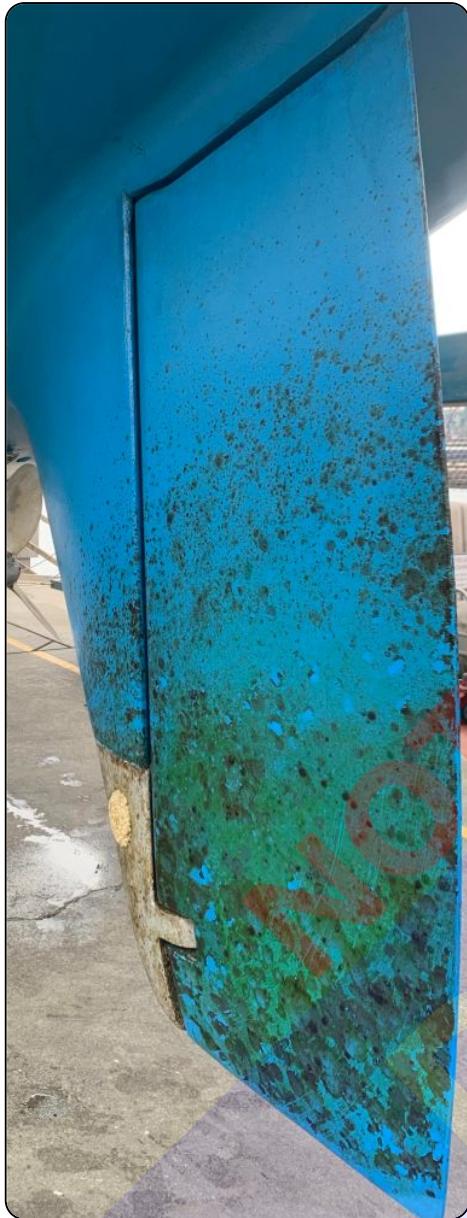
RUDDER MOUNTING

Skeg mounted.

Appeared well secured. No horizontal and fore/aft movement was observed when tested by hand.

Percussion hammer testing showed no evidence of softness or delamination on rudder.

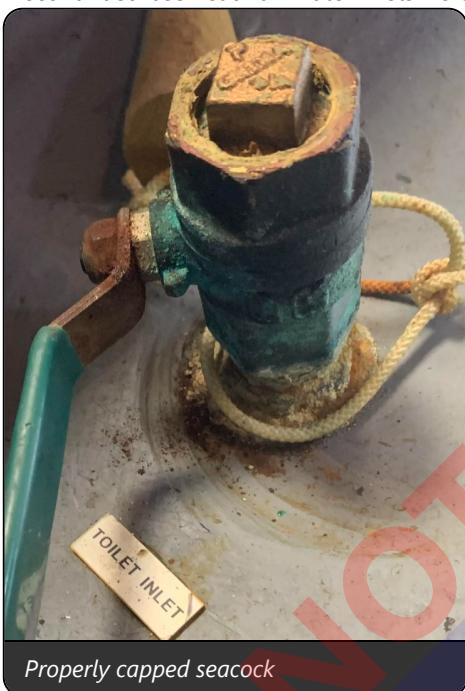
Discontinued-use head raw water inlets were properly capped.

Properly capped seacock

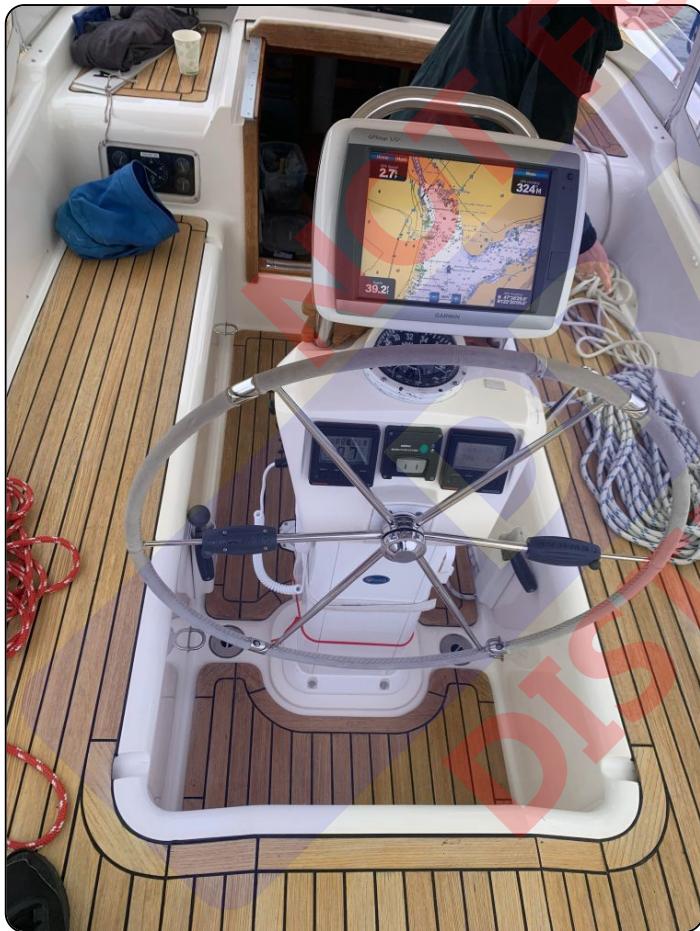
STEERING SYSTEM PULLEYS/CABLES

The cable and pulley system was well secured where sighted and operational during the survey. The sheaves moved freely when tested and no broken cable strands were sighted.

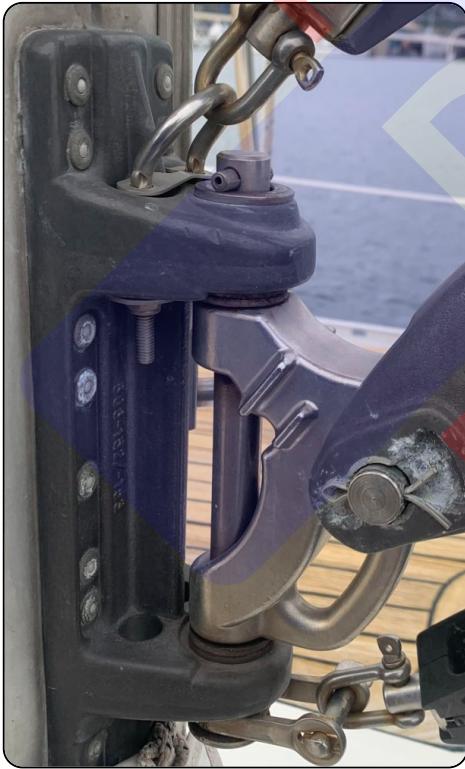
BOOM VANG GOOSENECK

Found secure.

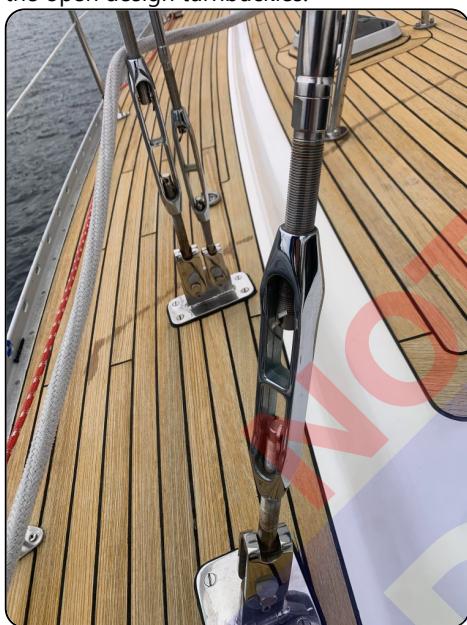
RIGGING TURNBUCKLES

Open design stainless steel turnbuckles. Observed with 40x Loupe LED magnifying glass. No significant corrosion had developed on the open design turnbuckles.

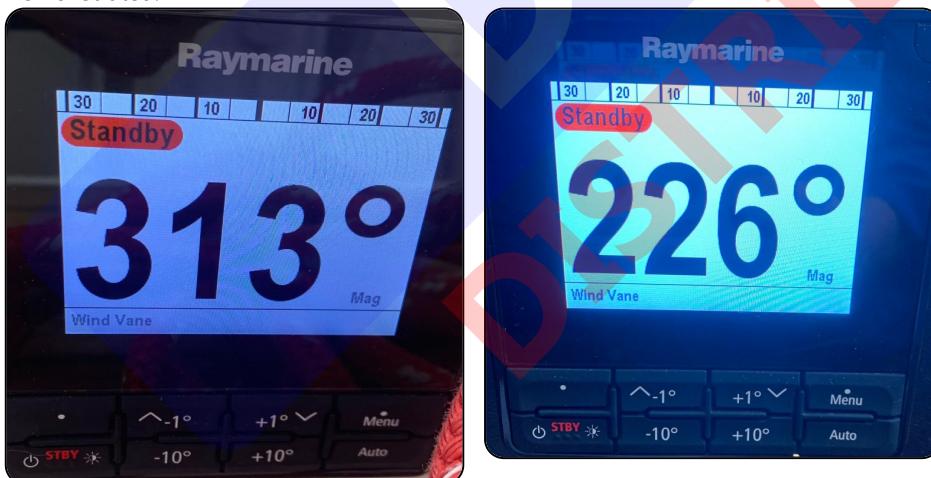
Autohelm Type 100/300 with Heavy Duty S Autopilot linear electric actuator to with displays at helm and navigation station. Demonstrated.

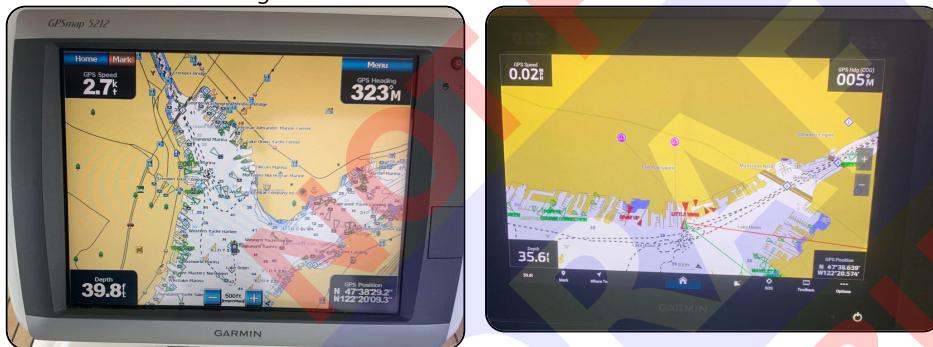
**GPS CHARTPLOTTER**

Garmin 5212 at cockpit. Demonstrated.

Garmin 8619XSV at navigation station. Demonstrated.

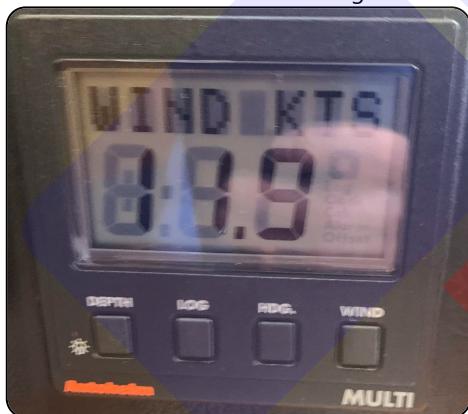
**MULTI-INSTRUMENTS**

Autohelm ST50 Plus Multi at navigation station. Demonstrated.

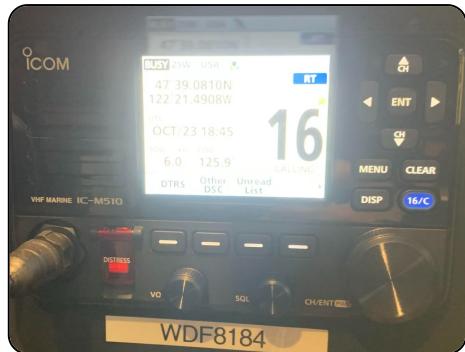
**VHF RADIOS**

iCOM IC-M510 VHF radio. Transmitted/received radio check signals.

iCOM IC-M710 SSB radio. Powered up.

ICOM HM195GW VHF RAM mic. Powered up.

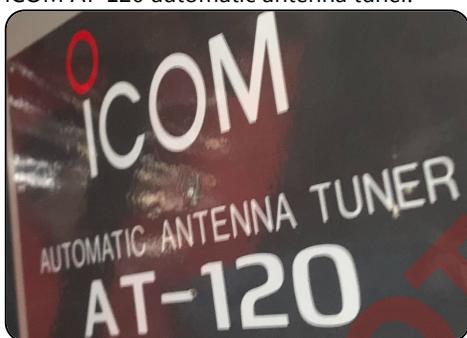
ANTENNAS

The antennas appeared to be well mounted. Sighted from deck level only.
iCOM AT-120 automatic antenna tuner.

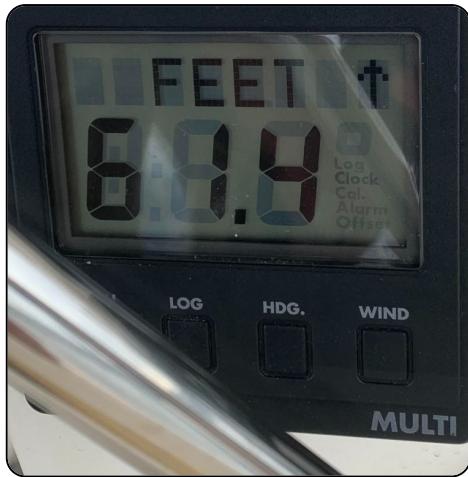
DEPTH DISPLAY

Autohelm ST50 Plus Depth display. Demonstrated.

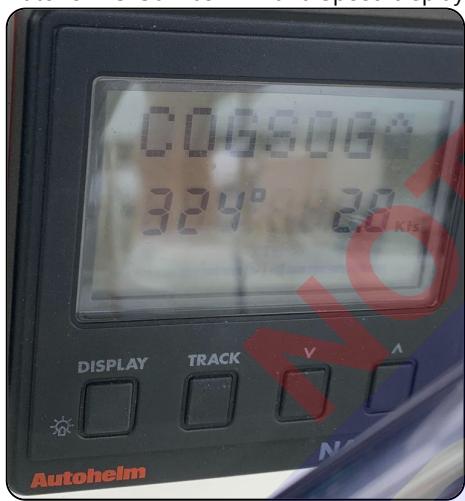
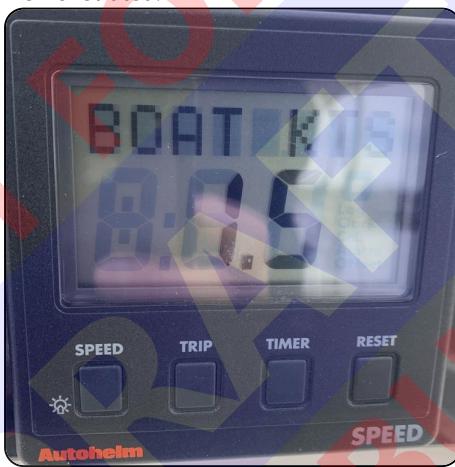
SPEED DISPLAY

Autohelm ST50 Plus NAV and Speed displays. Demonstrated.

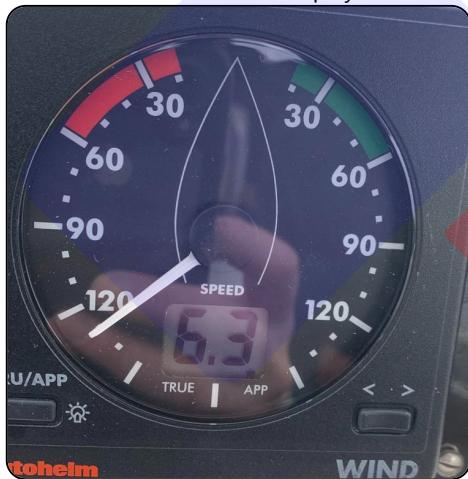
WIND INSTRUMENT

Autohelm ST50 Plus Wind display. Demonstrated.

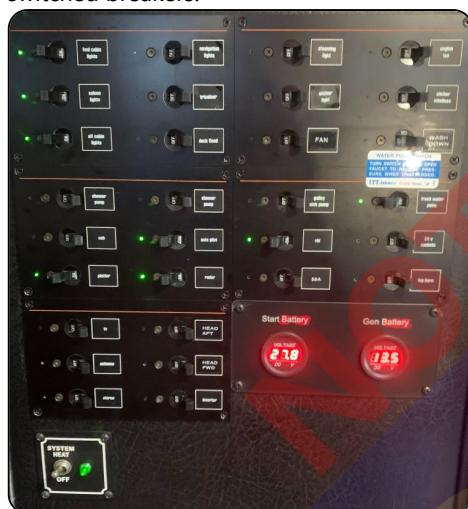
DC ELECTRICAL PANEL BREAKERS/FUSES

DC branch breakers were located in the main cabin electrical panel. All DC circuits appeared to be adequately protected by branch or switched breakers.

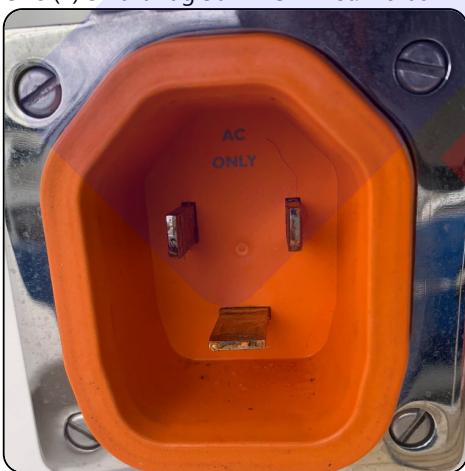
AC SHORE POWER INLETS

One (1) SmartPlug 30A 125V inlet. No burn marks or corrosion sighted. Appeared serviceable.

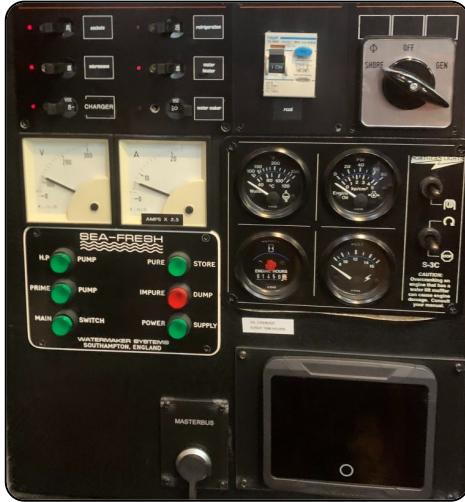
AC ELECTRICAL PANEL BREAKERS

AC branch breakers were located in the AC electrical panel. AC circuits appeared adequately protected by branch breakers.

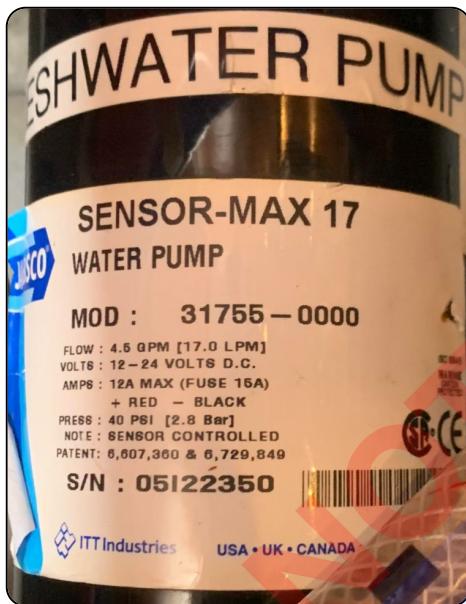
FRESHWATER PUMPS

12-24V Jabsco Sensor-Max 17. The freshwater system held pressure throughout the survey with no abnormal cycling or water leaks observed.
